# Technical Memorandum of Public Works Research Institute

No. 1344

Preliminary Report of Investigations on the Relief and  
Rehabilitation in the Izu-Ohsima Kinkai Earthquake of 1978

Public Works Research Institute  
Ministry of Construction

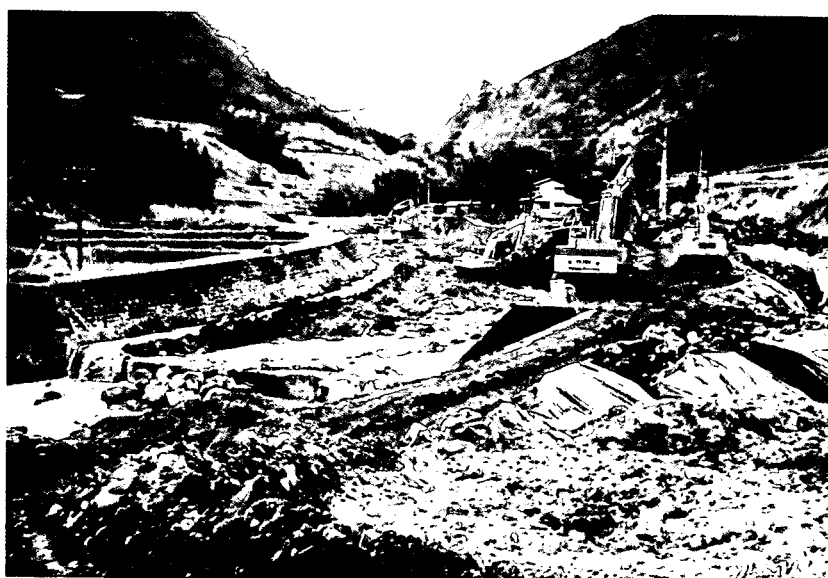
Photo 2. Sludge Removal from the Mochikoshi River

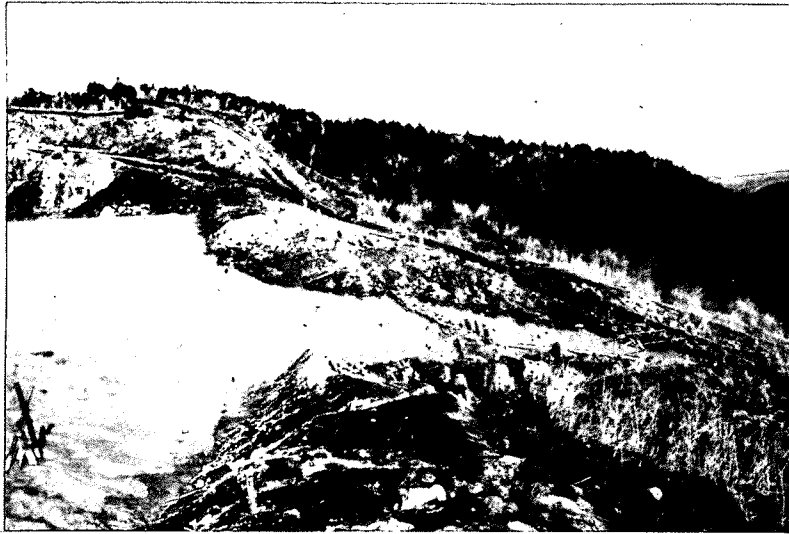
Photo 3. Flowing Out of Sludge Caused by the Failure of Dykes of its Reservoir

They repaired the dykes temporarily by driving double steel sheetpiles.

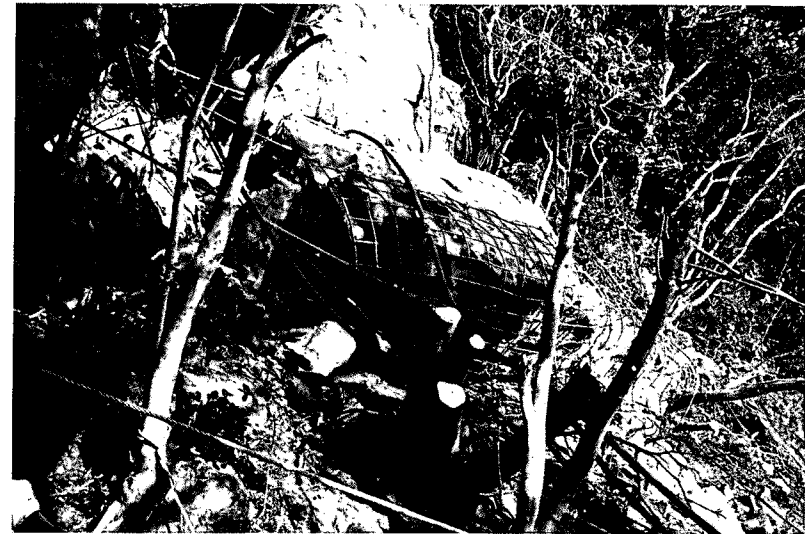
Photo 4. Temporary Countermeasures to Prevent Rock Fall in Shimoda City

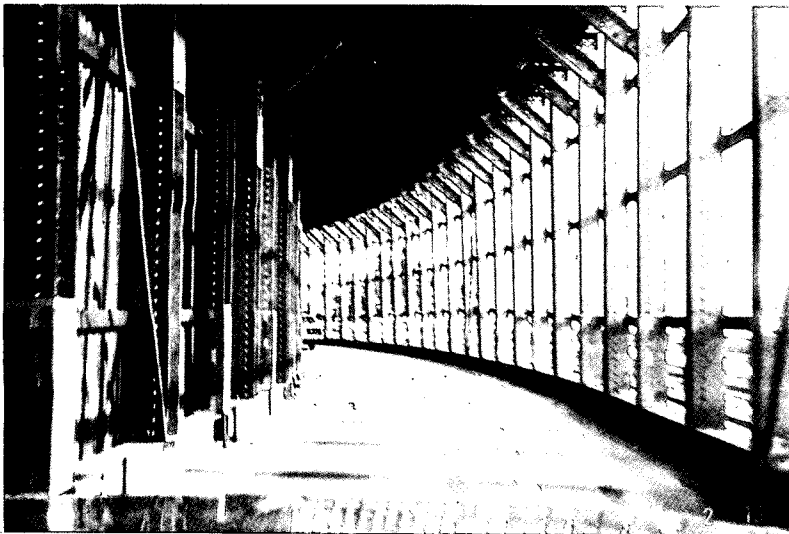
Photo 5. Temporary Structure to Prevent Rock Fall on the Higashi-izu Toll Road

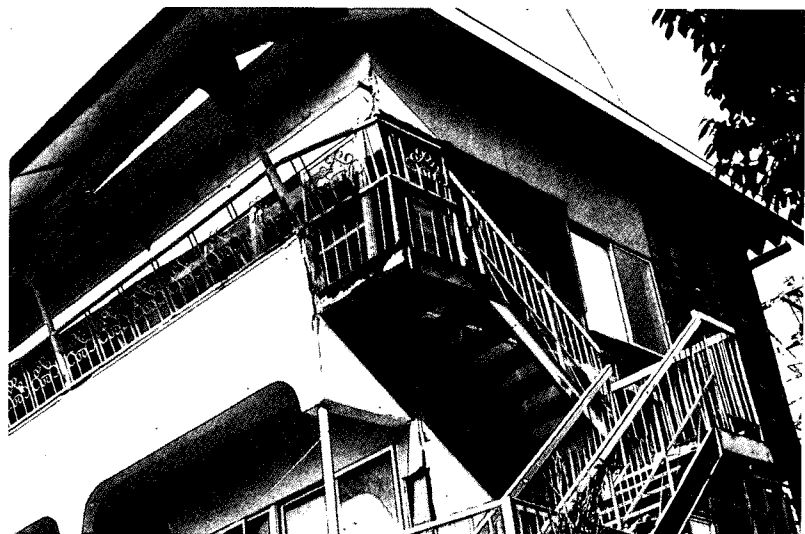
Photo 6. Residential Damage in Shimoda City

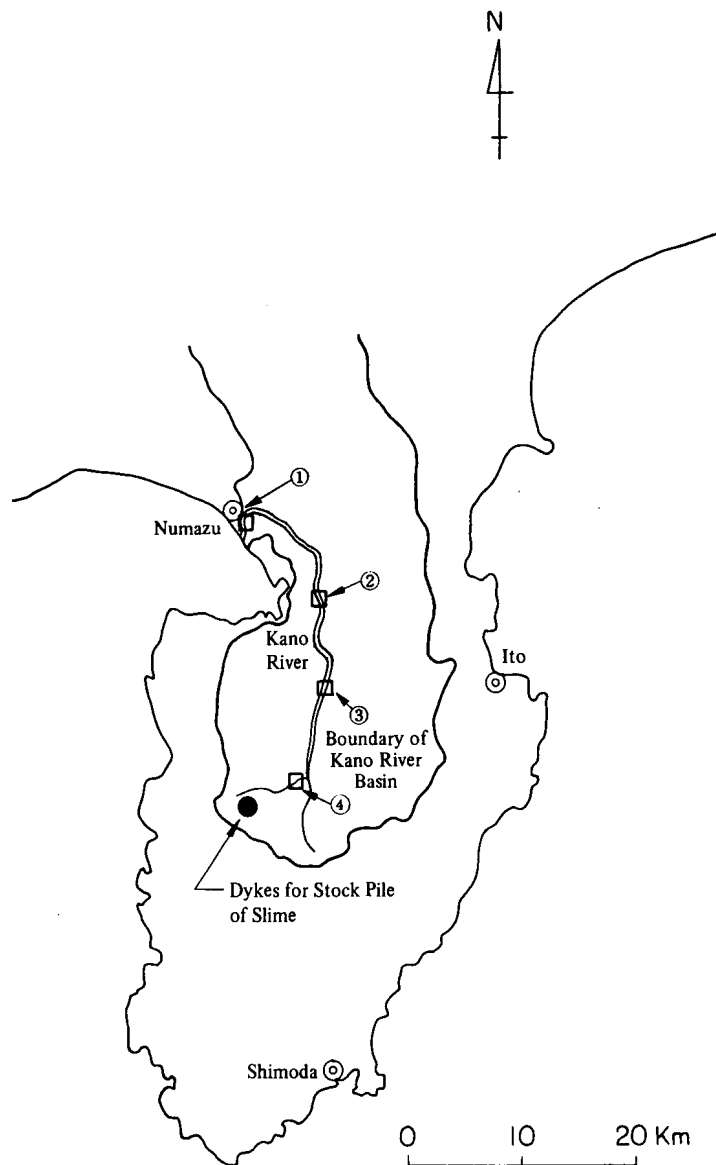
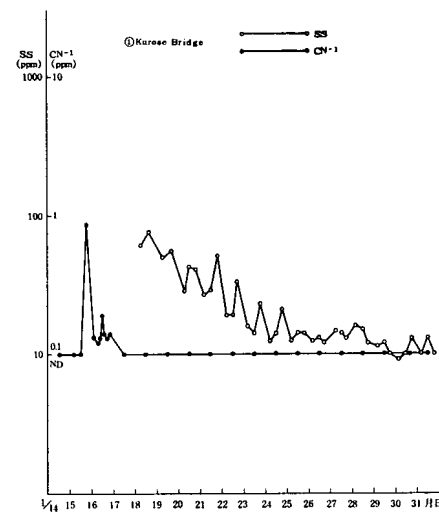
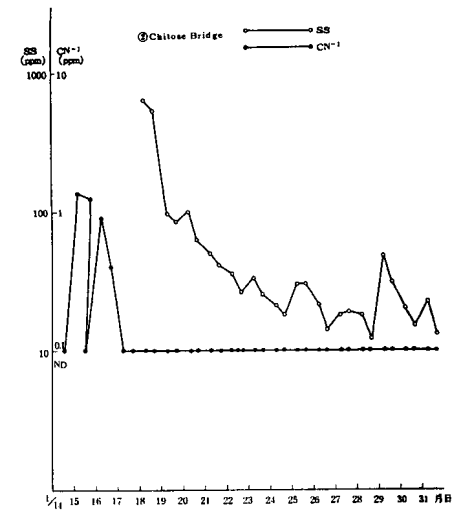
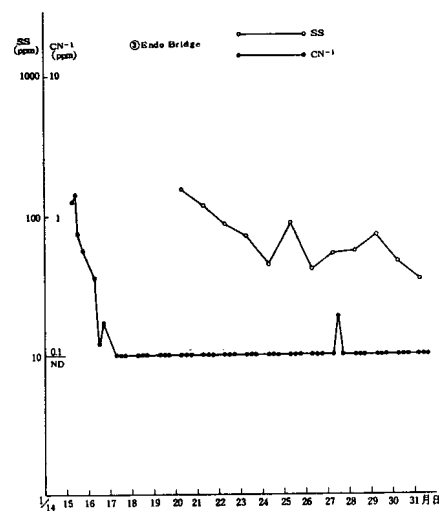
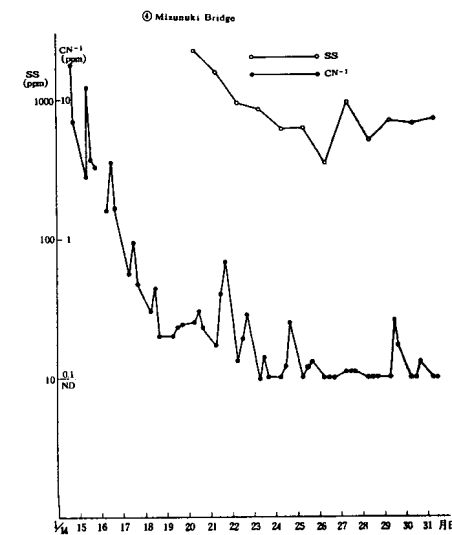
Fig. 2-5 Water Pollution due to Sodium Cyanide in Kano River

It has not been yet encountered that quantitative damage caused by the failure of two dykes of Mochikoshi Gold Mine shown in Fig. 2-5. Effects of polluted water by sodium cyanide contained in slime flowed out from breaks of the dykes are worried to water quality and bionomic systems in rivers and marine sites.

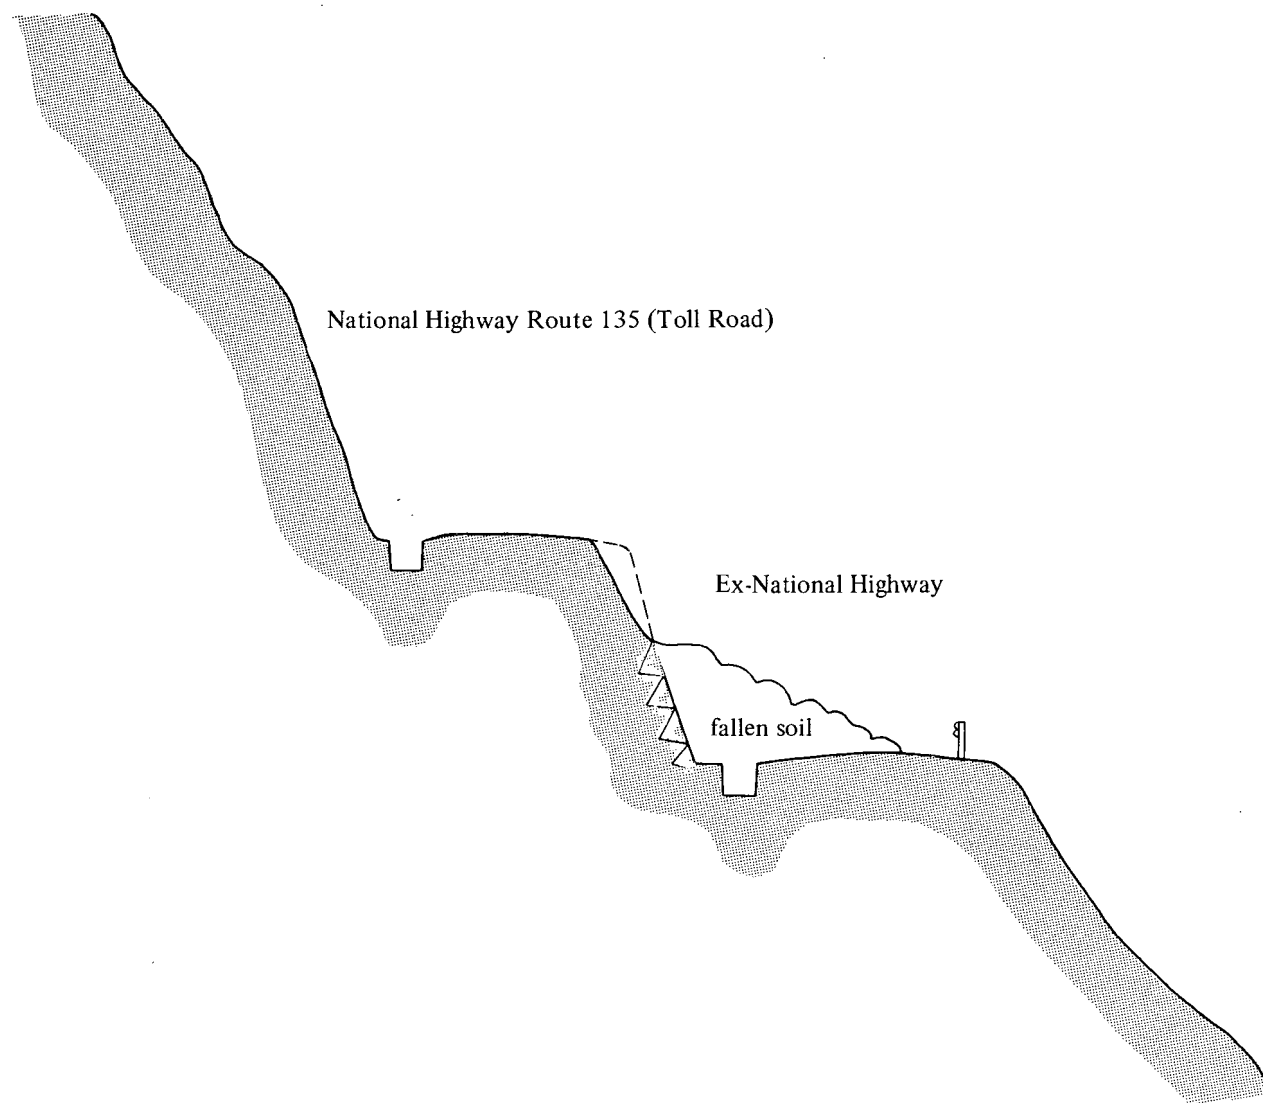
Fig. 3-6 Abstract of the Landslide at Route 135

with the damage circumstances. Drawing an example of the site like Fig. 3-6 the priority was given to the Toll Road even though the restoration of the ex-national highway was obliged to be delayed. In the result the resumption of the ex-national highway is still suspended as of Feb. 12 because of the heavy damage as shown in Photo-1. The Higashi-izu Toll Road was out of service from 14th through 16th of January. It opened from 17th through 29th exclusively to the emergency vehicles only in the daytime (7:00 ~ 19:00). It became shut again from Jan. 30 through Feb. 9 because of the rehabilitation works. Since Feb. 10 it has resumed with some one lane sections. Principal Prefectural Road, Shuzenji-Shimoda Line sustained an extensive damage, where a tourist bus was buried in a landslide and three passengers were dead. Prefectural Construction Office and SDF have made a great effort to restore the road, but it is still out of service as of Feb. 12.

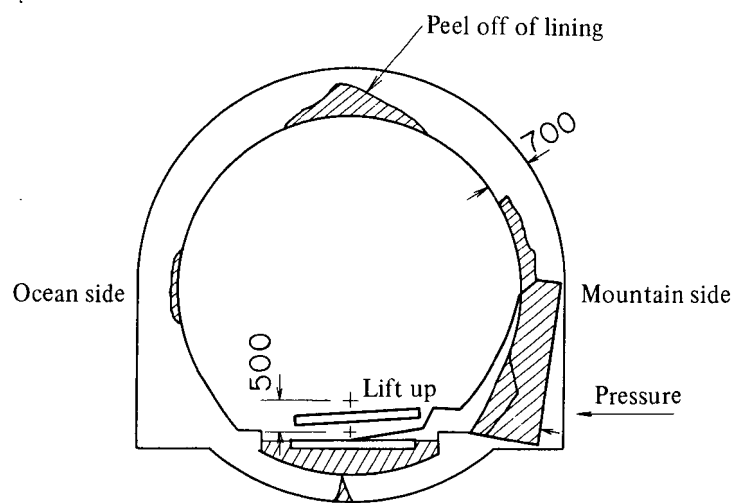
Fig. 4-1 Cross Section of Inatori Tunnel, Izu-kyuko Line

Izu-kyuko Railroad Co. Ltd has considered the reconstruction method of the Inatori tunnel, a most heavily damaged structure, in order to resume the blocked section as early as possible. The tunnel had been constructed in a circular section as illustrated in Fig. 4—1 and had been left with a space to the construction limit. The interior lining inside the existing one is the likliest method of reconstruction so far.
