# **A CASE HISTORY OF BRIDGE PERFORMANCE DURING EARTHQUAKES IN JAPAN**

(To be presented at the International Conference on  
Case Histories in Geotechnical Engineering,  
St. Louis, Missouri, USA, May 6-11, 1984)

**February 1984**

**Earthquake Engineering Division  
Earthquake Disaster Prevention Department  
Public Works Research Institute  
Ministry of Construction**

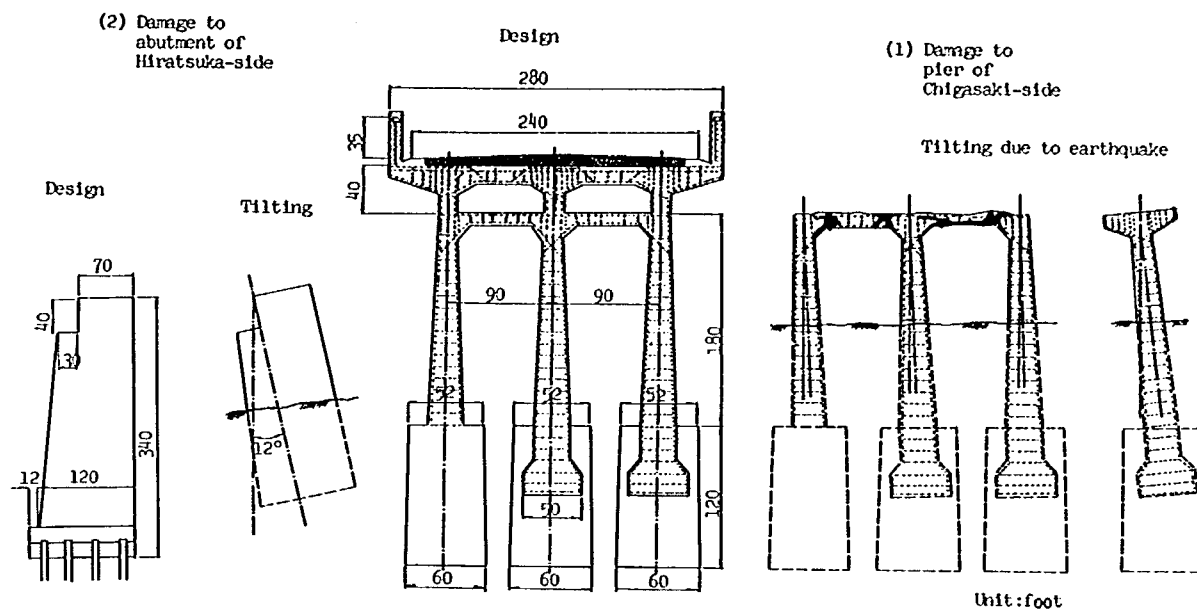
Fig. 3. Damage to the Banyu Bridge

During the Kanto Earthquake, the substructures sustained extensive damage as shown in Fig. 3 to 5. The right and left abutments tilted about  $12^\circ$  and  $4^\circ$ , respectively, towards the center of the river. Major failures occurred in the horizontal beams of the piers (Fig. 3). Insufficient curing of the concrete could have been an important factor causing this damage.

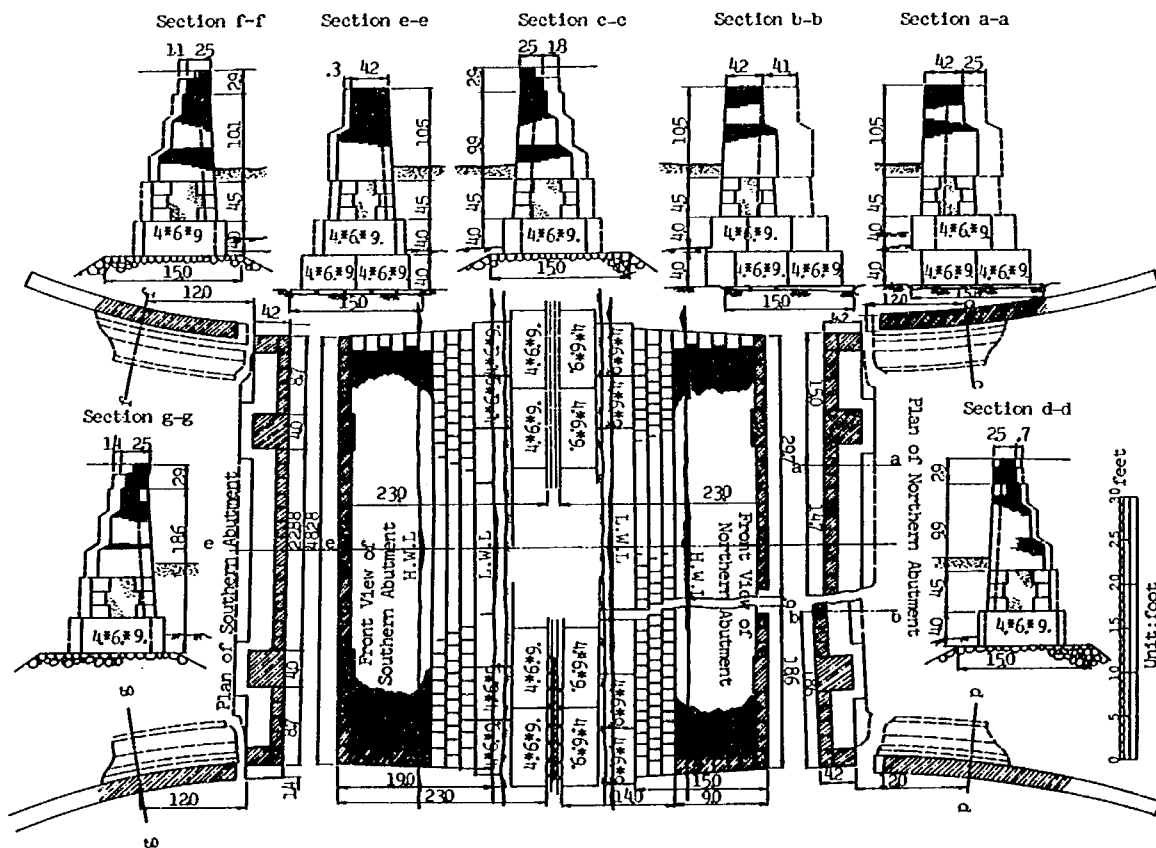
Fig. 7. Damage to the Northern Abutment of the Bankoku Bridge

The earthquake caused severe damage to the both abutments. The northern abutment slid by 1.2m horizontally toward the center of the river. This drastic sliding was accompanied by a relative movement between the upper and lower blocks of the foundation (see Fig. 7). Also observed was a huge vertical crack of the width of 2.7 cm in the abutment near the center line of the bridge axis. Excessive earth pressures forced on the two wing walls to cause their separation from the abutments. The upper portion of the southern abutment also slid toward the center of the river. The amount of sliding at this location totalled about 30 cm. Both wing walls at this abutment also separated.

It is clear from the damage experienced by this bridge that severe damage can be caused due to sliding between blocks in the abutments.

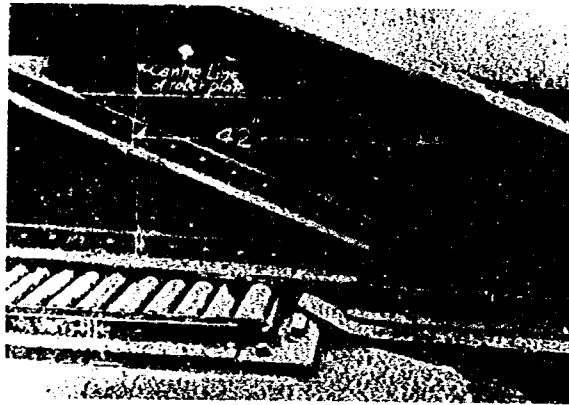
Fig. 8. Damage to the East Support at the Northern Abutment of the Bankoku Bridge

The bridge truss girder suffered no significant damage. However, several lattice beams attached to the lower chords buckled. The movable roller support on the northern abutment moved considerably (40 cm on the east side and 30 cm on the west side) towards the south, together with the abutment. At the east side of this support the sole plate attached to the end of the truss was completely dislodged from the rollers (see Fig. 8). The fixed support on the southern abutment moved to the north (22 cm at the eastern side and 34 cm at the western side) along with the abutment, and all anchor bolts on the both sides were sheared off, as shown in Fig. 9.

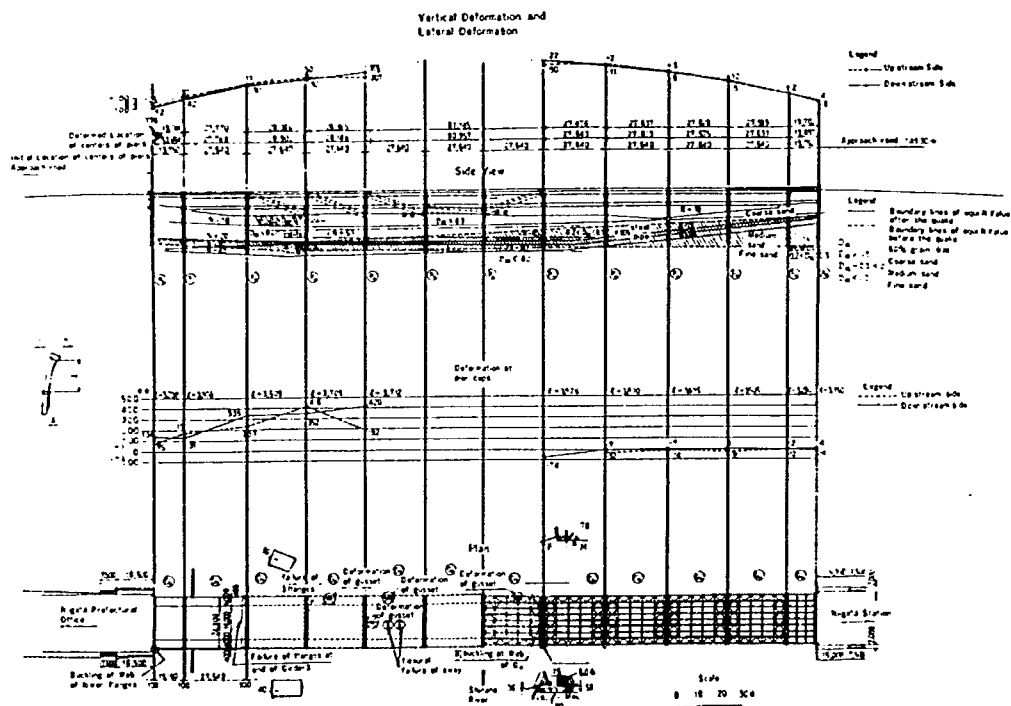
Fig. 22. Damage to the Showa Bridge

Due to the Niigata Earthquake, the bridge sustained severe damage (Fig. 22). The left abutment moved about 1m toward the center of the river and its approach

road settled considerably. In contrast with this behavior, the right abutment and its approach road sustained no significant damages.

The first to fourth piers from the left bank tilted toward the right bank. The magnitudes of permanent deformations were 13 to 42 cm at their caps. The fifth and sixth piers collapsed completely into the river beds, while the seventh through the eleventh piers suffered only slight damages.

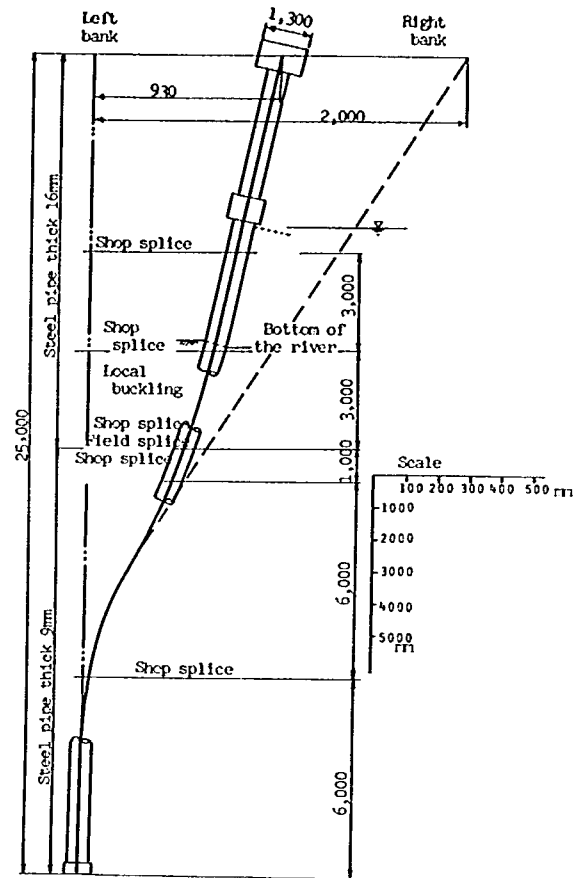
Fig. 25. Permanent Deformation of a Pile Pulled out at the Showa Bridge

Damage characteristics of this Showa Bridge are illustrated in Fig. 25. These reveal the following as main causes of the damages:

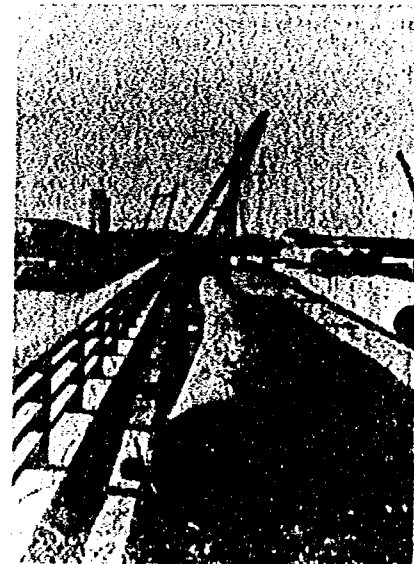
Fig. 26. Damage to a Pulled-out Pile at the Fourth Pier of the Showa Bridge

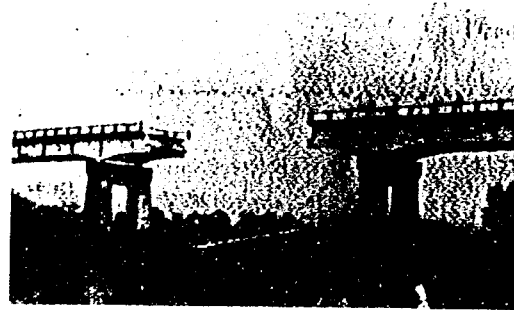
Kin-noh Bridge, completed in 1956, is located on National Highway No. 346, and crossing Kitakami River. The superstructures are single-span steel plate girder, 5-span simply supported steel trusses, and 9-span Gerber-type steel plate girders from the left bank to the right. The total length and the width are 575.5m and 6.0m, respectively. Substructures are reinforced concrete columns resting on caisson foundations for the truss spans, and reinforced columns resting on footing foundations with reinforced concrete piles for the Gerber plate girder spans. Soils are of soft silts and sands, and a firm sand layer exists approximately 30m below the ground surface. During the earthquake of June 12, 1978 one of suspended girders of this bridge fell down onto the river bed, as shown in Fig. 34. Kin-noh Bridge is only one bridge which completely fell down during the June Earthquake.

Fig. 34. Fall of a Suspended Girder, Kin-noh Bridge (During the Earthquake of June 12, 1978)

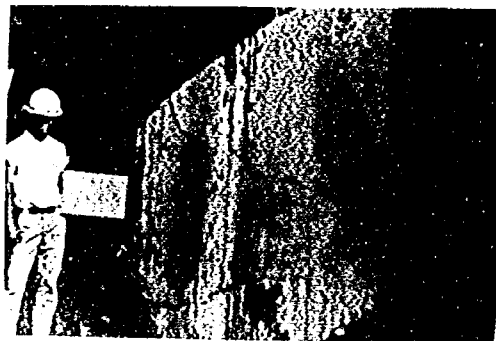
with a center hinge and of 7-span simply-supported post-tension pre-stressed concrete T-shape girders. The bridge has the total length of 541.7 m and the width of 8 m. Two abutments are on steel pile foundations, two piers in the lower river bed are on caisson foundations, and 7 piers are on well foundations. Due to the June 1978 Earthquake, the nine pier columns sustained cracks mostly at the level of the ground surface. First pier from the left bank (Pier-1) received numerous heavy cracks as shown in Fig. 38 and concrete pieces separated from the column. Stoppers of simple-roller-type movable bearing on Pier-1 were damaged, guide pieces of the bearing failed, and the roller almost rolled down from the shoe.

Fig. 38. Cracks at Pier 1, Yuriage Bridge

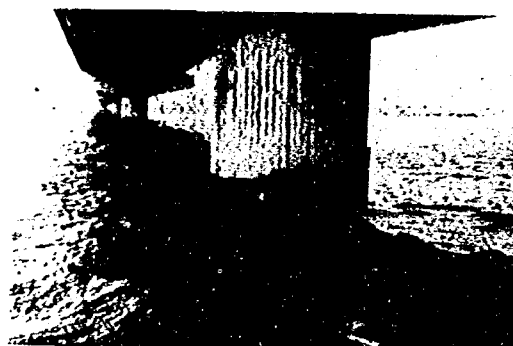
Due to the Urakawaoki-Earthquake, two pier columns (Piers-3 and 6) sustained very heavy cracks. Especially Pier-3 almost failed as seen from Figs. 48 and 49. Fig. 50 shows a damage feature of Pier-6. The lower sections of the column under the water sustained diagonal cracks similar to the case of Pier-3. Figs. 51 and 52 indicate damages to Piers-2 and 4, respectively. Separations of concrete pieces and cracks are seen at higher sections of the columns. Diagonal cracks are rather minor for Piers-2 and 4.

Fig. 50. Damage to Pier-6 of Shizunai Bridge, Seen from Pier-7

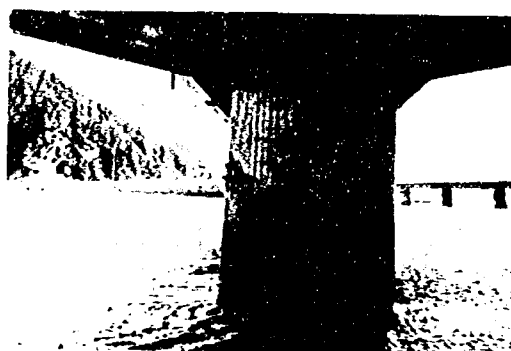
Fig. 52. Damage to Pier-4 of Shizunai Bridge
