# **THE WESTERN NAGANO PREFECTURE EARTHQUAKE, 1984 AND DAMS**

May, 1985

Fill Type Dam Division  
Dam Department  
Public Works Research Institute  
Ministry of Construction

by  
Dr. Norihisa Matsumoto  
Nario Yasuda  
Minori Shiga

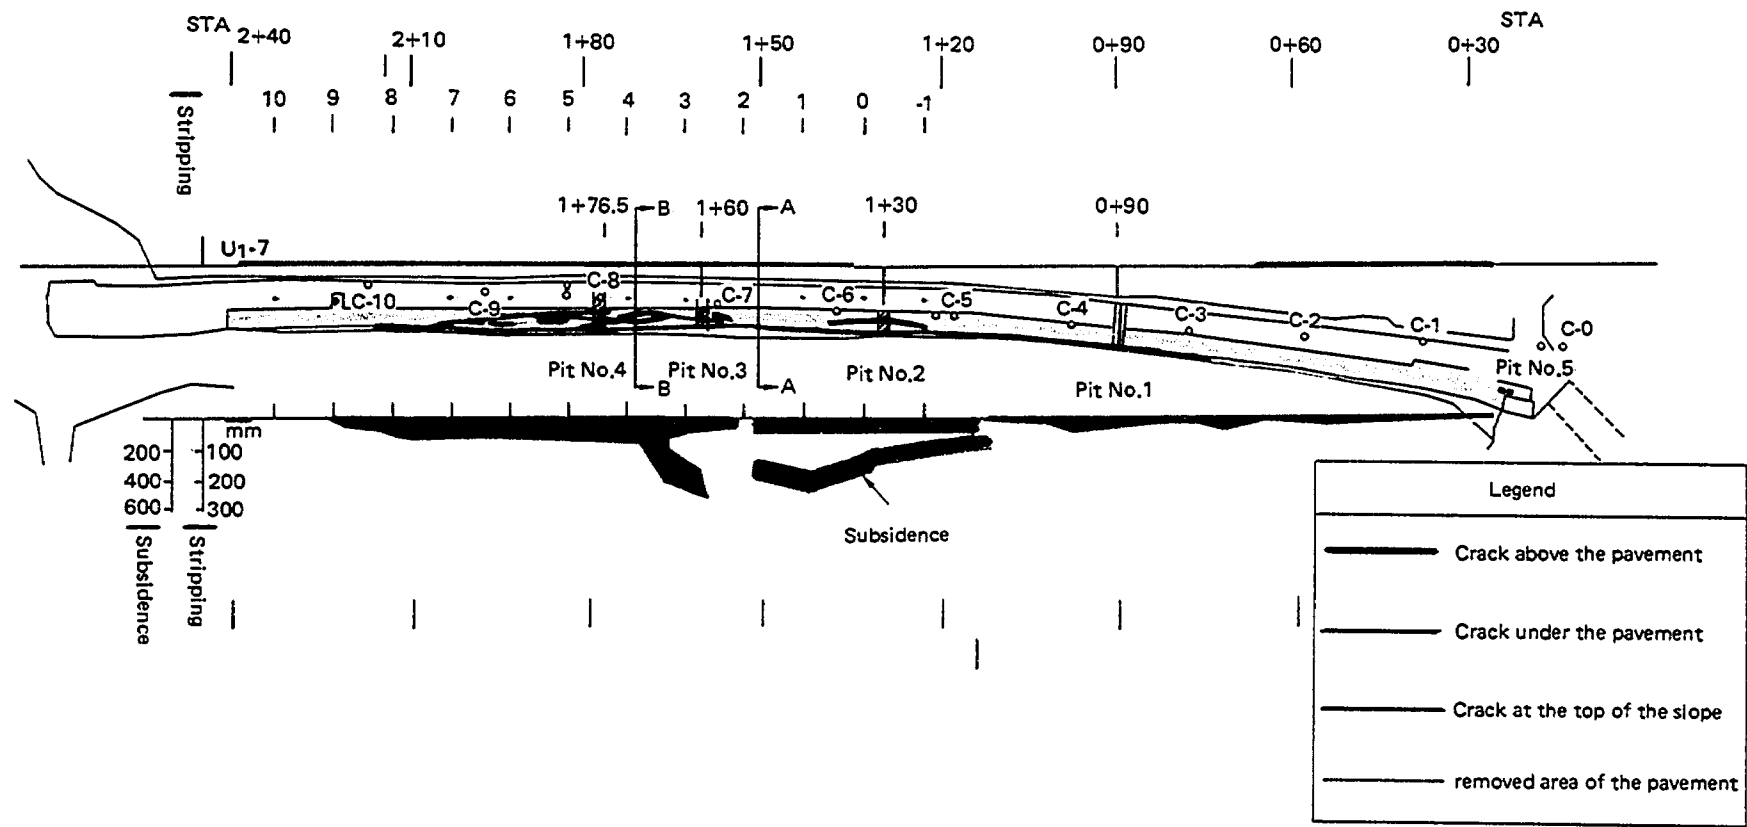
Fig. 4.3 Cracks at the crest of Makio Dam

Makio Dam suffered slight damage as shown in Figure 4.3, which indicates the cracks parallel to the dam axis at the crest, the settlement at the top of downstream slope, and the looseness and movement of the surface of the downstream slope. The dam was investigated by Water Resources Development Corporation and has been completely repaired. (Photo 1 to 4)

A crack such as that at crest is likely to be seen at earthfill dams subjected to heavy earthquakes and probably caused by extensional stresses during shaking. The settlement and loosening of downstream slope, were caused by the partial steep slope of the banking for the access road at downstream slope.

From the results of the survey, the maximum depth of the crack was 1.5 m, but there was no problem for the seepage because the cracks did not reach the designed upper level of the impervious core zone. Generally,

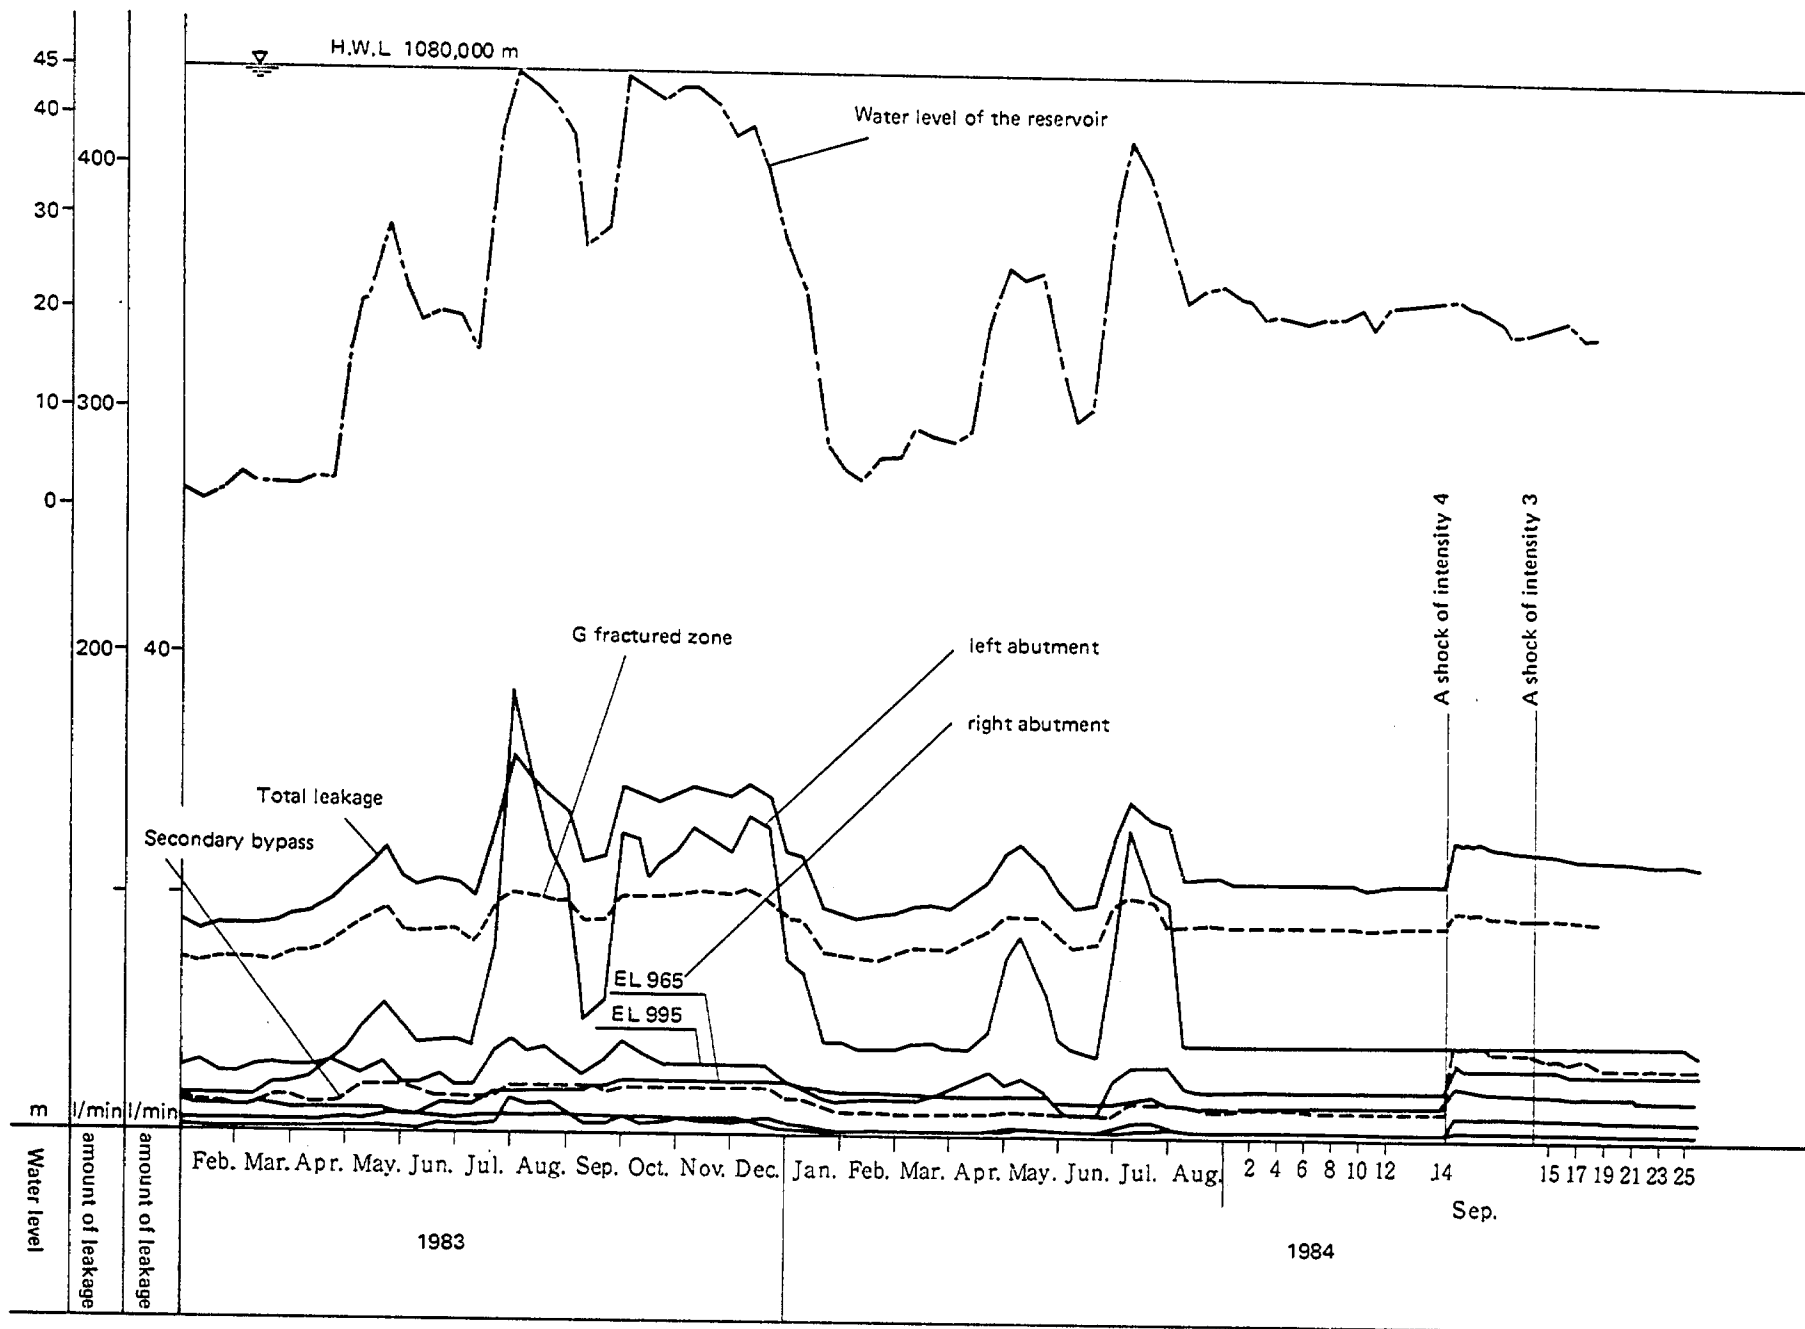
Fig. 4.7 Diagram of leakage (Takane No.1 Dam, Courtesy of Chubu Electric Power Co.)

Leakage before the earthquake increased by 18 liters to about 130 liters, but increment has been gradually decreasing.

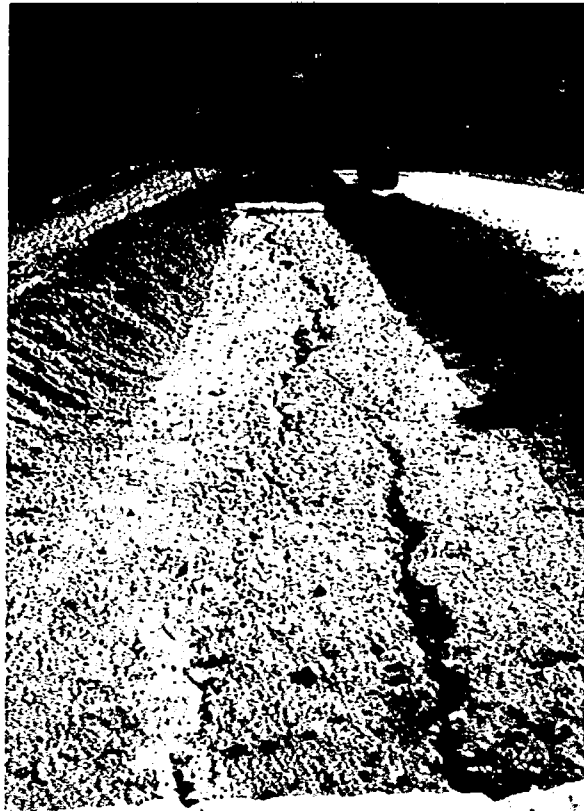
**Photo 1** Cracks parallel to dam axis (Makio Dam)
