PROCEEDINGS OF THE 27th U.S. – JAPAN BRIDGE ENGINEERING WORKSHOP

Tsukuba, Japan
November 7, 8 and 9, 2011

Technical Report
of PWRI No.4218

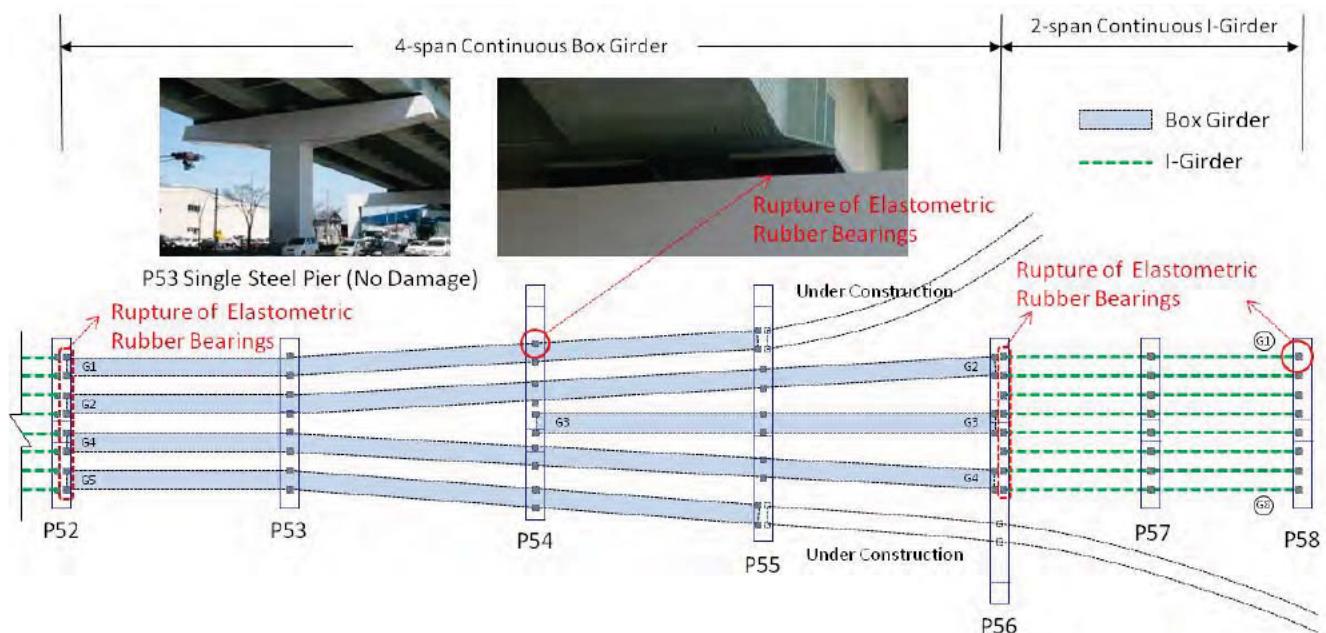
Fig. 2 Bridge Structure of Sendai-Tobu Viaduct and Position of Elastometric Rubber Bearing with Rupture

However, as shown in Photo 5, it should be noted that elastometric rubber bearings ruptured at the Sendai-Tohbu viaduct designed based on Post-1995 design specifications. Fig. 2 illustrates the structure of the Sendai-Tohbu viaduct and the positions of the elastometric rubber bearing with the rupture. As seen in Fig. 2, bridge structure in this junction is very complicate. Bridge width changes significantly in the 4-span continuous box girder with the change of the section. Span length of the section from P52 to 56 is around 70m, while that from P56 to P58 is 39m. P52 and P53 are single-column hammerhead steel piers, while P54, P55 and P56 are two-column steel frames. Rupture of the elastometric rubber bearings in the transverse direction was observed at the deck-end of P52 side in 4-span continuous box girder, though there are few damaged elastometric rubber bearings at the other deck-end side of the box girder on Pier 56. Photo 6 shows failure mode of the elastometric rubber bearing with the rupture. Comparison of the failure mode with the result of the shear loading test should be made, to estimate the capacity of the elastometric rubber bearing and the applied seismic force combination.

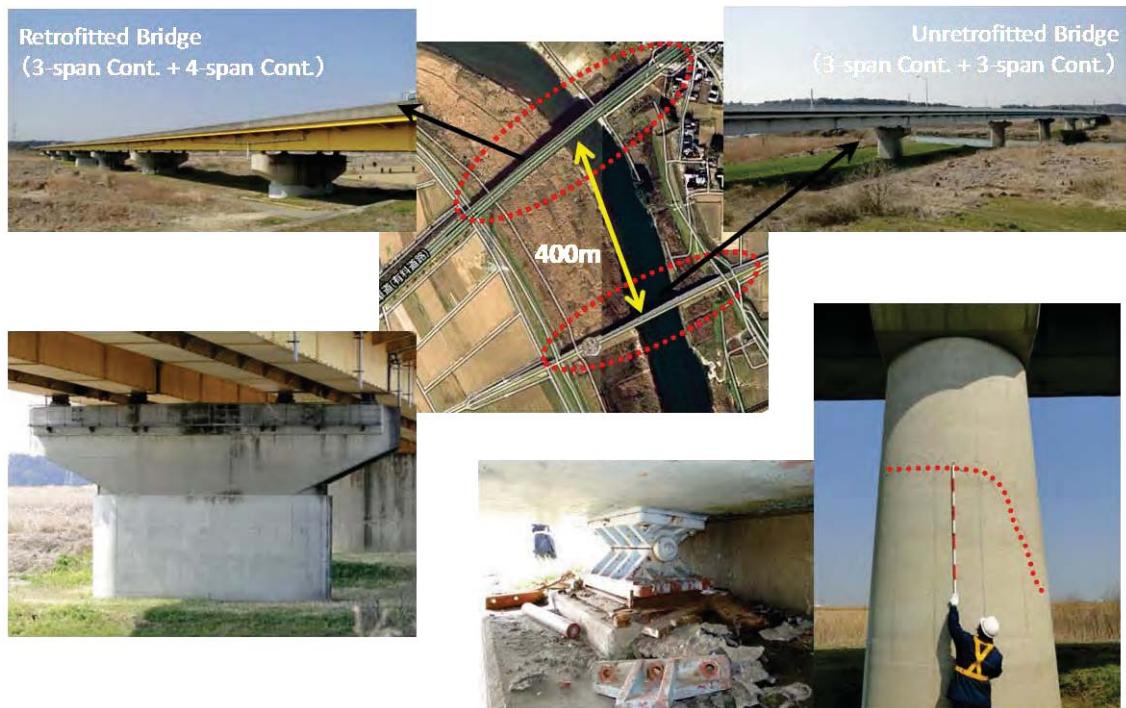
Photo 7 Comparison of Seismic Performance between Adjacent Two Bridges
(Nakagawa Bridge and Kunita Ohashi Bridge)

Photo 7 exemplifies the effectiveness of the seismic retrofit for bridge columns. As seen in Photo 7, there are two adjacent river-crossing bridges. Since one bridge (Nakagawa Bridge) is on the designate emergency route, bridge columns designed with the pre-1980 specifications have already been retrofitted by reinforced concrete jacketing. The other bridge (Kunita Ohashi Bridge) is on the local roadway and the bridge columns have not yet been retrofitted at the earthquake. Although Kunita Ohashi Bridge suffered from the vulnerable damage and thus lost the serviceability for the bridge, Nakagawa Bridge did not suffer from the damage and kept the serviceability soon after the earthquake. Seismic performance shown in these two bridges clearly exhibits the effectiveness of the seismic retrofit.

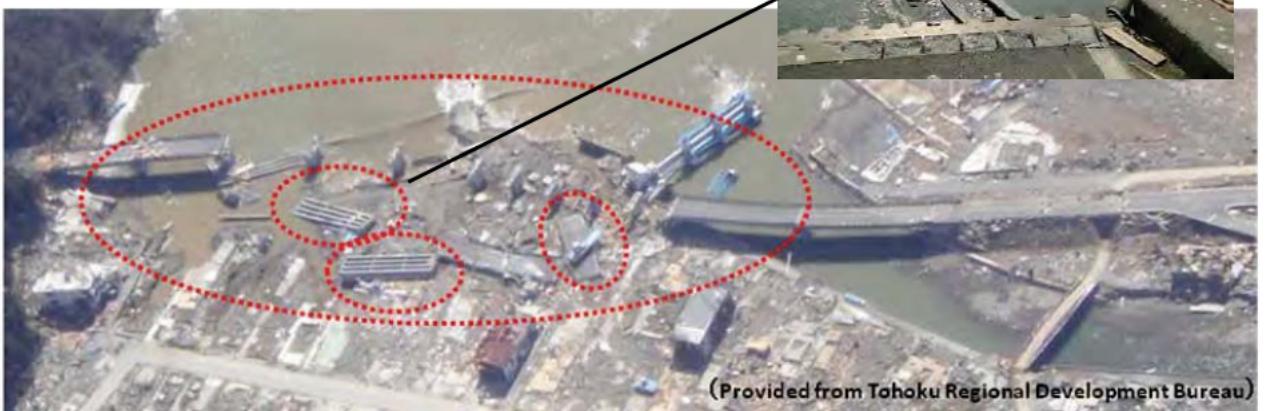
Photo 11 Washed Away of PC Superstructure (Utatsu Ohashi Bridge)

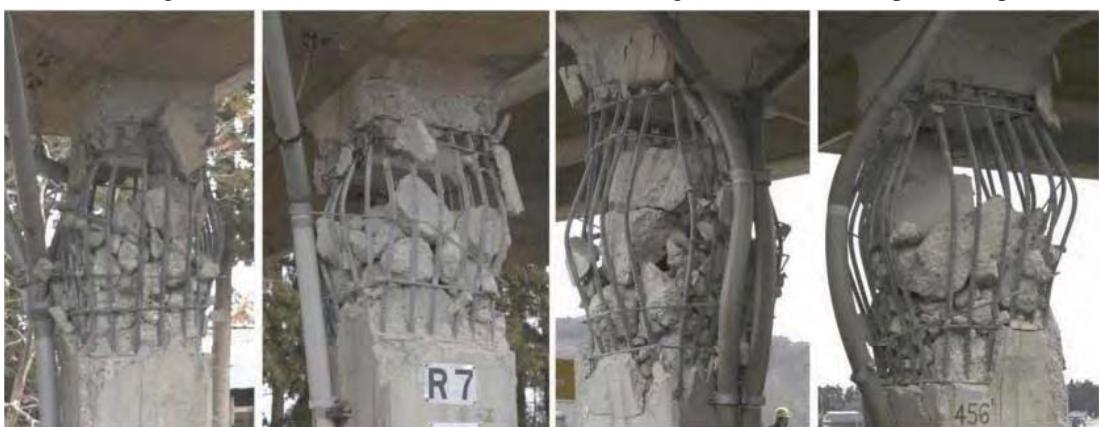
Photo 17 Close view of damage of R7-1 and R7-2 columns

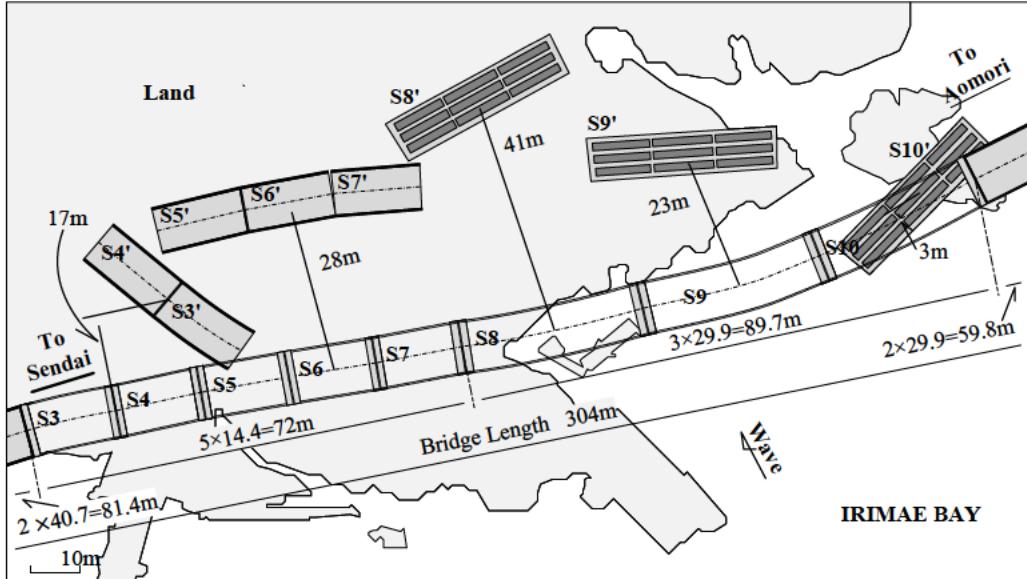
Fig. 7 Outflow of superstructure

outflow displacements of S3~S10 are shown in Fig. 7. It should be noted that the spans located at the center such as S5-S7 and S8 were flowed 28 m and 41 m away from the original position, while the spans located at the sides such as S1, S2, S11 and S12 were

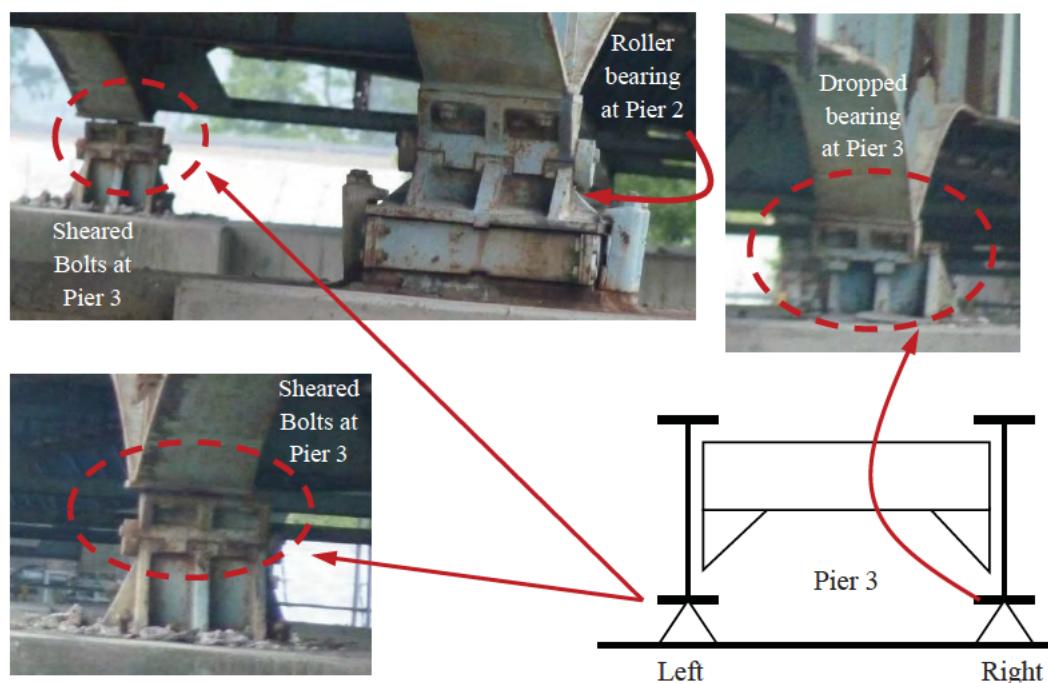
vertical support. It is likely that the upper bolts of the left-hand bearing sheared before the right-hand bearing dropped from its pedestal. There is no vertical load path through the bearing pin to sustain tensile forces on the bolts and thus shear is the probable mode of failure. Following loss of shear capacity on the left side, all shear for this frame would have to be resisted by the right-hand bearing. This increase in shear demand likely caused the right-hand bearing to unseat. Failure of this bearing is probably the reason for the noticeable dip in the elevation of the bridge roadway and handrail (estimated at 10 cm) seen in Figure 10. It also possible that some of this deformation is due to foundation settlement due to widespread liquefaction in the area.

FIGURE 9 – UNSEATING AND FAILURE OF BEARINGS AT PIER 3, SHIDA BRIDGE
(Photos and Graphic: E. Monzon)

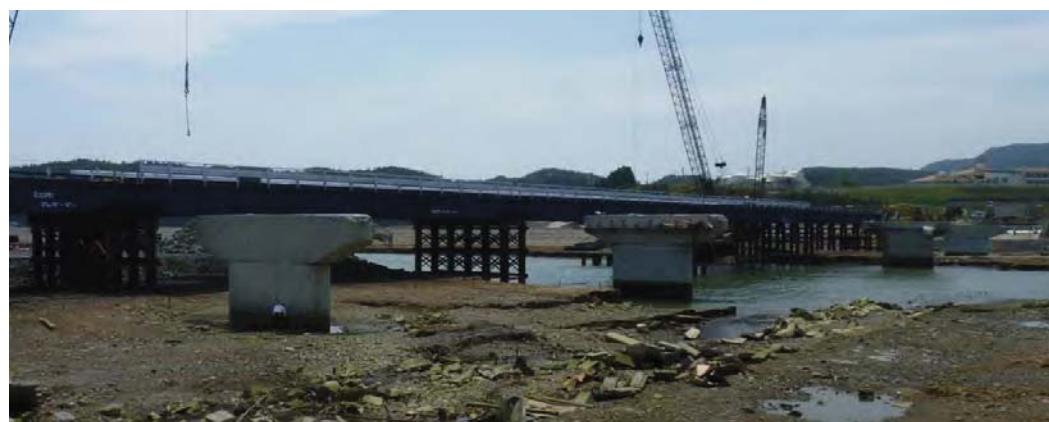
All six spans were swept away during the tsunami (Figure 13). Wave heights of the order of 11.8 m were registered at Ofunato City just north of this site and the tsunami clearly overtopped this bridge taking all six spans upstream. Based on damage to the levee on the north bank of the river, some of these spans were lifted off their piers and swept along the top of the levee on the north bank, then over the levee altogether on the north side, and later back over the levee into the main channel where they came to rest about 400 m upstream from the bridge (Figure 14). Other spans took a different path and came to rest about 300 m upstream but on the south side of the levee on the south bank of the river. Four of the five piers are still standing, but the center pier (Pier 3) was overturned and believed to be under water in the river channel just upstream of the bridge (Figure 13).

FIGURE 13 – REMAINING PIERS OF KOIZUMI BRIDGE. TEMPORARY BRIDGE IS UNDER CONSTRUCTION ON SEAWARD-SIDE OF ORIGINAL BRIDGE (Photo: E. Monzon)

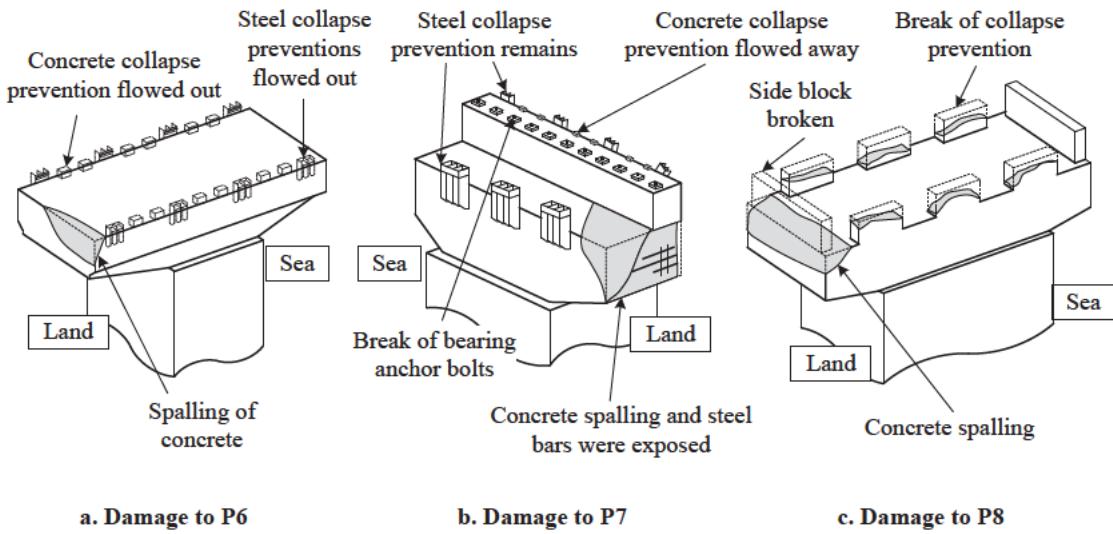
Fig. 15 Detailed damage to piers

Fig. 15-b illustrates the detailed damage of P7 which supported 2 types of superstructures: S7 and S8. At S7 side, the installing details of superstructure collapse preventions were same as P6. Although the 6 concrete collapse preventions were crushed, the 4 steel ones were left. However, due to the girder-induced impact, the steel ones tilted. At S8 side, different from P6, only 3 larger steel collapse preventions were anchored and they did not flow out. The damage condition of steel collapse preventions demonstrates that when the superstructures, located on P7, displaced they were elevated by a wave-induced uplift. Because of this, the superstructures flowed from the top of the steel collapse preventions and did not impose a sufficient impact to make them separate from supports. Besides that, at the land side, the concrete surface of the beam was crushed and some steel bars could be observed.

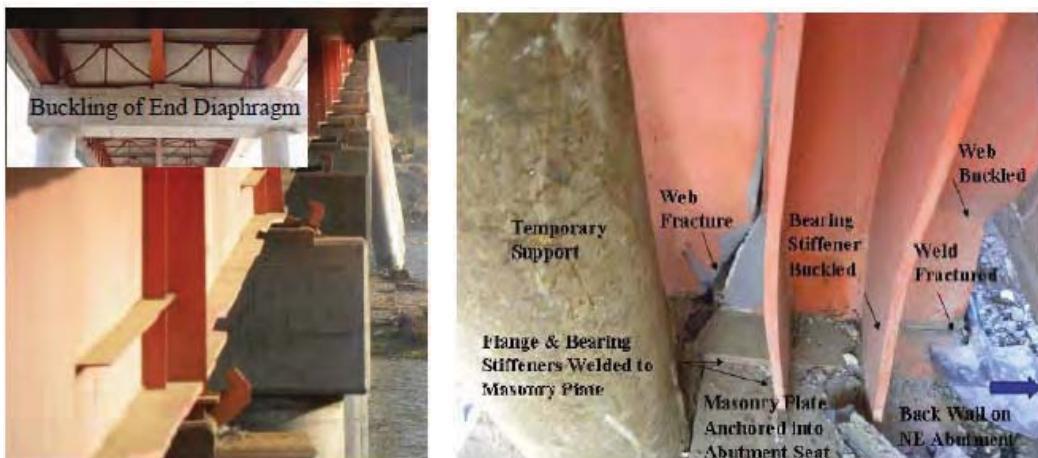
During the earthquake, the NE portion of the bridge moved transversely from west to east as shown in Fig. 3(a). All steel stoppers were deformed and girders were displaced from their elastomeric pads, resulting in the web and flange bending of the exterior girder about its weak axis. At the NE abutment, the webs and bottom flanges were fractured in all three girders, and both bearing stiffener and web buckled as illustrated in Fig. 3(b). The cause of this type of damage is indicative of excessive longitudinal loads in the superstructure that was resisted by the weld bearing connection at the abutment. At the SW abutment, the welds from the girder bottom flanges to the masonry plates were fractured [Chen et al., 2010].

(a) Girder offset and cross frame buckling (b) Girder fracture at the north abutment

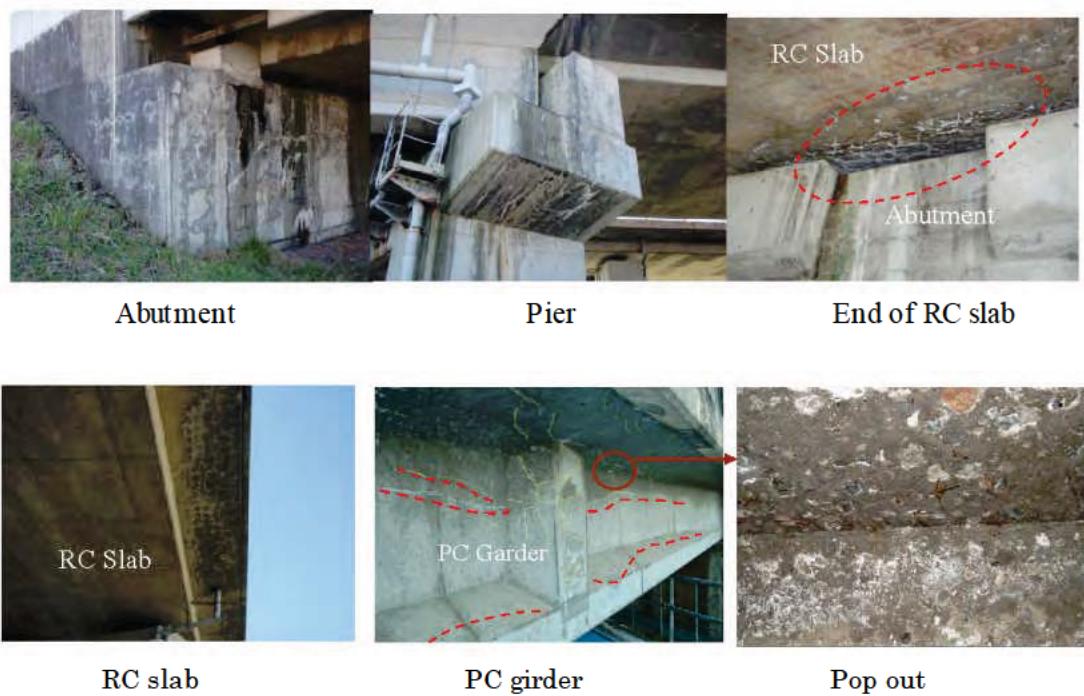
Fig.6 Cases of ASR deterioration

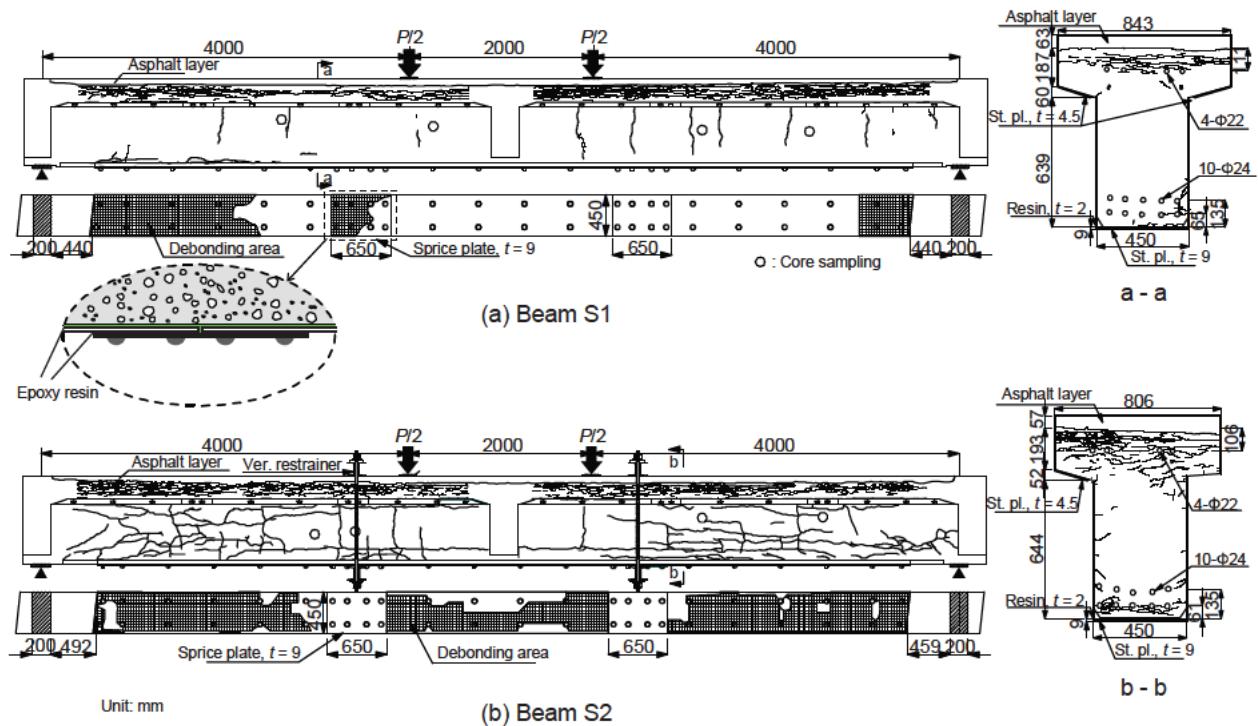
Fig. 12 Deterioration of old reinforced concrete beams with bonded steel plates

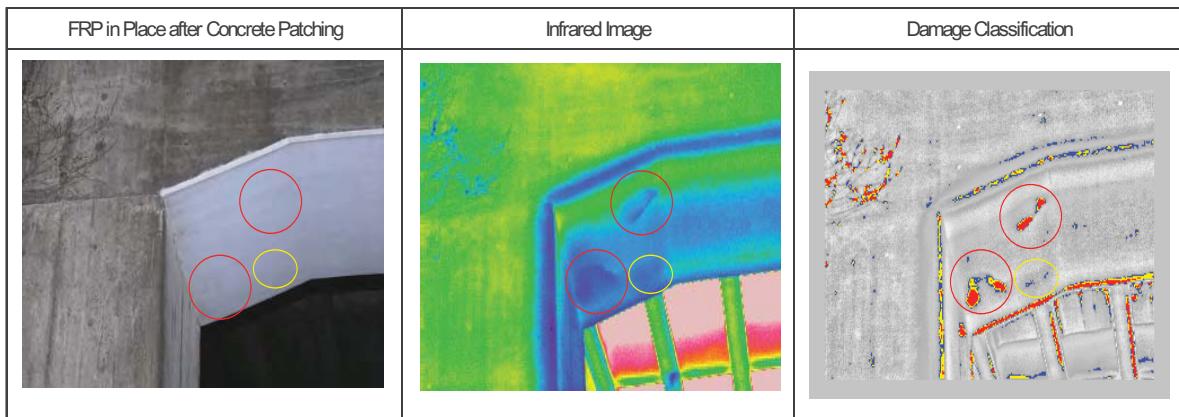
that have been covered with fiber reinforced polymer (FRP) materials (see FIGURE 13). Another application is to identify subsurface irregularities (grout covered rock pockets) in new construction structure immediately after the removal of form work.

FIGURE 13 DETECTING POTENTIAL SPALL BENEATH THE FRP COVER

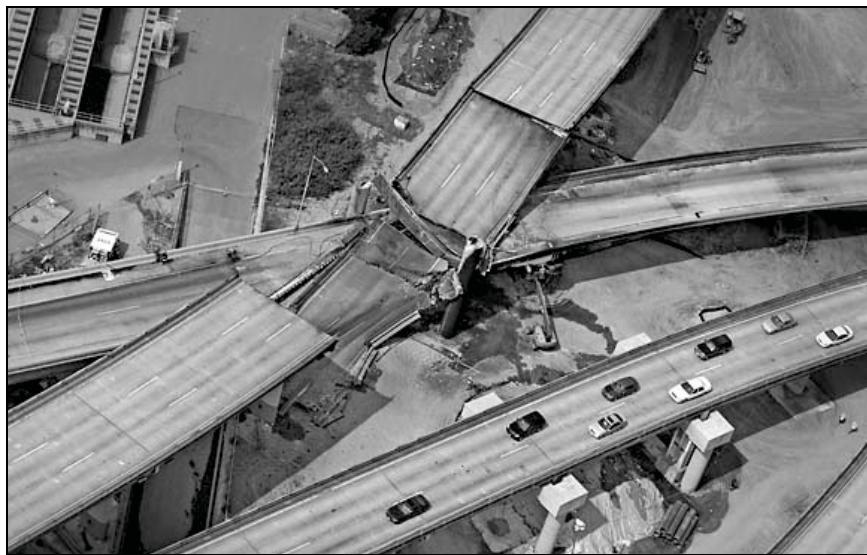
Early on the morning of April 29, 2007, a tanker truck carrying nearly 3400 L (9000 gallons) of gasoline overturned on the I-80/880 interchange in Oakland, California and burst into flames [Bulwa and Firmrite, 2007]. The accident occurred at 3:41 A.M. and just over 20 minutes later, at 4:02 A.M., the elevated roadway collapsed (see Figure 1). “As the fire progressed, the bolted connections in the collapsed girder began to weaken due to heat and were placed under increasing load from the weakening of the remainder of the bridge” [Kodur, *et al.*, 2010].

Figure 1 - Collapse of the McArthur Overpass
Photograph by Robert Campbell (used with permission)

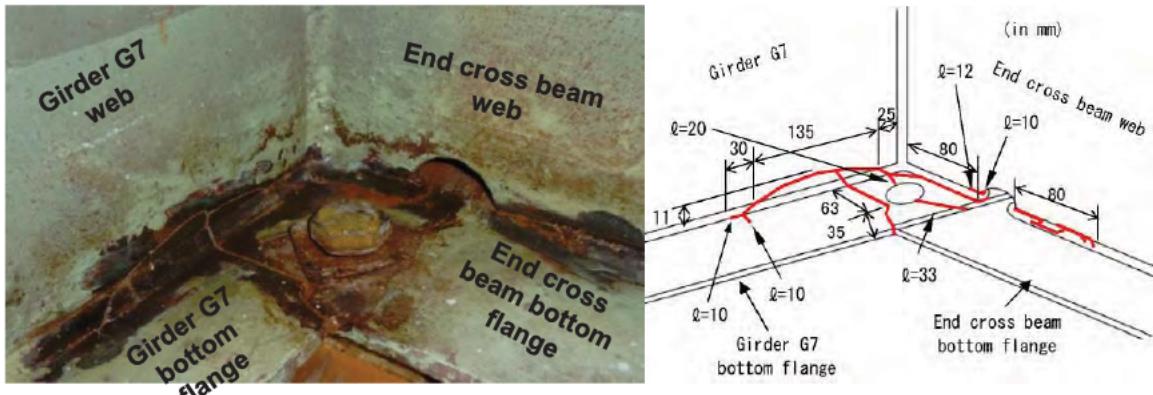
PHOTO 2 CRACKS IN GIRDER G7
