**BULLETIN OF  
PUBLIC WORKS RESEARCH INSTITUTE**

HISTORY OF EARTHQUAKE-INDUCED  
SOIL LIQUEFACTION IN JAPAN

**PUBLIC WORKS RESEARCH INSTITUTE  
MINISTRY OF CONSTRUCTION**

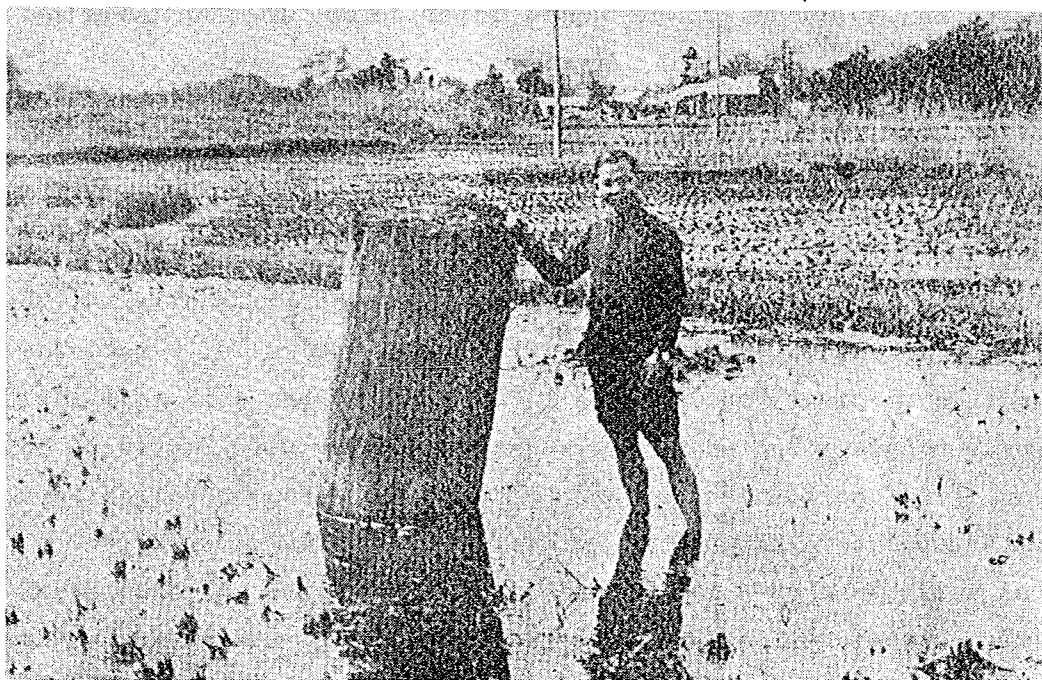
Photo. 2     Wooden piles which floated up from a rice paddy at Chigasaki during the Kanto Earthquake

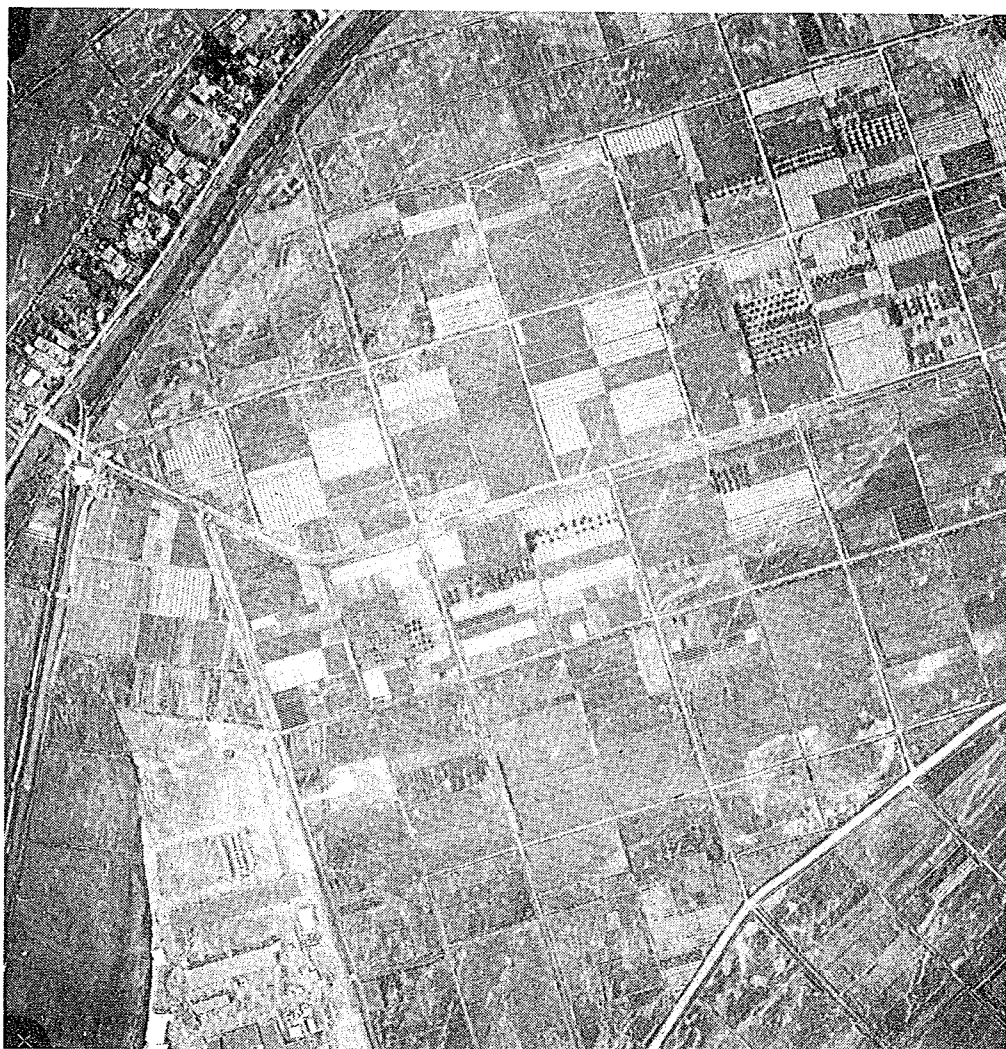
Photo. 8     Sand boils in the old riverbed of the Agano river  
during the Niigata Earthquake

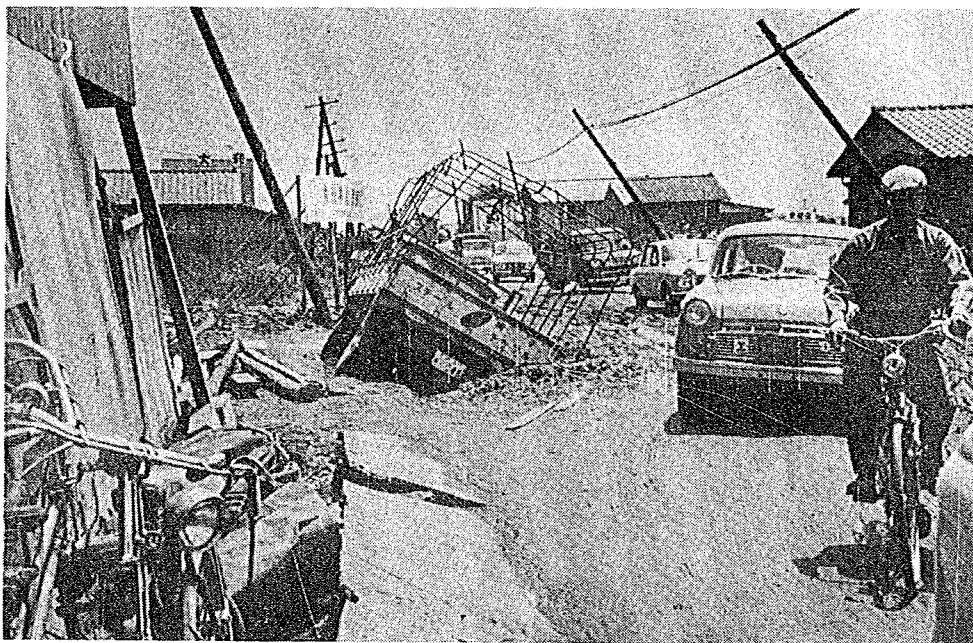
Photo. 9 A truck which sank into the liquefied low bank of the National Highway No. 7 at Ebigase during the Niigata Earthquake

The earthquake No. 42 (Niigata) is well known for its widely spread liquefaction and the damage to modern buildings and civil engineering structures due to the liquefaction of deep saturated sand deposits. As this is reported in detail in many other reports, only a summary is presented in this paper. Liquefied zones during this earthquake are denoted by hatched zones with numerals 1 to 13 in Fig. 4 and it may be seen that these zones are limited to the original riverbeds of rivers of Shinano, Agano, etc. For example, the zone denoted by the letter a in Fig. 4(a) is the original riverbed of the Agano river which connected with Shinano river at the river mouth about three hundred year ago. (Photo. 8). This zone was reclaimed by sand about fifty years ago. The national highway No. 7 passes through this zone and its low bank made with sand of 1 m in height in this zone settled down about 1 m and moved laterally 4 m in the maximum during the earthquake. This would be due to liquefaction of sandy bank and sandy ground because boiled sand covered the road surface and one truck on the bank sank into the ground. (Photo. 9)

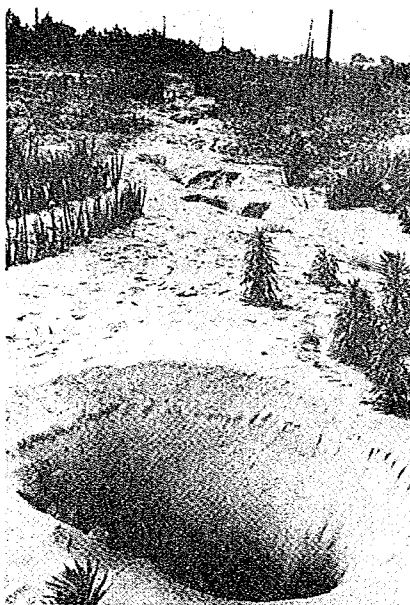
Photo. 10 Large holes in the liquefied ground at the zone 10 in Fig. 4 which is the old riverbed of the Shinano river during the Niigata Earthquake

Furthermore, Photo 10 shows large holes in the liquefied ground at the zone No. 10 in Fig. 4 which is the old riverbed of Shinano river.
