# **A CASE STUDY ON THE RESCUE AND REHABILITATION AFTER AN UNEXPECTED DISASTER**

**— THE ERUPTION OF MT. USU OF  
AUGUST 7 TO 13, 1977 —**

**PWRI TECHNICAL MEMORANDUM No.1293**

**Public Works Research Institute  
Ministry of Coustruction**

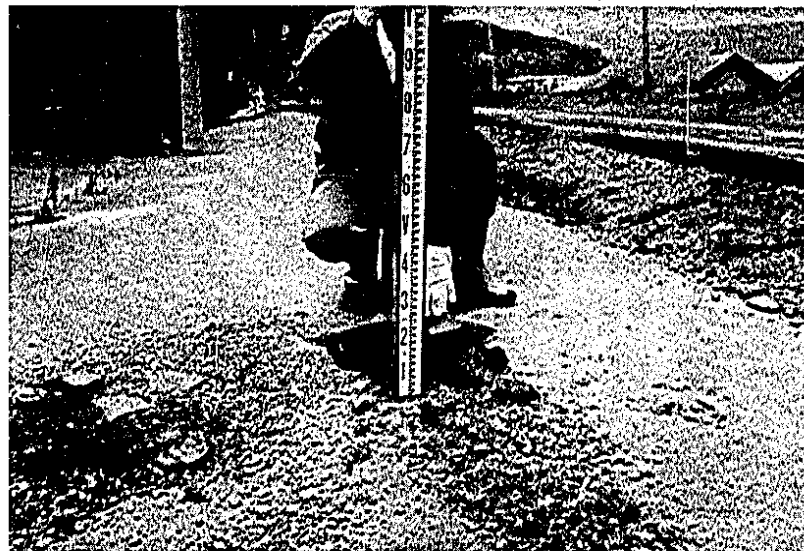
Photo-11 Ash Fall on the National Highway and the Removal Works.

For example Abuta Branch Office of Muroran Construction Division, HDB were responsible for national highways route 36, 37 and 230. At the first eruption WNW wind brought the ashes to the area along route 36. The ashes on the road was a few but deteriorated the perspective on route 36. The Branch Office stopped the traffic of route 36 from Noboribetsu C. to Shiraoi T. from 13:31 through 18:00 of August 7. Only a little traffic confusion emerged for this control owing to an adequate previous notice.

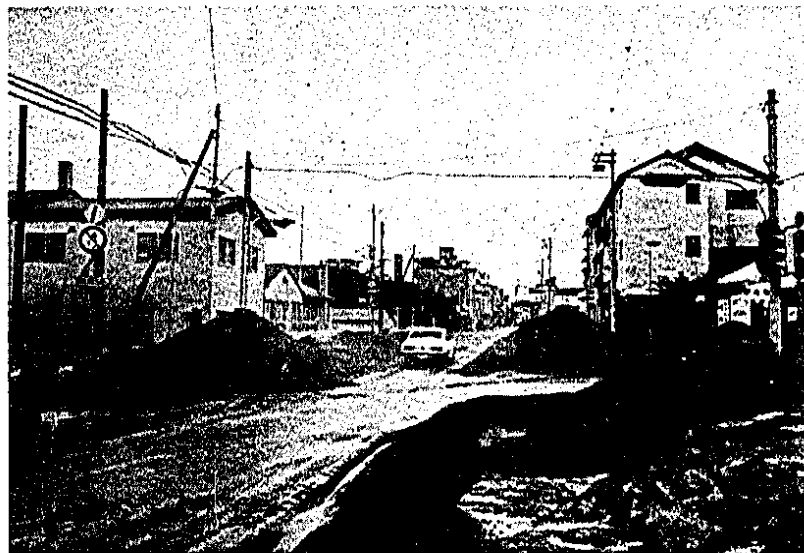
Photo-13 Ash Fall on the National Highway and the Removal Works.

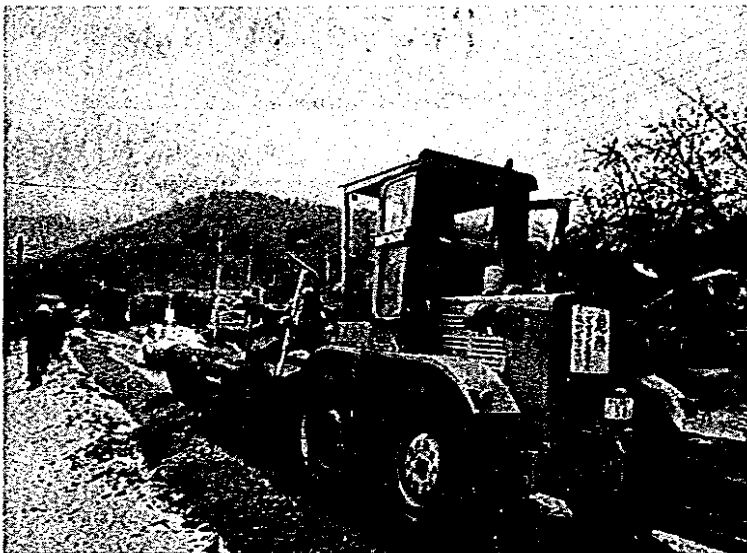
Photo-15 Ash Fall on the National Highway  
and the Removal Works.

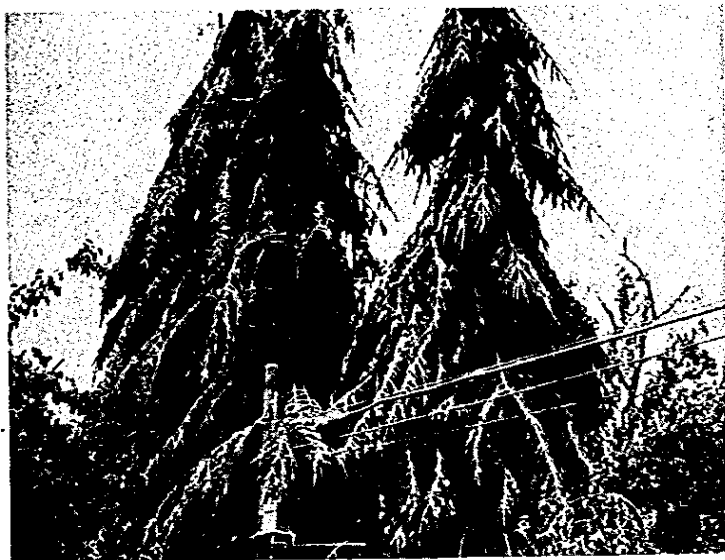
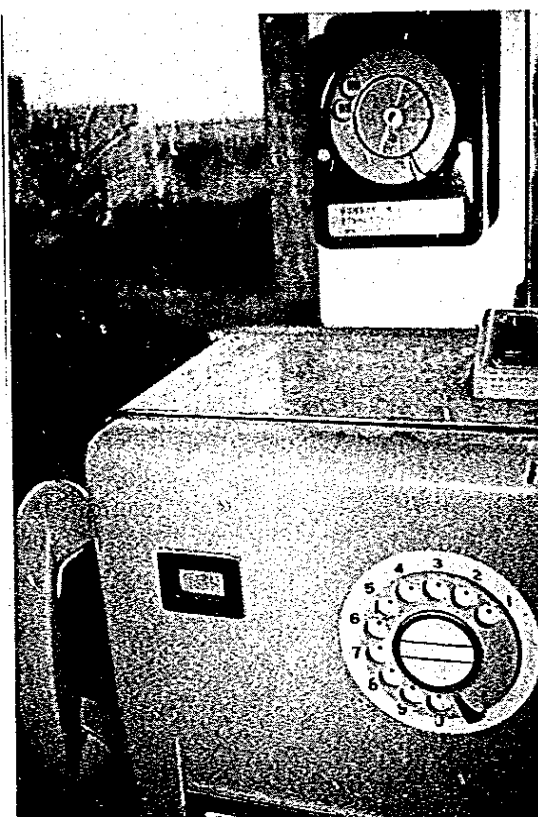
Photo-18 Damages of Telecommunication Facilities.

Photo-20 Damages of Telecommunication Facilities.

Photo-19 Damages of Telecommunication Facilities.

Photo-21 Damages of Telecommunication Facilities.

Damage of telecommunication facilities were mainly caused by the adhesion of ashes to cables and the leaning of trees near them.

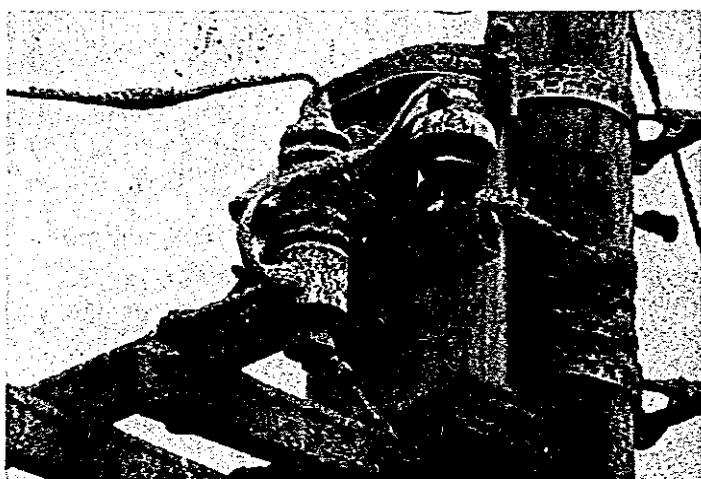
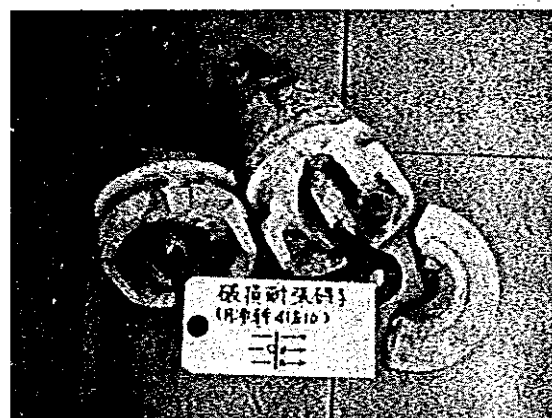
Photo-22 Damages of Electric Facilities

Photo-25 Damages of Electric Facilities

Photo-23 Damages of Electric Facilities

Photo-26 Damages of Electric Facilities.

Photo-24 Damages of Electric Facilities

In the area of 3 km far from the volcano electricity cables were cut by the volcanic bomb fall. As for the area of 15 km electric leakage emerged because of the decrease of insulation caused by the wet ashes. The leaning of trees caused the disconnection of the cable.

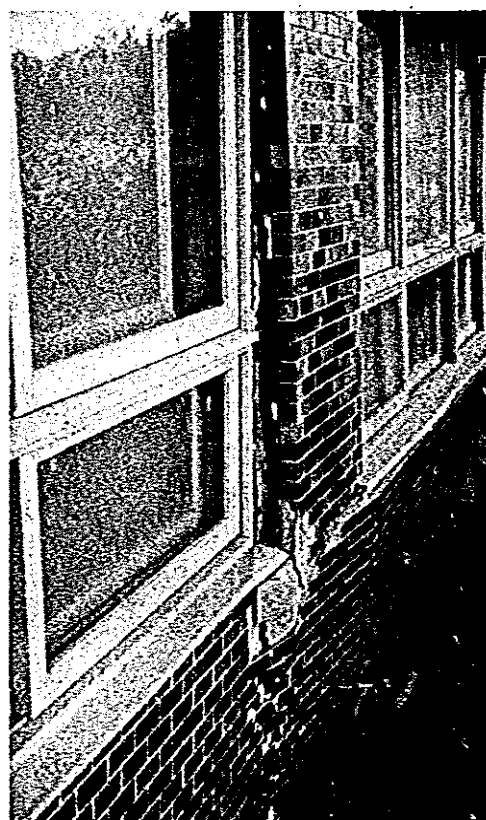
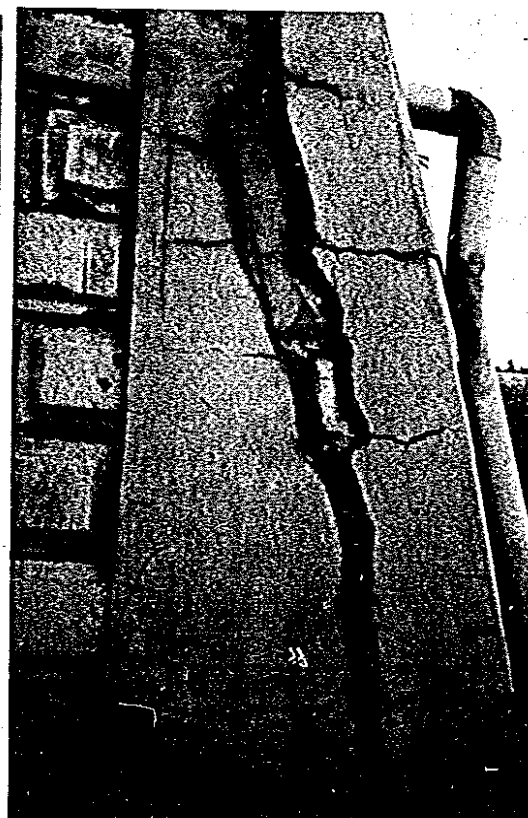
Photo-27 Damages of Sankei Hospital in Sobetsu Town.

Photo-28 Damages of Sankei Hospital in Sobetsu Town.

Photo-30 Damages of Sankei Hospital in Sobetsu Town.

Photo-29 Damages of Sankei Hospital in Sobetsu Town.

Water supplies in Abuta T. and Toyoura T. were cut off after the eruption, because the water quality of the rivers and lake got worse. A filtration plant in Abuta T. was abandoned since the debris flow was anticipated nearby to destroy it. A hospital in Sobetsu T. quitted the practice having cracks on the walls and columns of the building. (Ref. Photo. 27 - 30)
