Technical Memorandum of PWRI No. 1438

**FUNCTIONAL DAMAGE AND  
REHABILITATION OF LIFELINES  
IN THE MIYAGIKEN-OKI  
EARTHQUAKE OF 1978**

December 1978

Earthquake Engineering Division  
Earthquake Disaster Prevention Department  
Public Works Research Institute  
Ministry of Construction

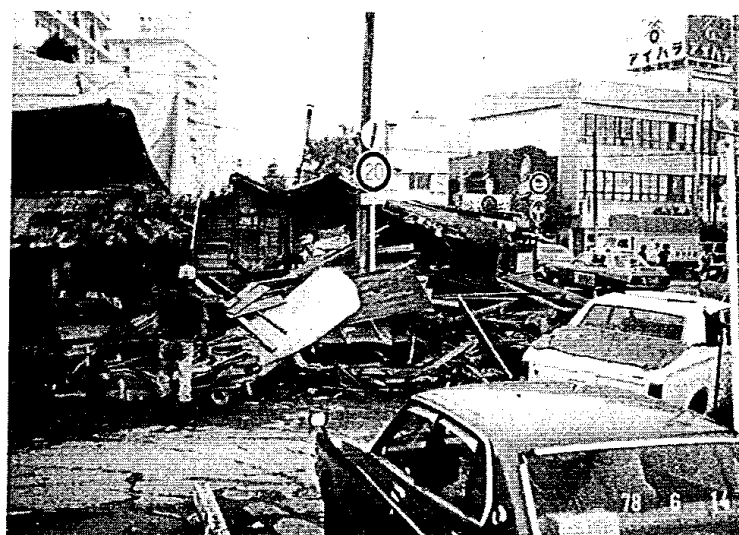
Photo. 3. Damaged Wooden House at Naga-machi, Sendai

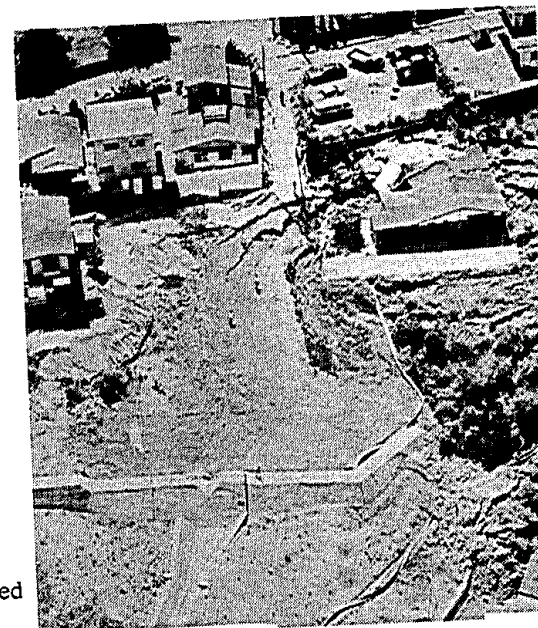
Photo. 5. Landslide of the Lately Developed Land at Midorigaoka, Sendai

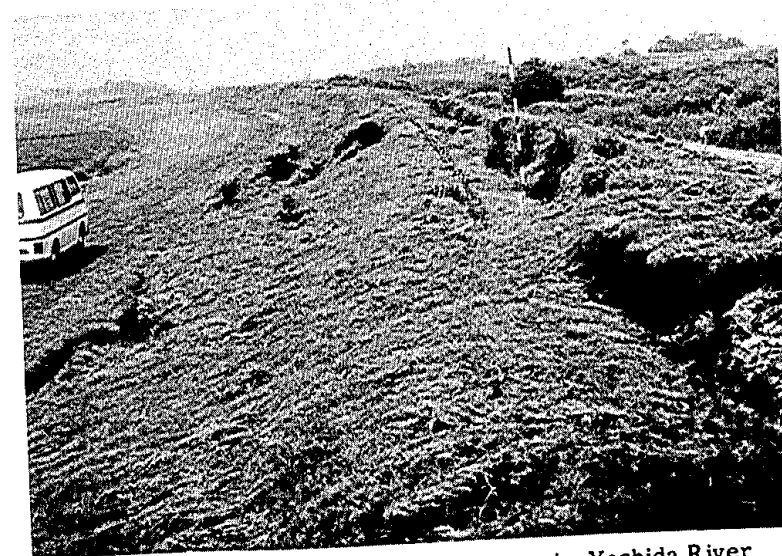
Photo. 6. Subsidence of Dyke Settlement at the Yoshida River

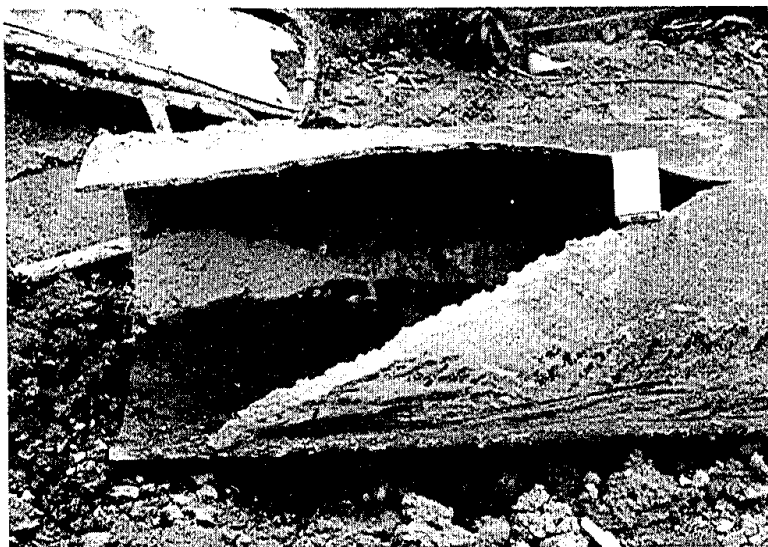
Photo. 11. Damaged Conduit of 400 mm at Mikoyama 4, Sendai

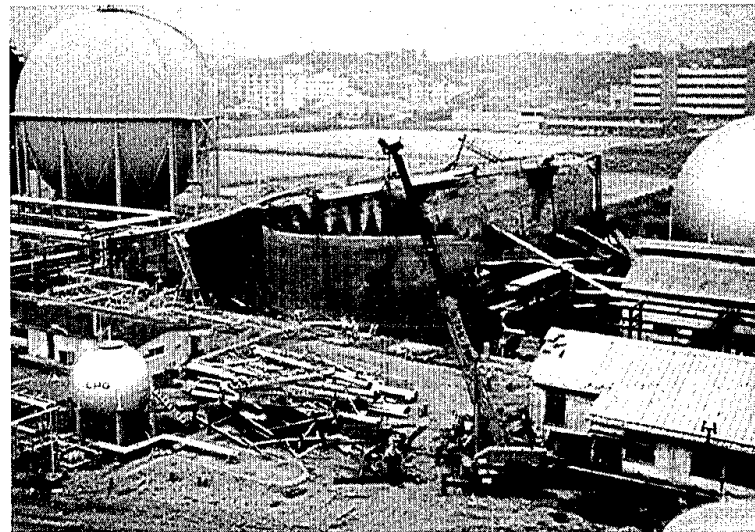
Photo. 14. Burned Gas Holder at Harano-machi, Sendai
