**PROCEEDINGS OF  
THE 25<sup>th</sup> U.S. – JAPAN  
BRIGDE ENGINEERING WORKSHOP**

Tsukuba, Japan  
October 19, 20 and 21, 2009

CENTER FOR ADVANCED ENGINEERING STRUCTURAL ASSESSMENT AND RESEARCH  
PUBLIC WORKS RESEARCH INSTITUTE  
Incorporated Administrative Agency

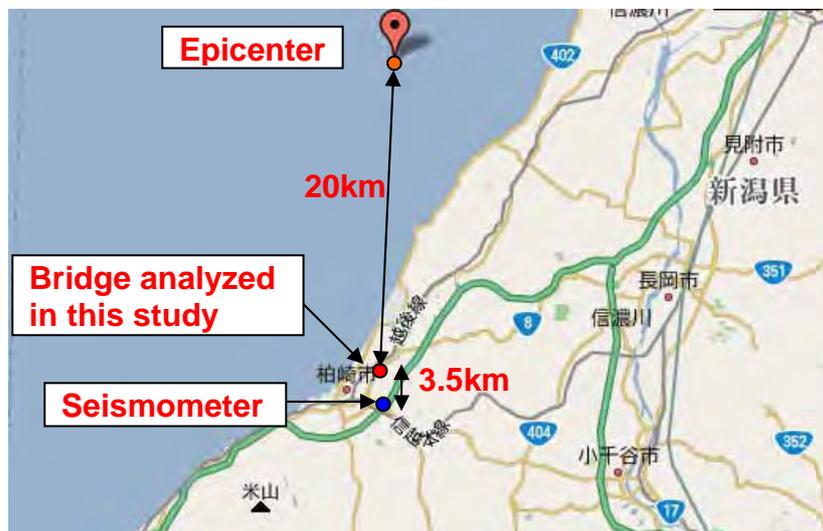
**Fig. 1** Location of the bridge analyzed

The bridge analyzed in this study is located as shown in **Fig. 1**. The bridge is about 20km away from the epicenter. The bridge was designed based on the Specifications for highway bridges (March 2002) and was constructed in 2005 to overpass the river as shown in **Fig. 2**. The bridge length is about 150m (47.6m +55m + 45.2m). The superstructure is 3-span continuous curved steel box girder. The substructures are RC columns with a wall type section and supported by the cast-in-place RC pile foundations. The ground consists mainly of soft silt and clay including thin sandy layers causing liquefaction. The ground type for seismic design is classified in TYPE III. The pile lengths are 55 ~ 70 m and the pile diameter is 1.5m. Bearings are rubber bearings to disperse seismic lateral forces in all direction. Two

The acceleration strong motion records were obtained by the seismometer of Kashiwazaki interchange which was located nearby the bridge as shown in **Fig. 1**. The accelerations of three directions were used as input ground motion to perform the dynamic analyses. The records were observed in north-south direction and east-west direction. The input accelerations are transformed in the direction of the bridge axis and transverse of the bridge axis. **Fig. 7** shows the input accelerations and the acceleration spectra. The natural period of the bridge is 1.25 seconds. The value of the accelerations is slightly smaller than the standard acceleration for Type II earthquake design ground motion in the range of fundamental natural period of this bridge.

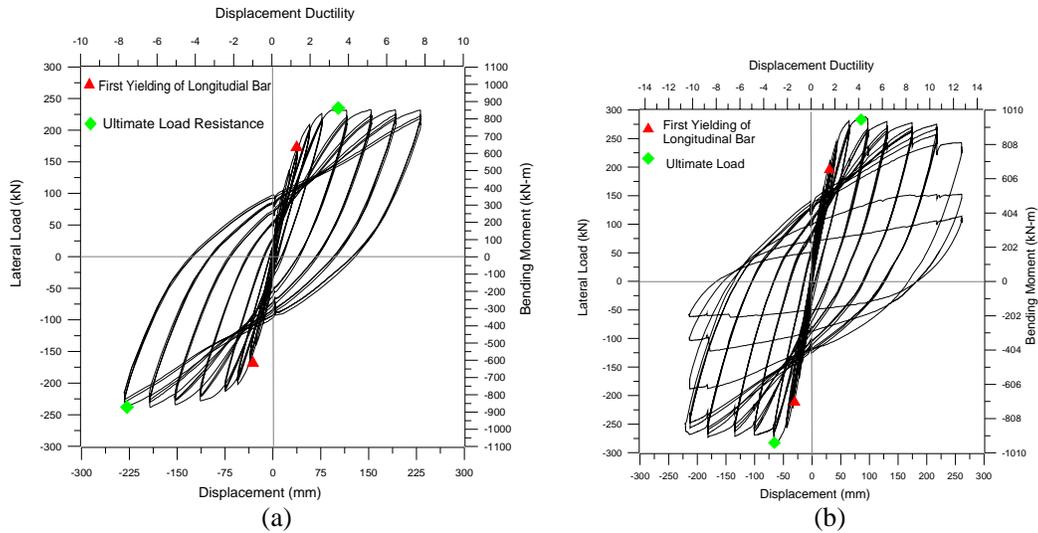
Circular Column: The column tested under flexure and shear began exhibiting flexural cracks near the bottom on side A and side C after cyclically loading the column to 50% of  $F_y$ . These cracks continued to grow and new cracks appeared on both sides of the column as higher levels of ductility were reached. The cover concrete started spalling at a drift of about 3.2%. Spacers were attached between the actuators and the column and the displacement was applied only in the A-C direction after ductility eight. The failure mode of the specimen began with the formation of a flexural plastic hinge at the base of the column, followed by core degradation, and finally by the buckling of longitudinal bars on the compression side at a drift of about 12.7%. The flexural hysteresis is shown in Figure 3 up to ductility level of eight. The flexural resistance was stable between 3% and 12.7% drift with nearly a constant flexural strength of 232.8 kN. During the last cycle of loading, a longitudinal bar started buckling while unloading, as shown in Figure 4c. The yielding zone of the longitudinal bars was about 610 mm from the base of the column. Longitudinal bars on sides 'A' and 'C' both reached the yield strain at the predicted ductility level one. The spirals remained elastic until a ductility level of six, after which they yielded. Soon after cracking and spalling at the location of the spiral gages, the spiral gages became non-functional.

Figure 3 Hysteresis Curves under Flexure and Shear (a) Circular and (b) Square

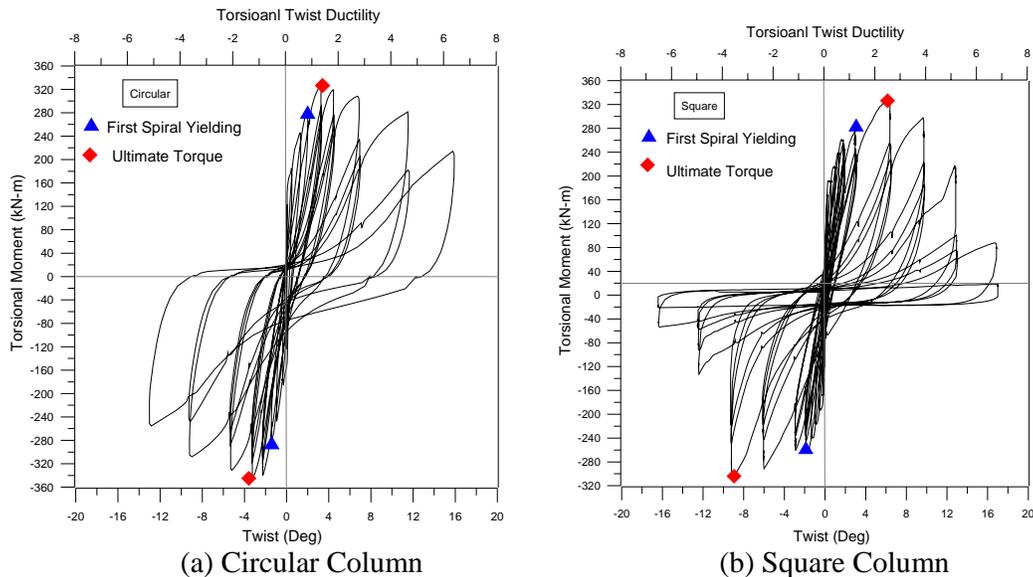
damage pattern of the column under pure torsion was significantly different from that of column under flexure and shear.

Figure 5 Torsional Hysteresis under Pure Torsion

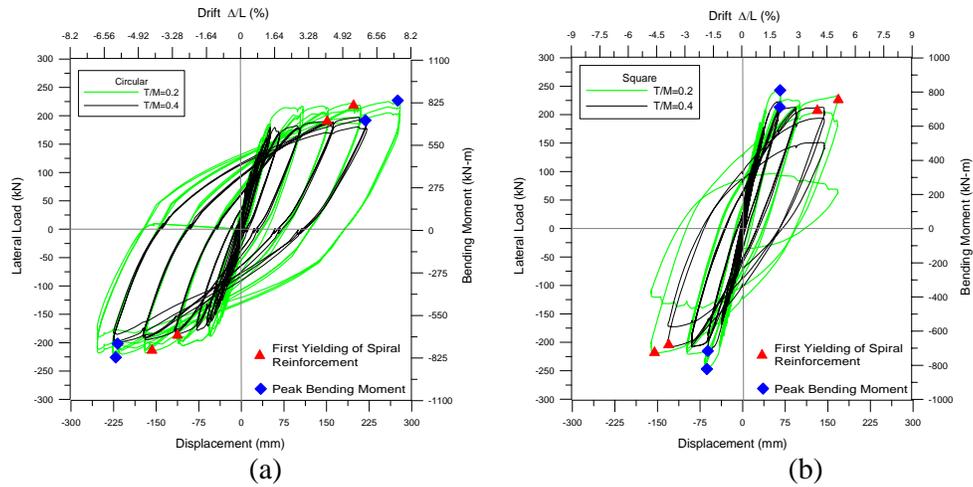
Figure 7 Comparison of Flexural Hysteresis Behavior under Combined Loading  
(a) Circular and (b) Square

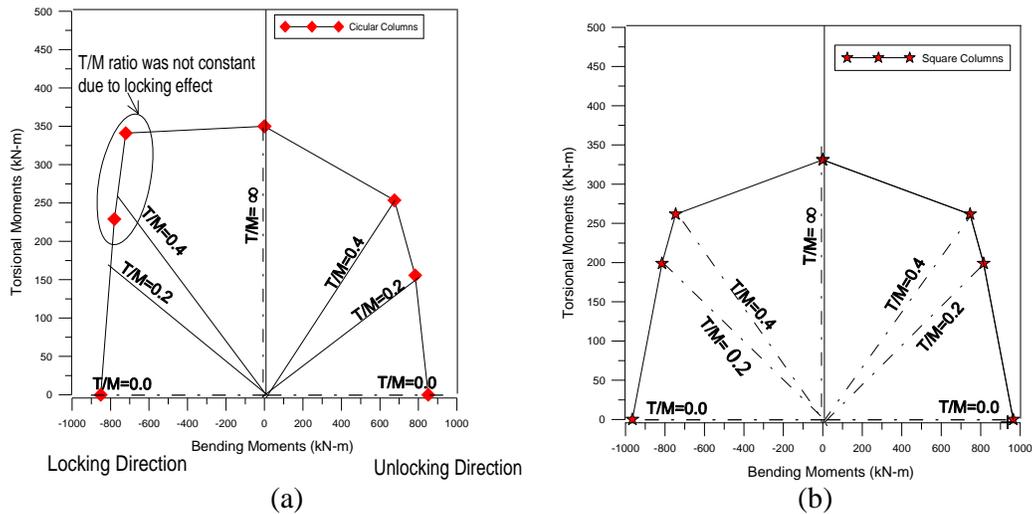
Interaction diagrams between flexural and torsional moments are shown in Figure 10. The locking and unlocking effect of the spiral was significant in circular columns. It can be observed that in circular columns, the torsional strength was reached first and then flexural strength, while the square columns reached their torsional and flexural strength simultaneously. However, the failure sequence in all the specimens were in the order of flexural cracking, followed by shear cracking, longitudinal bar yielding, spalling of concrete cover, spiral yielding and then final failure by buckling of longitudinal bars after severe core degradation. It should be noted that the T/M ratio was close to the desired loading ratio in all the specimens till peak torsional moment. Soon after reaching the peak torsional strength, it was not possible to maintain the desired loading ratio as torsional strength was degrading much faster. Further, experimental research is in progress on behavior of square columns at Missouri S&T. Additional test results at different T/M ratios and further analysis would provide valuable information on the effect of warping and its significance on the torsion and flexural moment interaction diagrams.

Figure 10 Torsion and Bending Interaction at Peak Torque (a) Circular and (b) Square

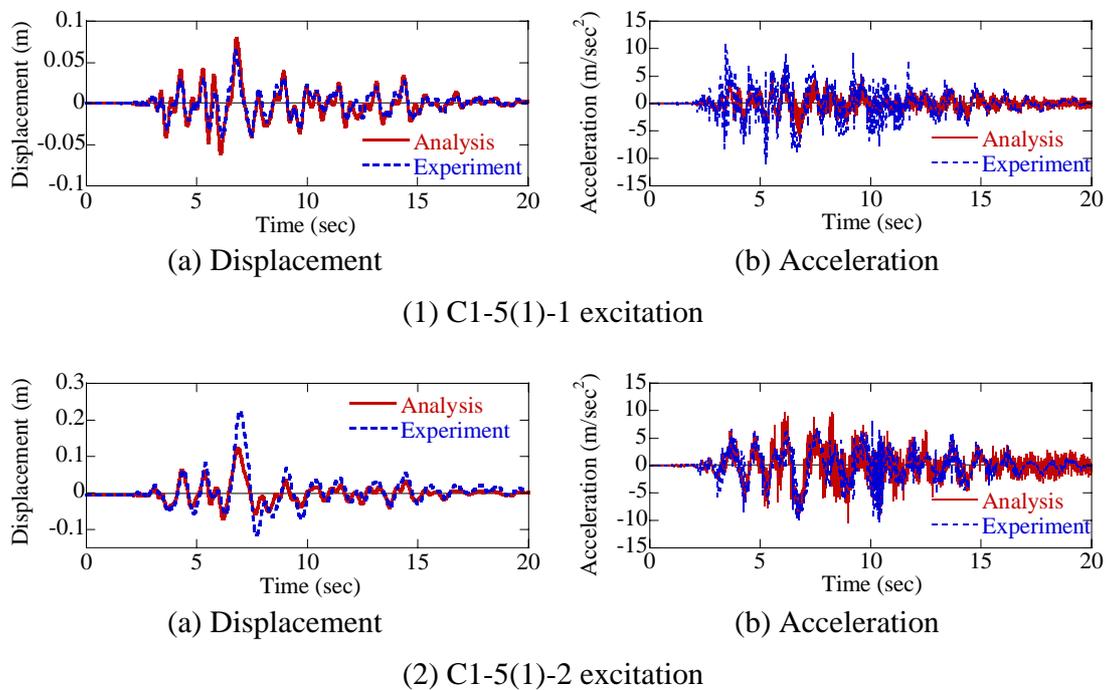
Fig. 11 shows the analytical correlation on the response displacements at the top of the column in the principal direction during C1-5(1)-1 and C1-5(2) excitations. Fig. 12 compares the measured and computed moment at the base vs. lateral displacement at the column top hysteresses during the two excitations. Because nonlinear hysteretic response was still limited during C1-5(1)-1 excitation, the computed response displacement and moment vs. lateral displacement hysteresses are quite in good agreement with the experimental results, however as C1-5 suffered more damage, the accuracy of analytical prediction decreases.

**Fig. 11** Analytical correlation for the response displacement and acceleration at the column top in the principle response direction

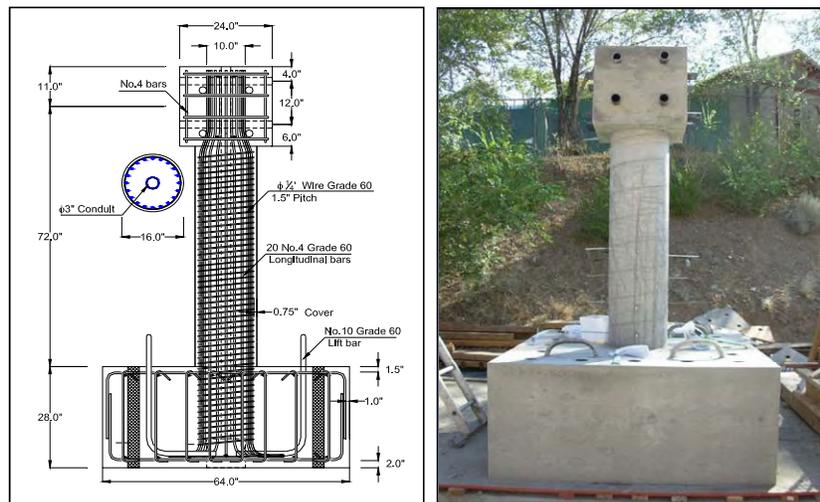
**Figure 1: Geometric configuration and reinforcement for circular RCC\*.**

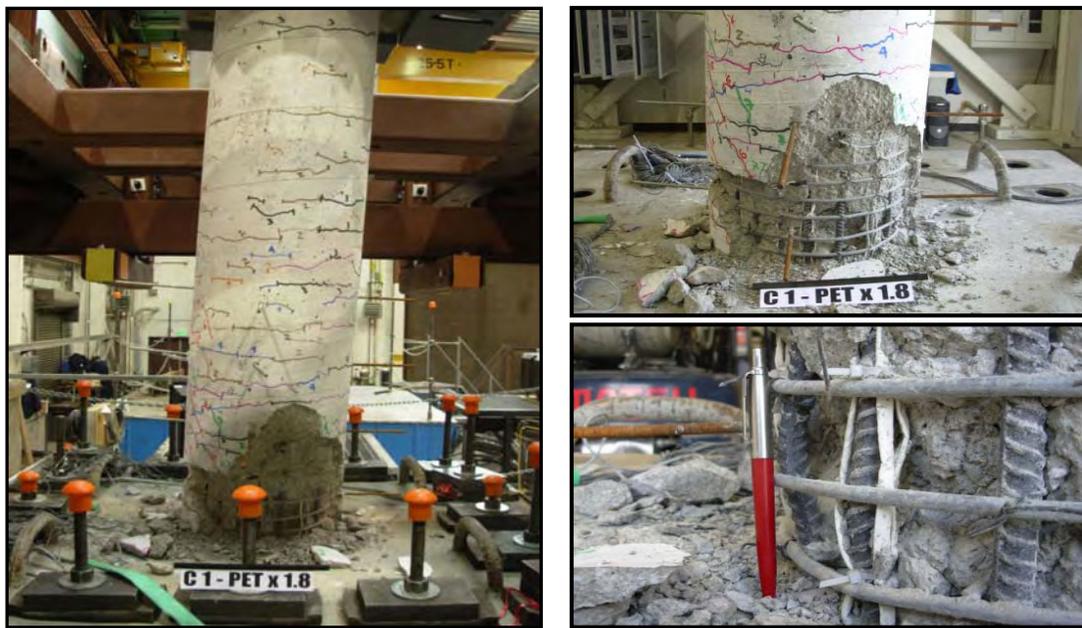
Figure 4 – Specimen C1 after failure

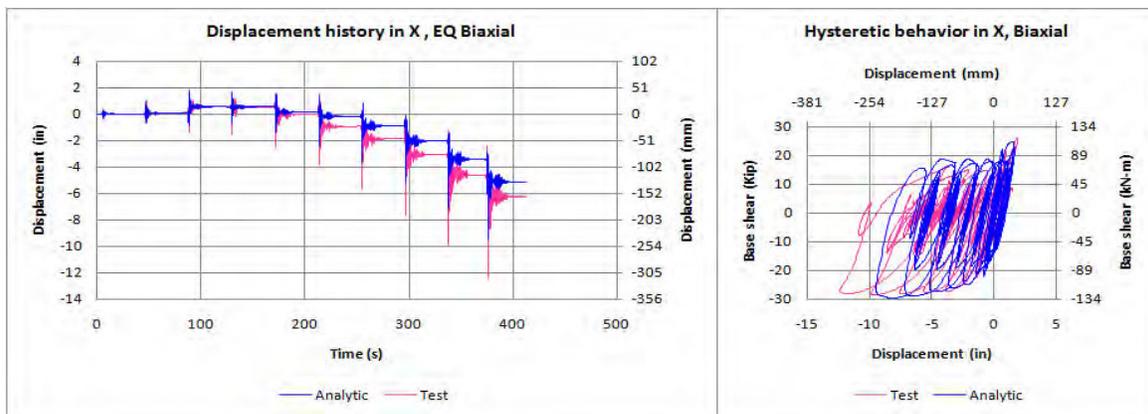
The first yielding was observed during 0.2xPET, after this motion, horizontal cracks spreaded out from the bottom of the column until the motion 1.0xPET, where the concrete cover at the south side spalled out. The maximum force was recorded at 1.6xPET, at this stage most of the transverse reinforcement was exposed. Finally the failure of the column was observed at 1.8xPET, at this stage some of the longitudinal bars undergone buckling and large degradation of the concrete core was observed. Figure 4 shows the final damage state of the column, while figure 5 shows the displacement history and the hysteretic behavior of the specimen in longitudinal direction (X). On the same plot is shown the predicted behavior using the analytical model.

Figure 5– Displacement history and hysteresis for specimen C1

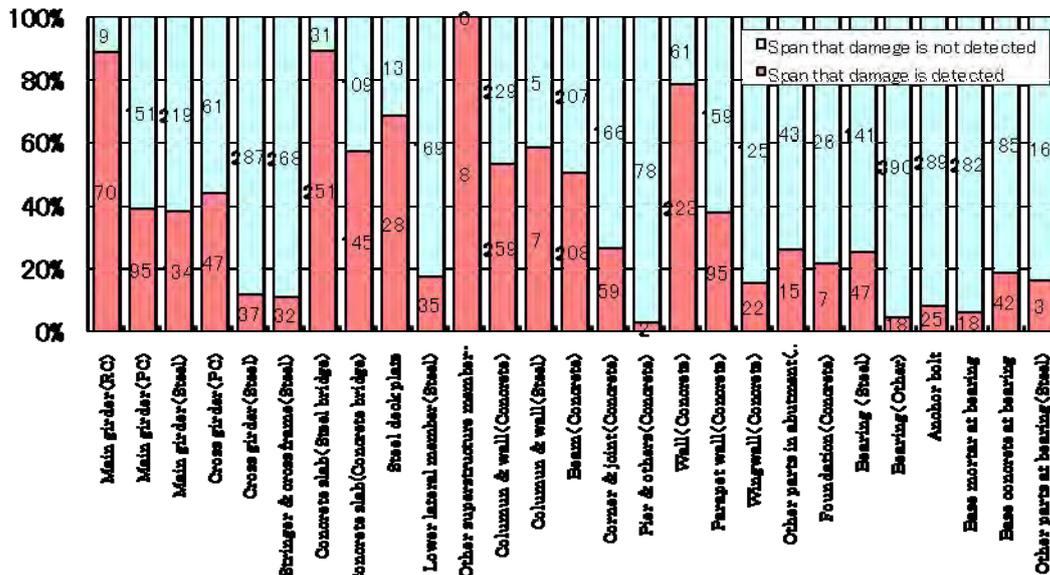
Damages were detected in most of bridges in first inspection. The number of bridges as the objects of first inspection was 198, which were within 2 years after opening to the traffic and after construction completed, and damages were detected in 193 bridges (97%). The most detected damage was deterioration of rust-proof performance and corrosion in steel members and crack, leakage and isolated lime in concrete members. Abnormality of anchorage zone of PC member and abnormality of performance of bearing were detected as the serious damage to affect performance of bridge.

Fig.1 Initial inspection results (main members)

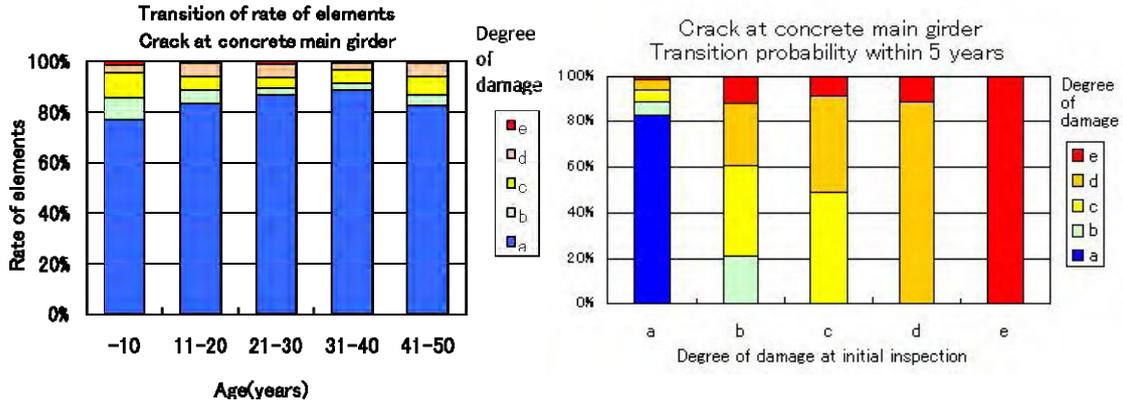
Among the relationships between age and degree of various kinds of damage, the example of crack at concrete main girder is shown in Fig.3, and the example of abutment is shown in Fig.4. The transitions of main girder and abutment are different. On the other hand, it can be inferred that when crack generated even at main girder, the crack certainly progresses within 5 years.

Fig.3 Relationship between age and degree of damage (crack at concrete main girder)

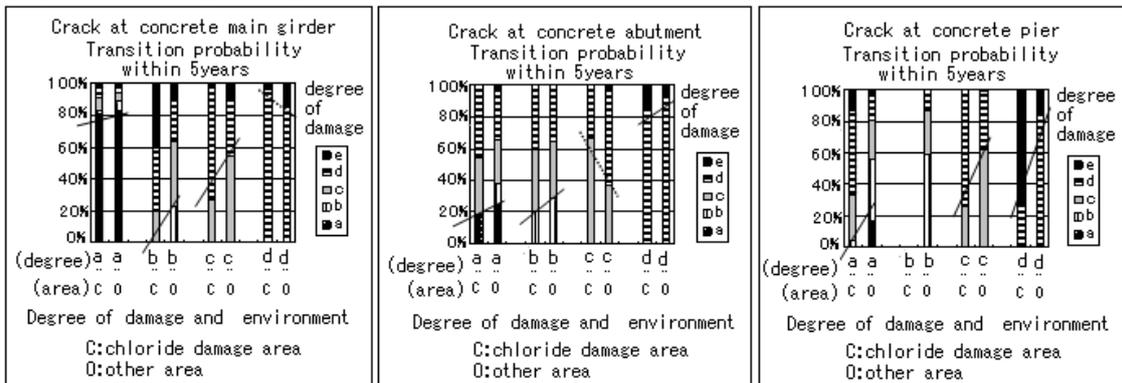
Fig. 5 Transition probability of generation of crack at concrete members

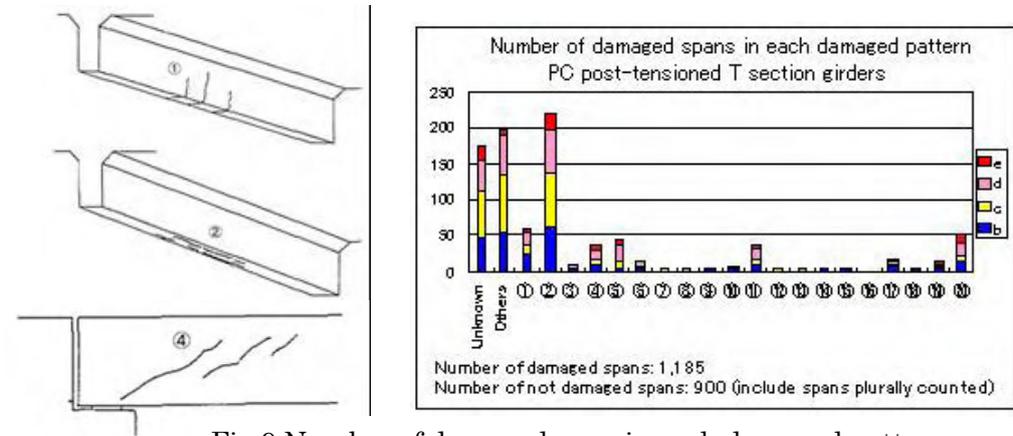
For PC post-tensioned T section girders, age and state of crack generation in each pattern whose generation rate is high is shown in from Fig.9 to Fig.12

Fig.9 Number of damaged span in each damaged pattern (PC post-tensioned T section girder bridge)

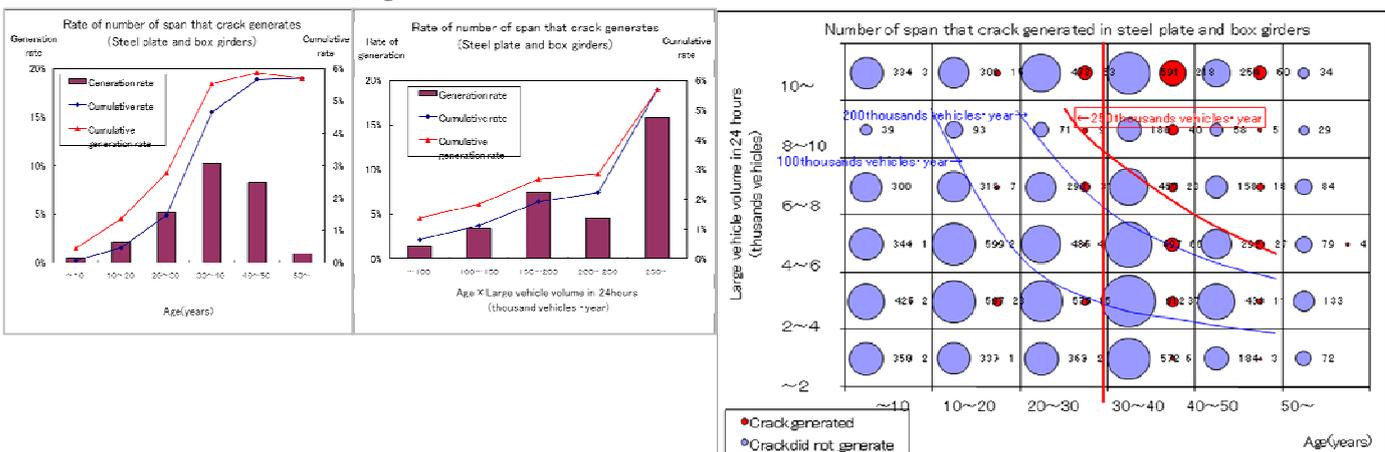
In the crack of steel member, the relationship of fatigue damage, age, and cumulative traffic volume was analyzed. The results of steel plate girder bridges and steel box girder bridges are shown in Fig.14, and the results of steel truss bridge are shown in Fig.15. The trend is recognized that the rate of generation of crack increases when the age gets more than 30 years, and cumulative large vehicle volume gets 250 thousand vehicles·year in steel plate girder bridges and steel box girder bridges, and that the rate of generation of crack increases when the age gets more than 30 years in steel truss bridges.

Fig.14 Rate of number of span that crack generates (Steel plate and box girder bridges)

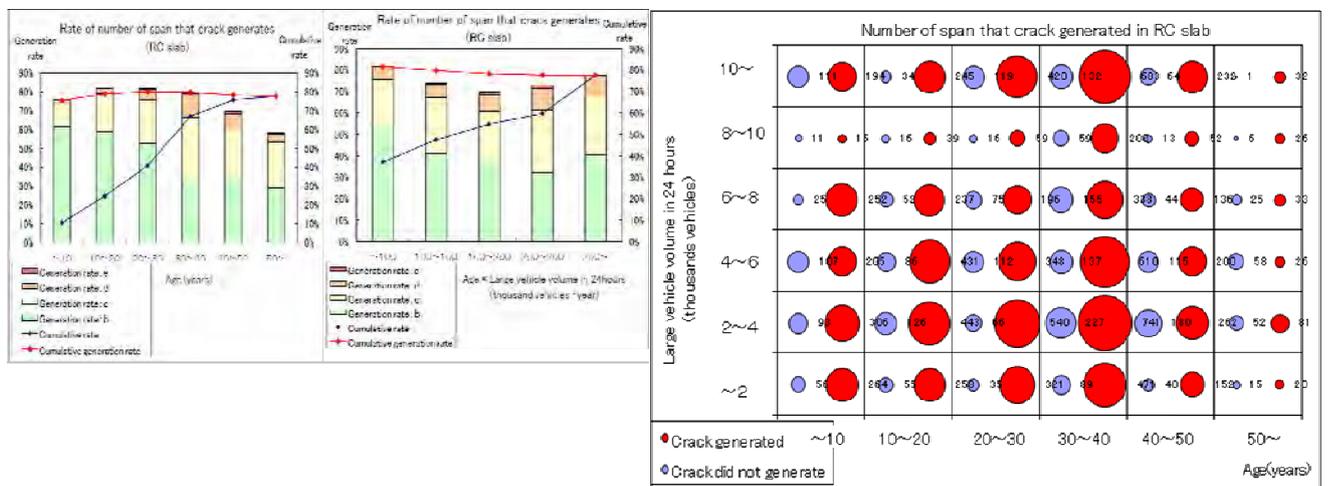
Fig.16 Rate of number of span that crack generates (RC slab)

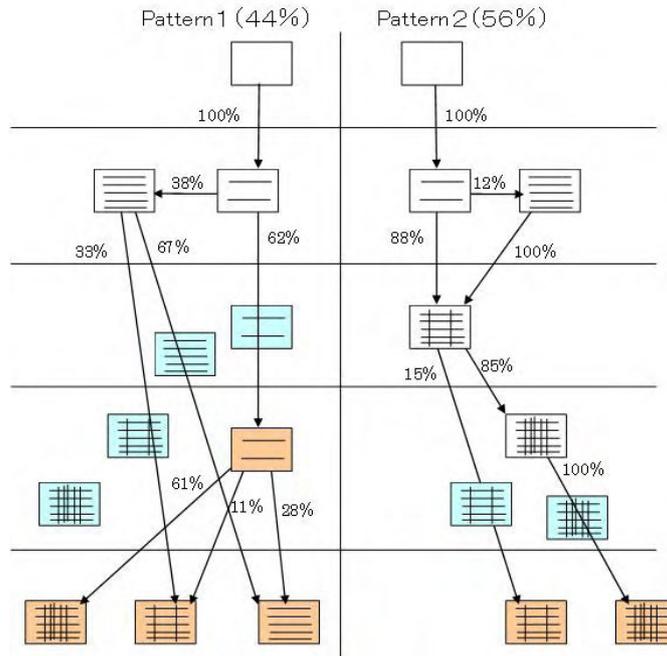
For fatigue damage of RC slab, damage progress patterns are being analyzed including states of leakage and isolated lime with crack. The result of analysis of crack patterns is shown in Fig.17

Fig.17 Analysis of crack patterns of RC slab

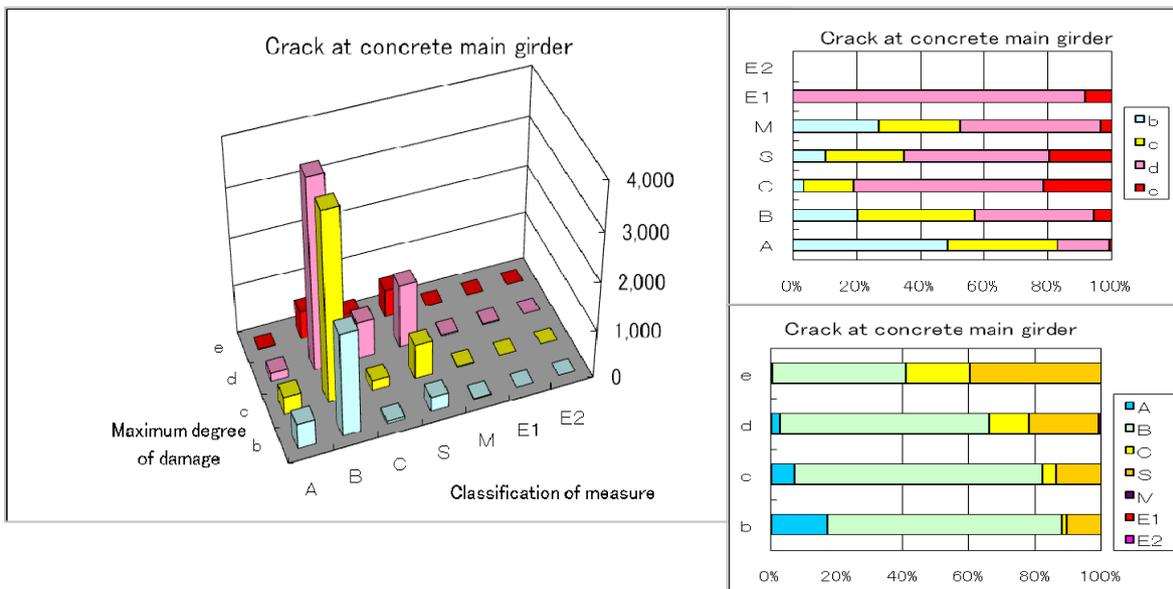
The relationship of degree of damage and classification of measure in the case of crack at concrete main girder is shown in Fig.18. Both evaluations are not coincident. It can be inferred that engineers evaluate in classification of measure considering the bridge's unique condition like environment.

Fig.18 The relationship of degree of damage and classification of measure (crack at concrete main girder)

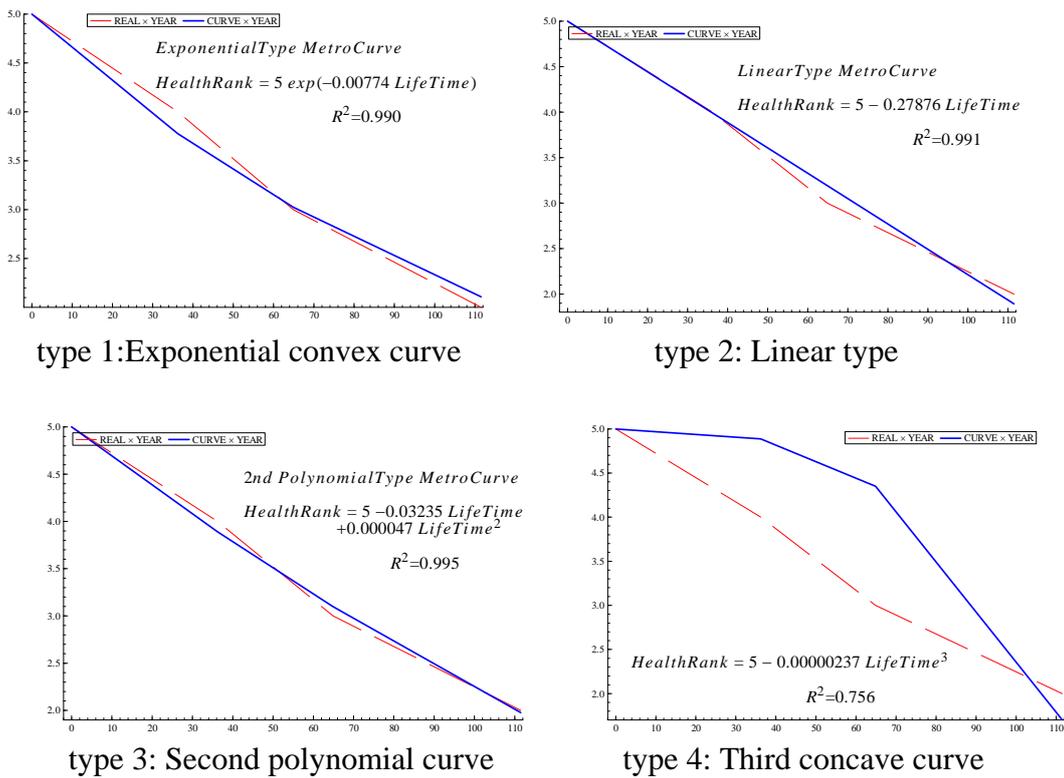
Figure 4: four alternative deterioration curve types

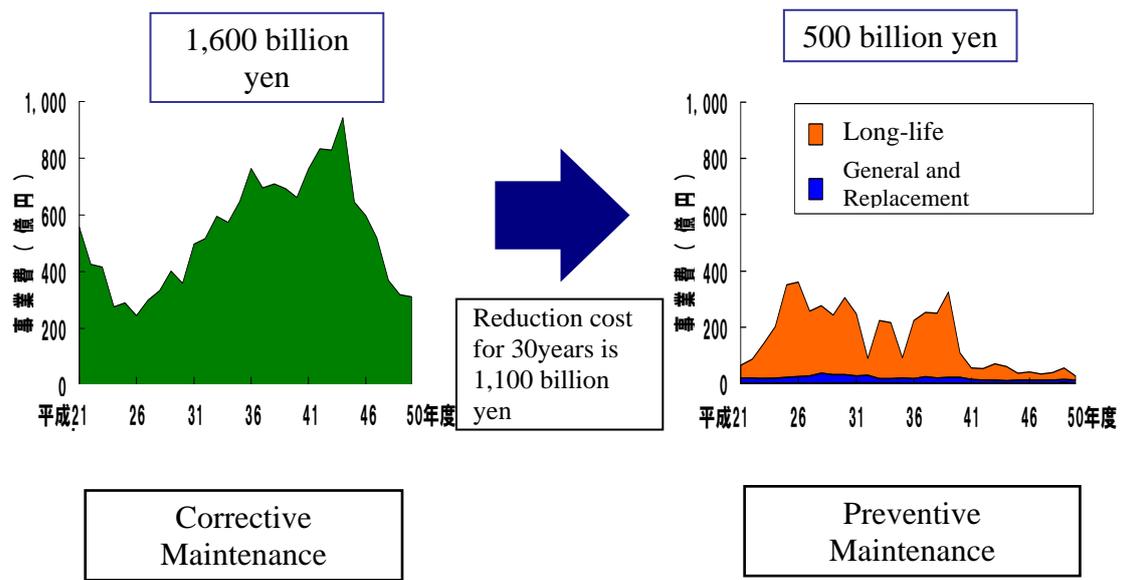
Figure 5: Project cost compared preventive and corrective

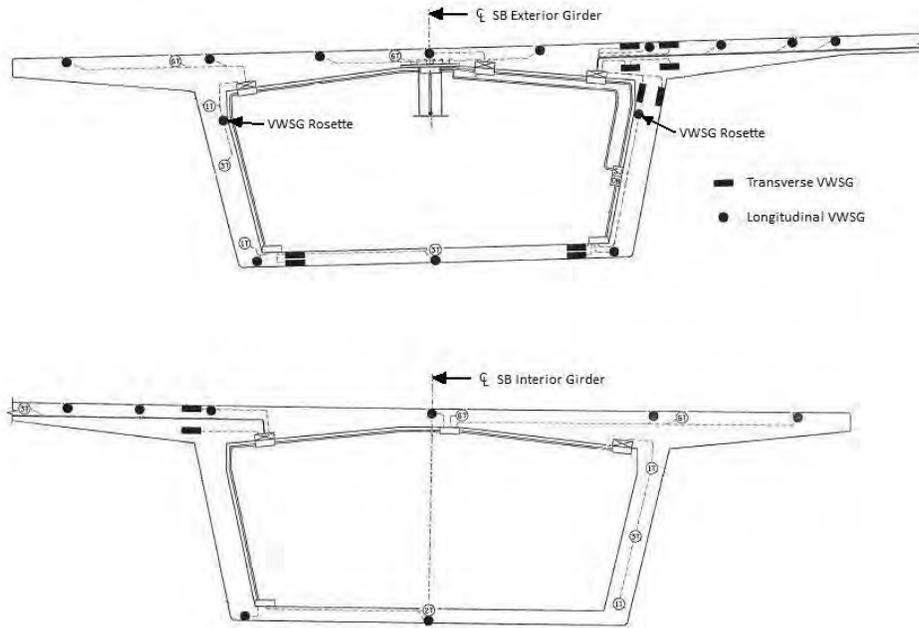
FIGURE 4: VIBRATING WIRE STRAIN GAGE LAYOUT FOR MIDSPAN OF SPAN 2 OF SOUTHBOUND BRIDGE (LOCATION 7SB)

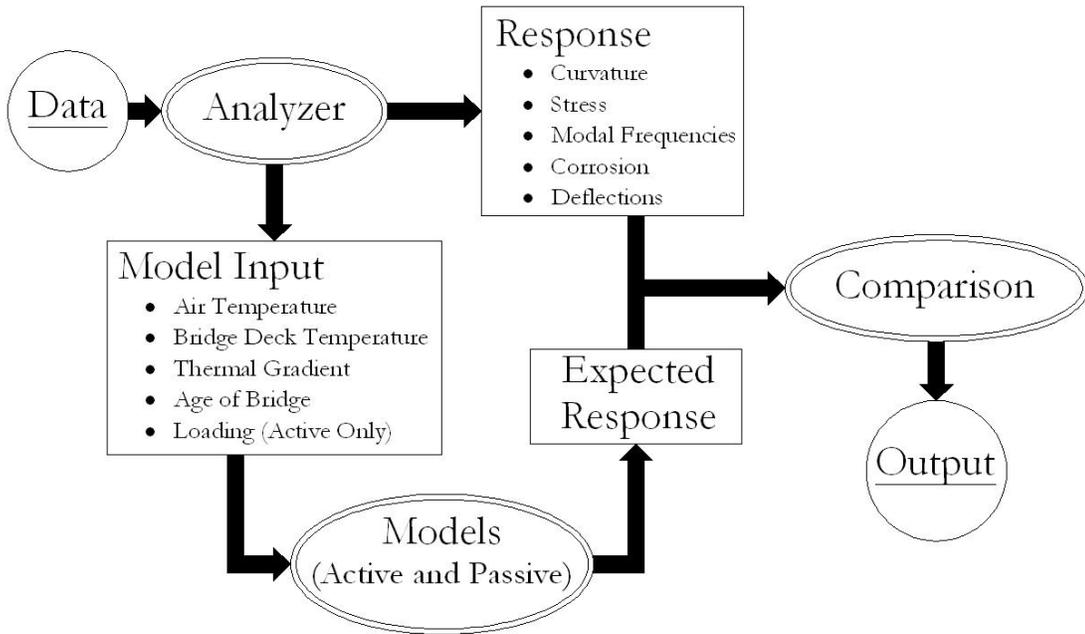
FIGURE 16: SCHEMATIC FOR DEVELOPMENT OF STRUCTURAL MONITORING SYSTEM

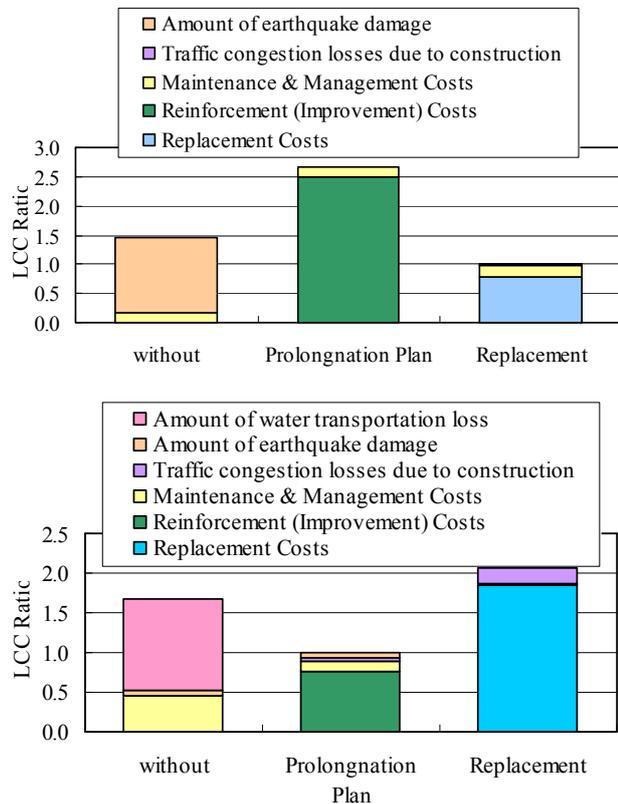
Fig.9 Result of LCC Analysis

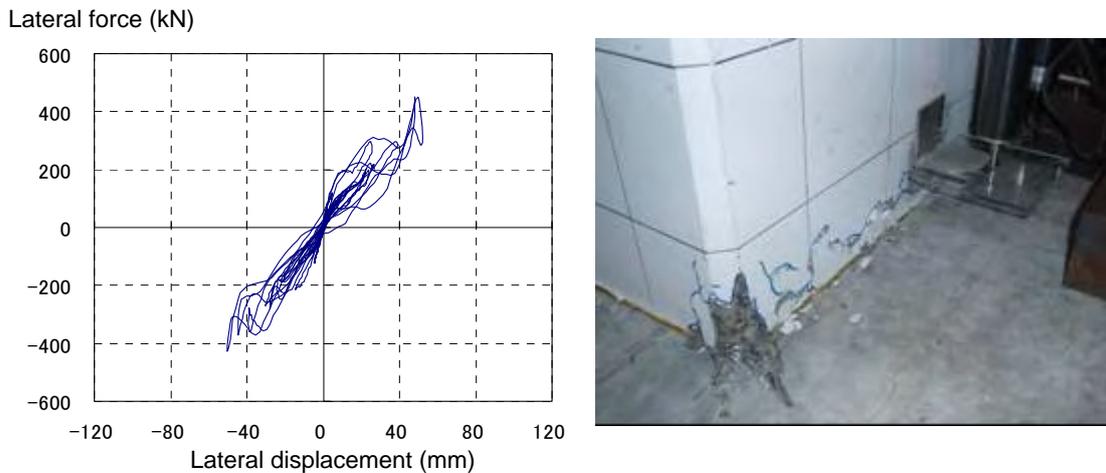
**Figure 9** Seismic Response and Failure Mode after Design Ground Motion Level Test for Precast Prestressed Column

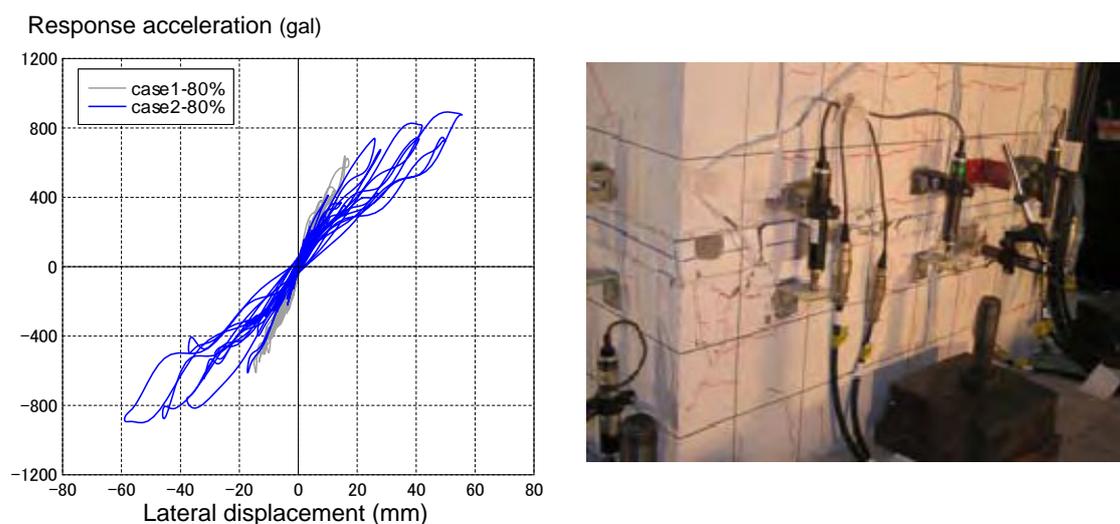
**Figure 11** Seismic Response and Failure Mode after Design Ground Motion Level Test in Post-repair Series for Precast Hybrid Column

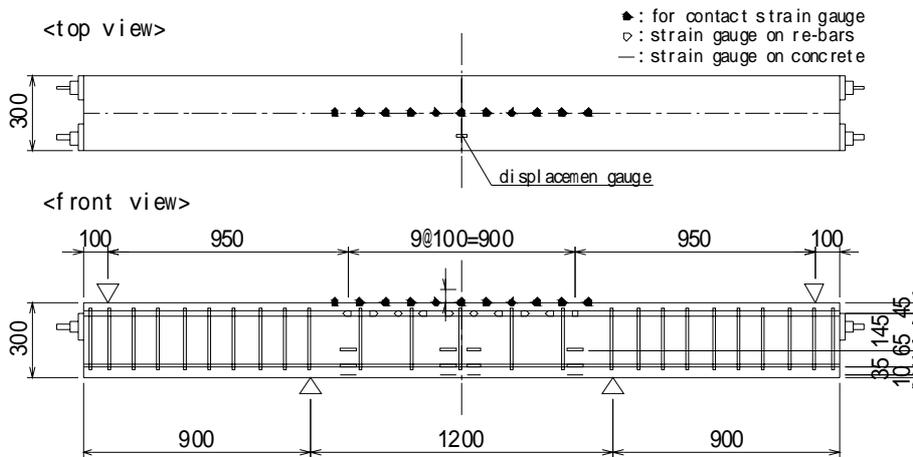
Figure 3. Positions of strain gauges and points for measurement (dimensions in mm).

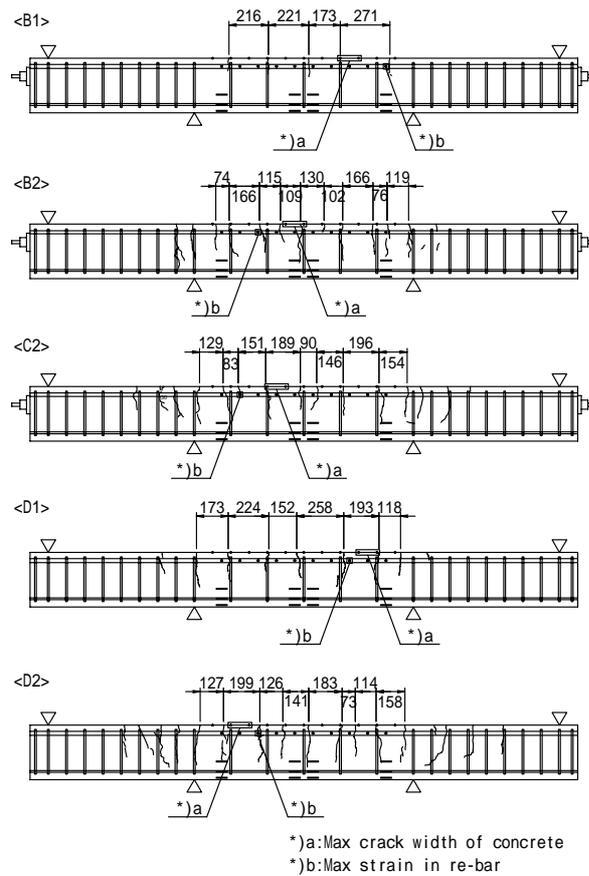
Figure 4. Cracking maps after one sustained load test.

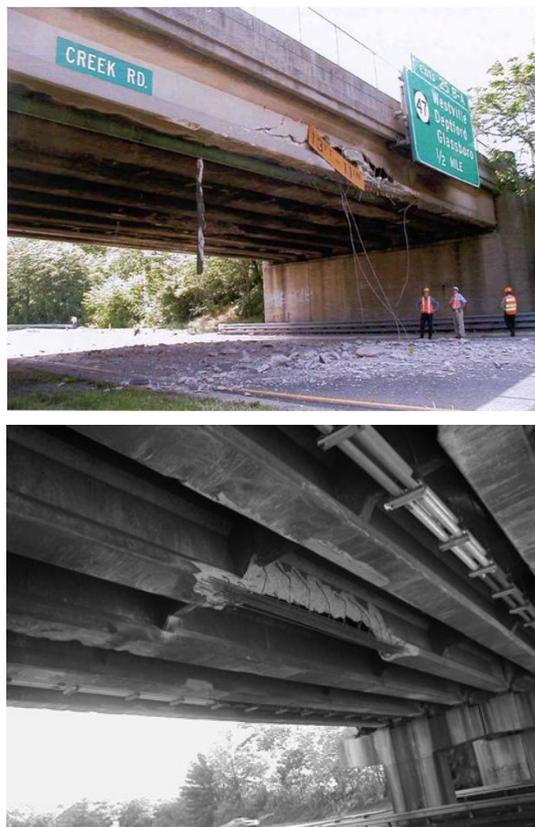
After initial inspection by the NJDOT bridge staff, the overpass was found to be structurally unsound requiring closure of the both I-295 mainline and Creek Road until temporary repairs could be made. The bridge was strengthened with a new, reinforced beam that was installed from the top of the bridge deck (strongback). Options to repair the bridge from under the deck were evaluated, but ultimately rejected, because they would have further restricted the bridge's maximum height safety requirements. The mainline of Route I-295 was reopened after the installation of a temporary support beam, but replacement of a portion of the deck and structural members down to the abutments was required before Creek Road could be reopened.

**Figure 1** Exposed Prestressing Strands of Damaged Interior and Fascia Girder of Creek Road Overpass Bridge

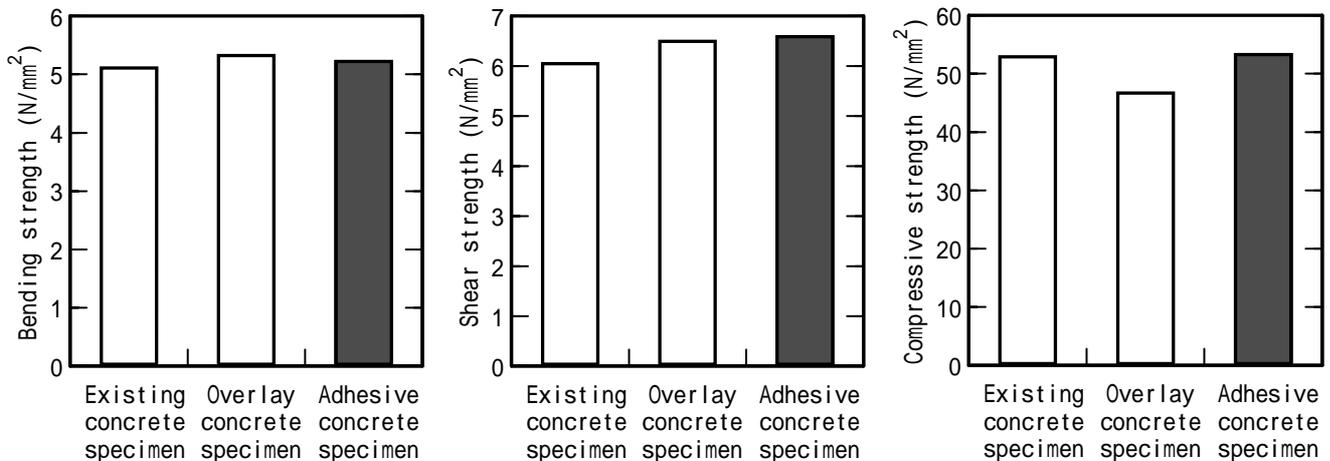
The results of strength test are shown in Fig.3. The bonding strength of bonded specimen was equivalent to a body of base concrete and overlay concrete. Moreover, there was no exfoliation at interface between base concrete and overlay concrete. Shear strength of bonded specimen is equivalent to base concrete and overlay concrete, and the rupture position is inside of the overlay concrete. It is thought that this was destroyed in concrete because interfacial bonding strengths of the adhesive and the overlay concrete are larger than tensile strength of overlay concrete. Sufficient adhesion to shear stress was checked. It was shown that it is equivalent to a body of base concrete and overlay concrete in compressive strength, and the adhesion by adhesives is absolutely excellent.

Fig. 3 Strengths of adhesive bonded specimen

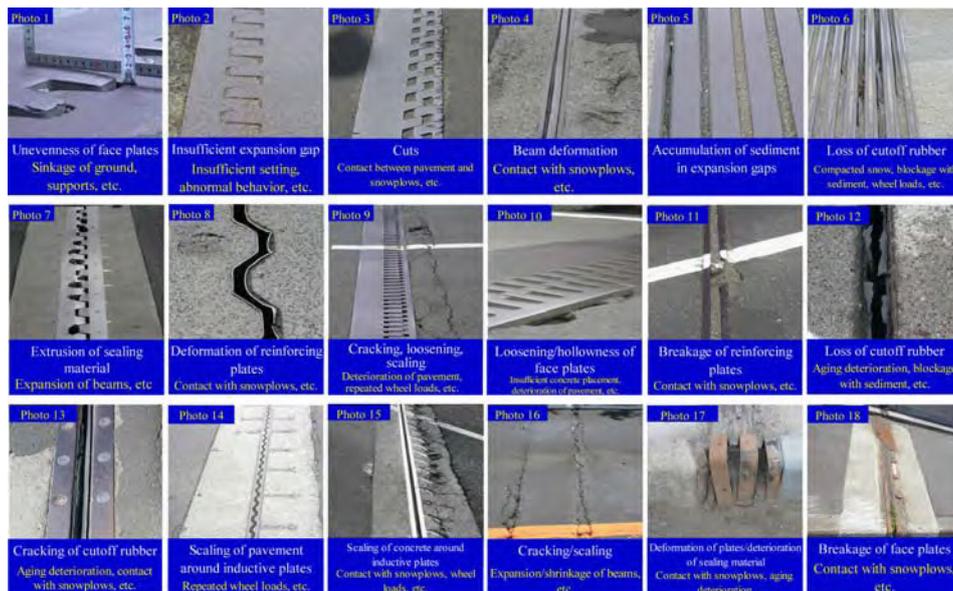
FIG. 1.6 CONDITIONS OF DAMAGE TO EXPANSION DEVICES

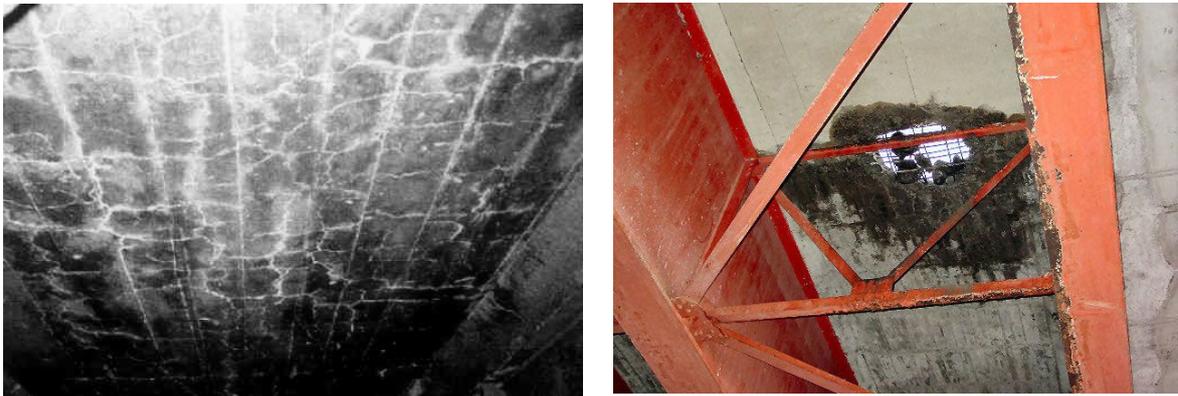
(a) Grid cracks (b) Through hole  
Fig. 2 Deterioration due to fatigue in reinforced concrete decks

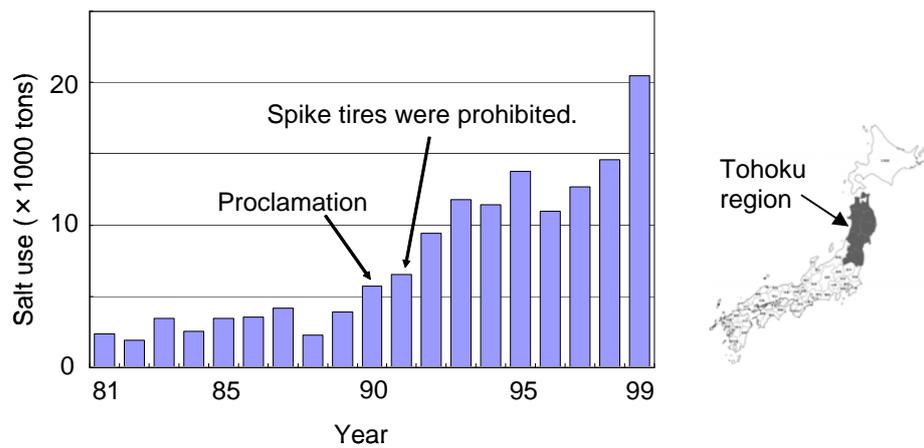
Fig. 3 Trends in deicing salt use in Tohoku region in Japan

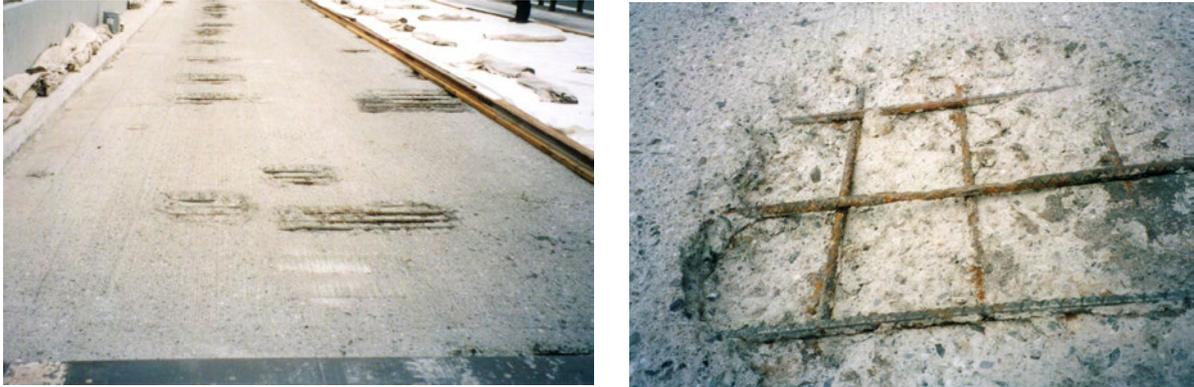
Fig. 4 Corrosion of top mat reinforcement due to salt use in reinforced concrete decks  
Both photo shows top of decks after asphalt and spalled concrete cover were removed.

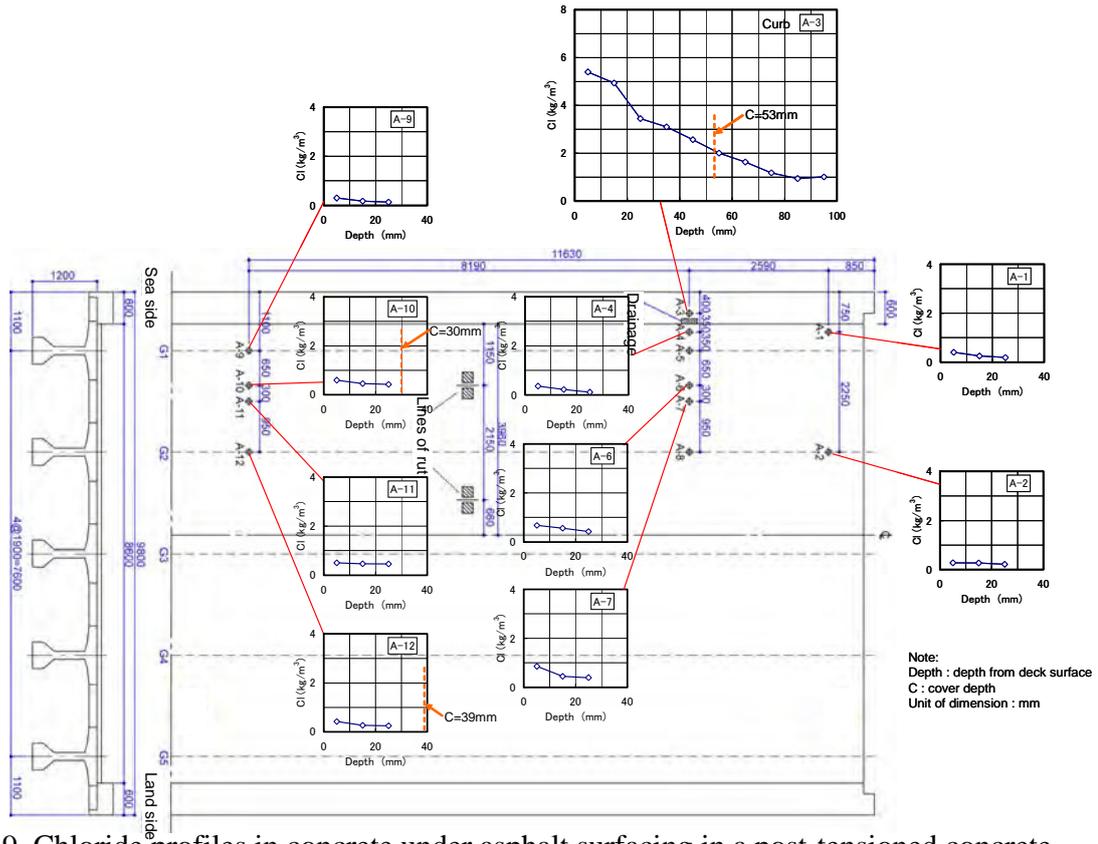
Fig. 9 Chloride profiles in concrete under asphalt surfacing in a post-tensioned concrete bridge exposed at coastal area for 34 years (ATG bridge)

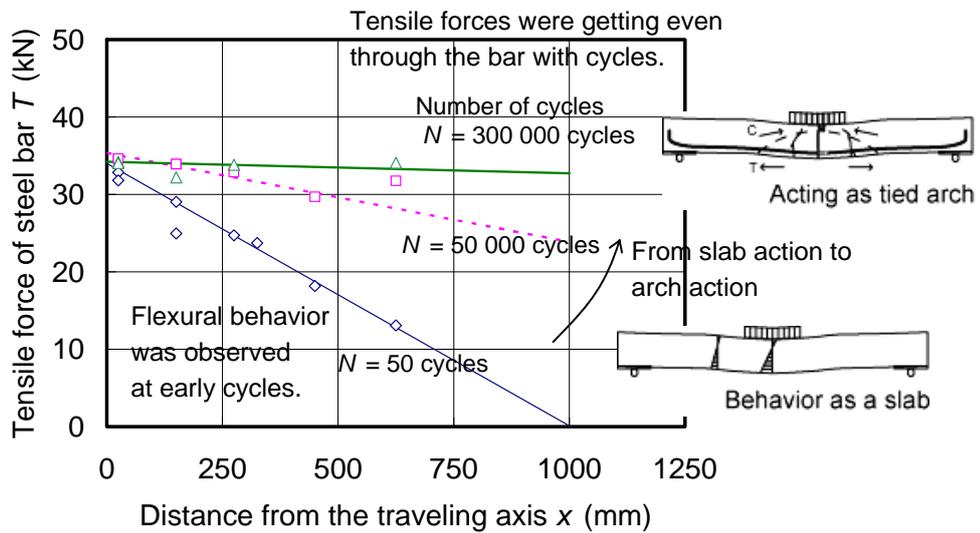
Fig. 16 Distributions of tensile axial force acting on a main reinforcing bar
