**PROCEEDINGS OF  
THE 25<sup>th</sup> U.S. – JAPAN  
BRIGDE ENGINEERING WORKSHOP**

Tsukuba, Japan  
October 19, 20 and 21, 2009

CENTER FOR ADVANCED ENGINEERING STRUCTURAL ASSESSMENT AND RESEARCH  
PUBLIC WORKS RESEARCH INSTITUTE  
Incorporated Administrative Agency

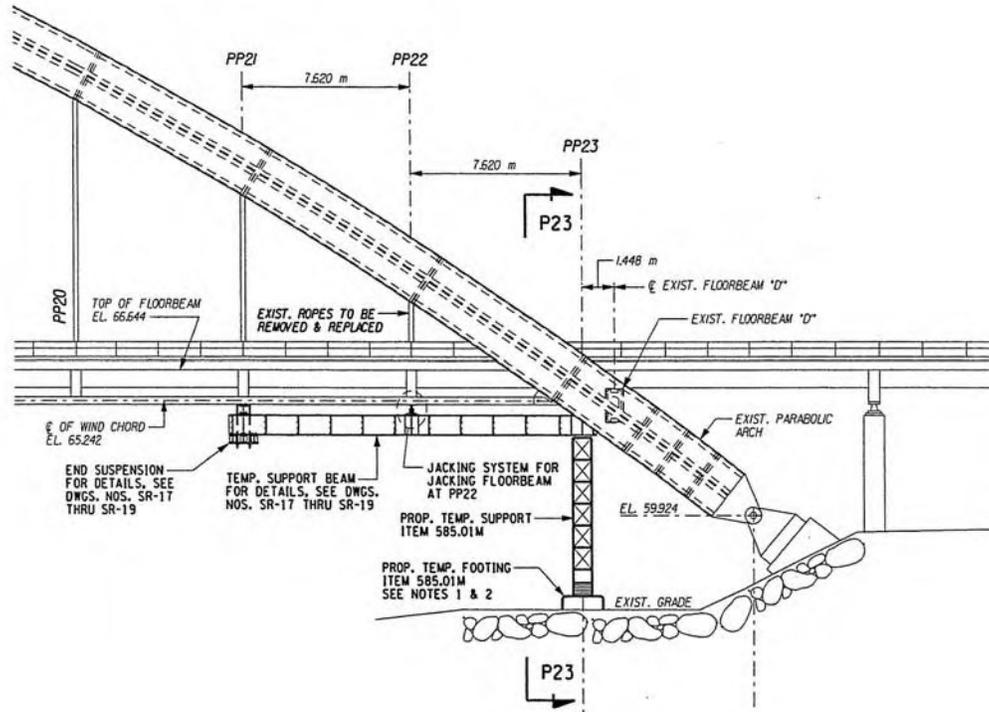
**Figure 4 – Method of Replacing Suspenders in Original Contract Plans.**

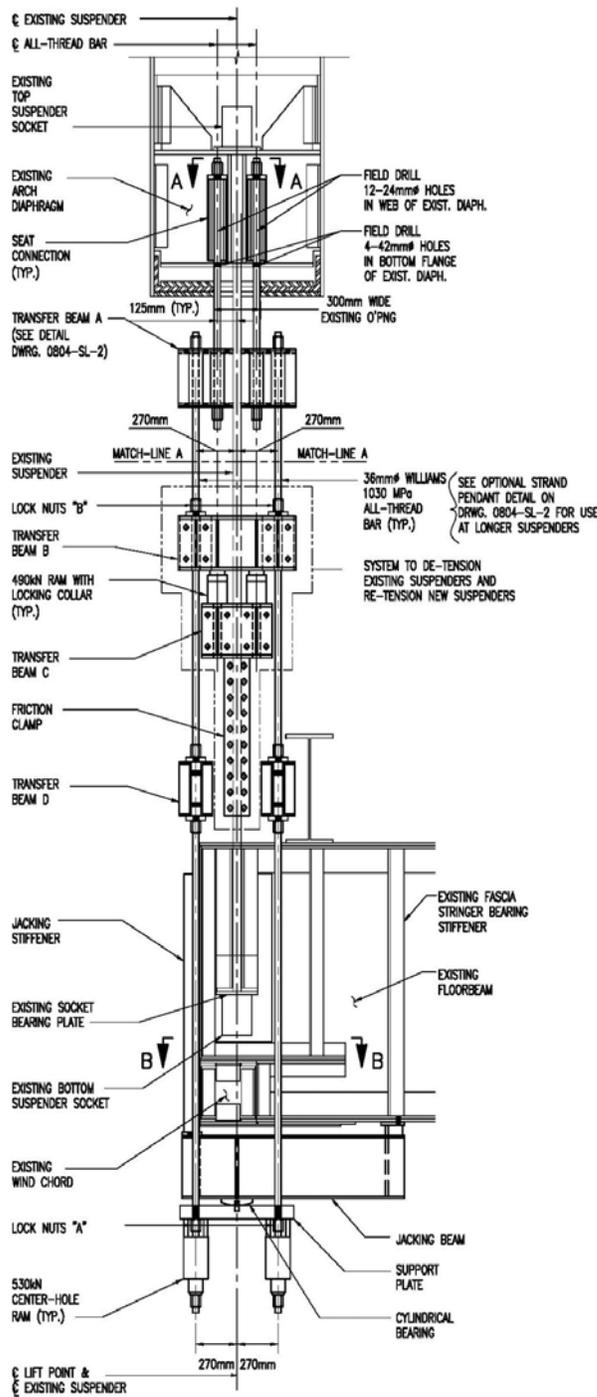
**Figure 5 – Alternate Structural Lift System**

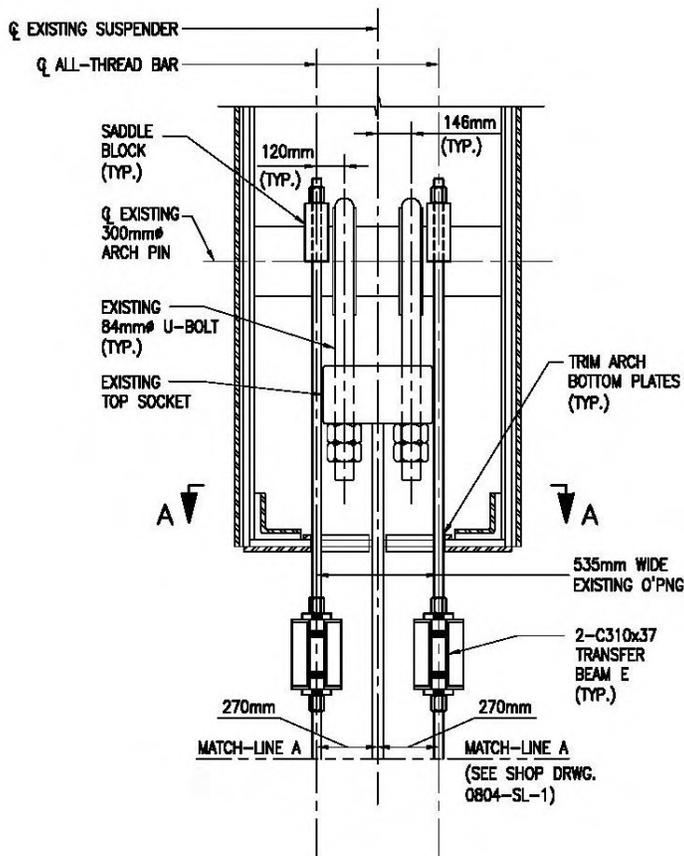
Figure 9 – Cross-Section at Crown of Arch (Panel Point 12)

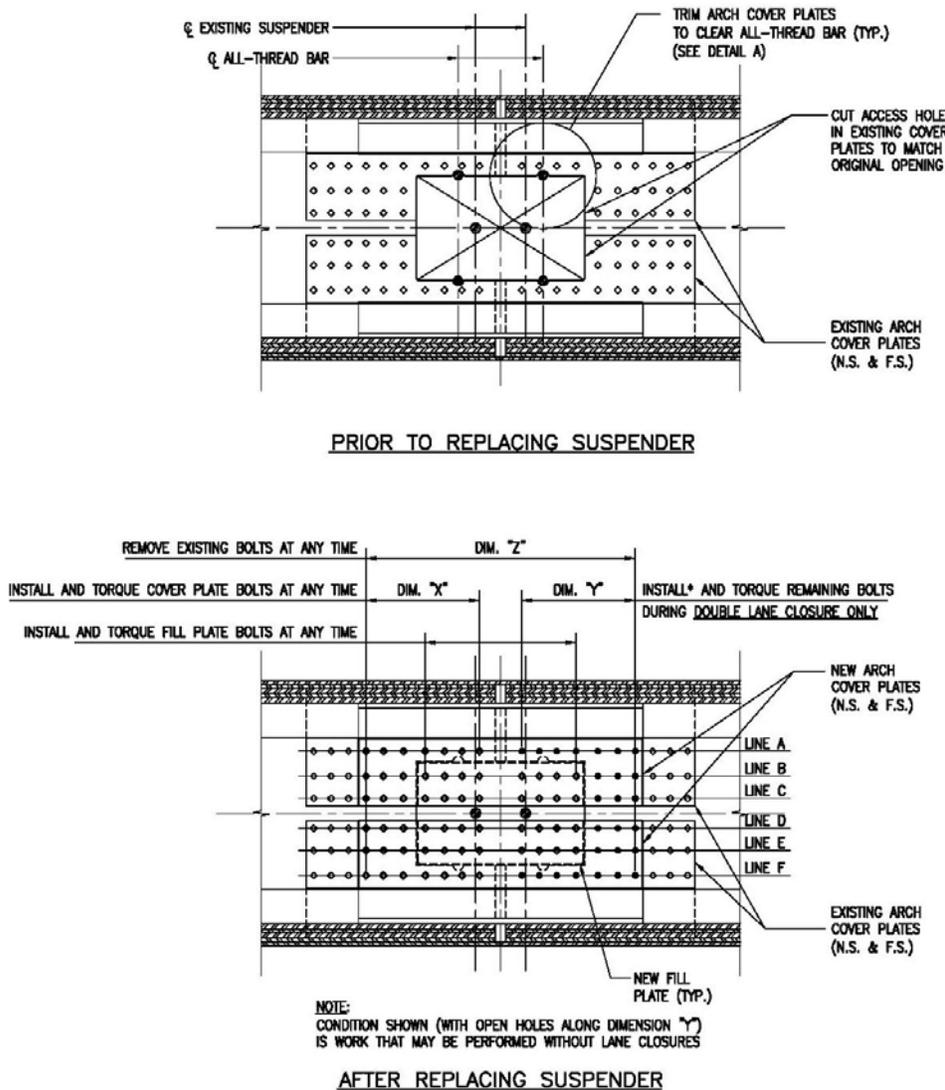
**Figure 10 –Access Opening Repairs at Crown of Arch (Panel Point 12)**

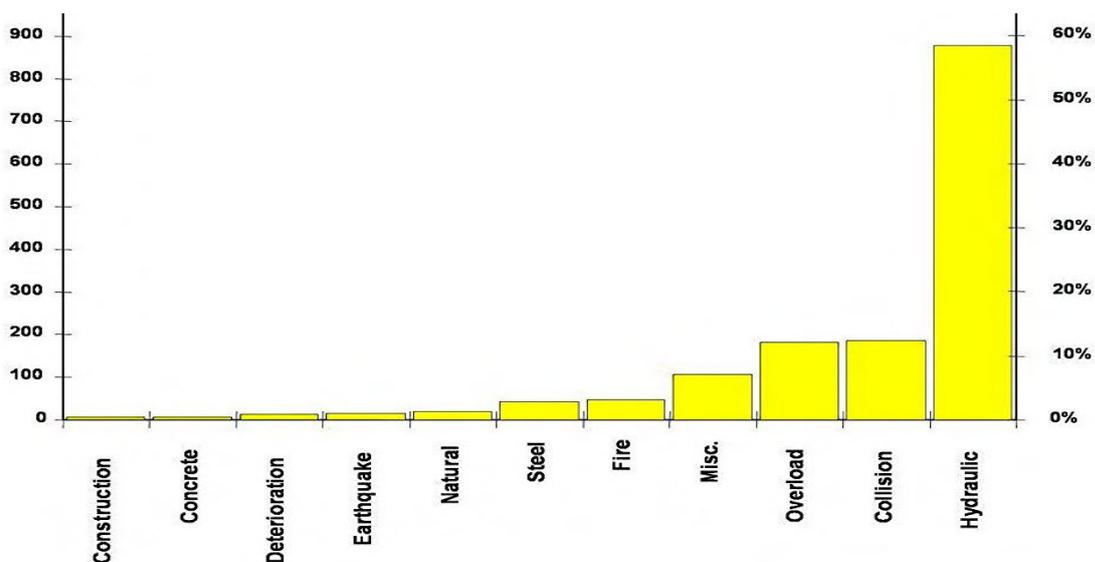
Figure 1. 1502 bridge failures in the USA, 1966 – 2005 (courtesy STV Engineers)

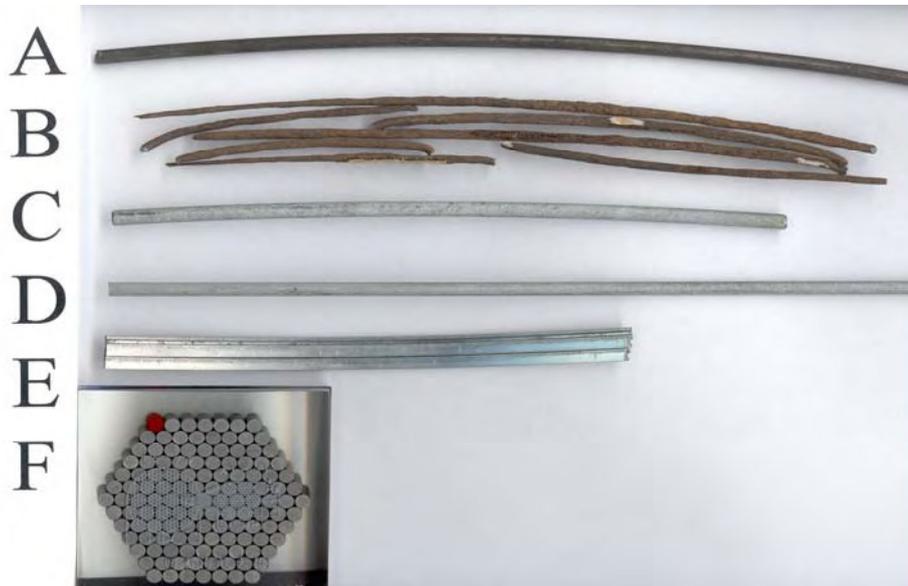
Figure 2. Suspension cable wires, z-shaped wrapping wire, and 127 wire strand

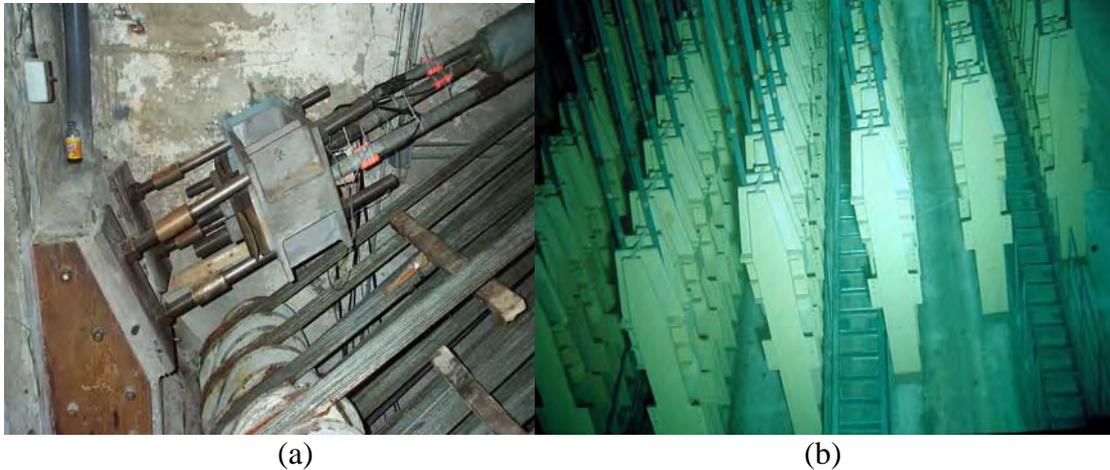
Figure 4. Anchorages (a) air-spun cable with re-anchoring; (b) prefabricated cable

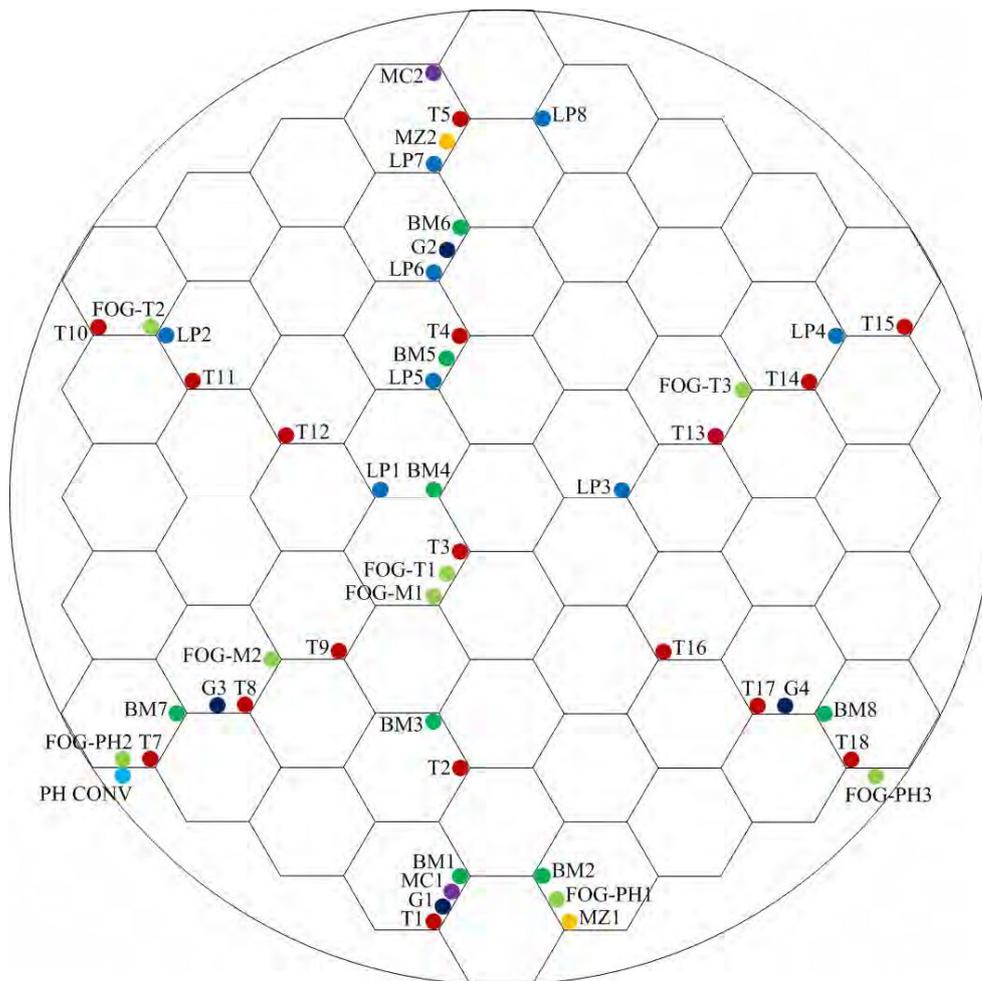
Figure 6. Sensor allocation in the cable model

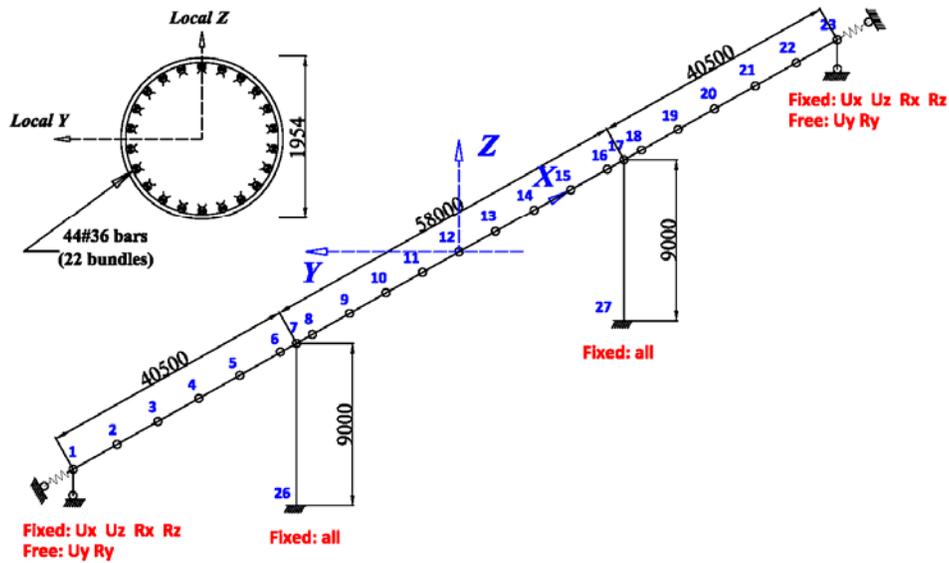
Figure 6 – Simulation model of the Plumas Bridge used in Phase II Study

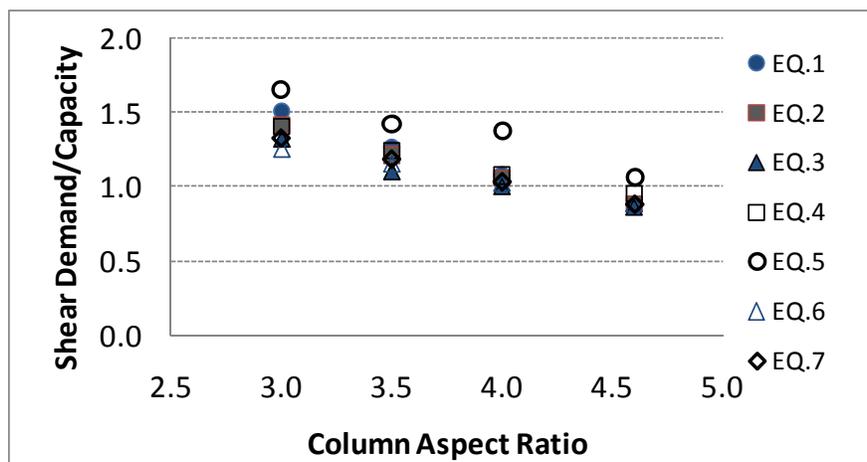
Figure 9 – Effect of aspect ratio (column height/diameter) on shear DCR

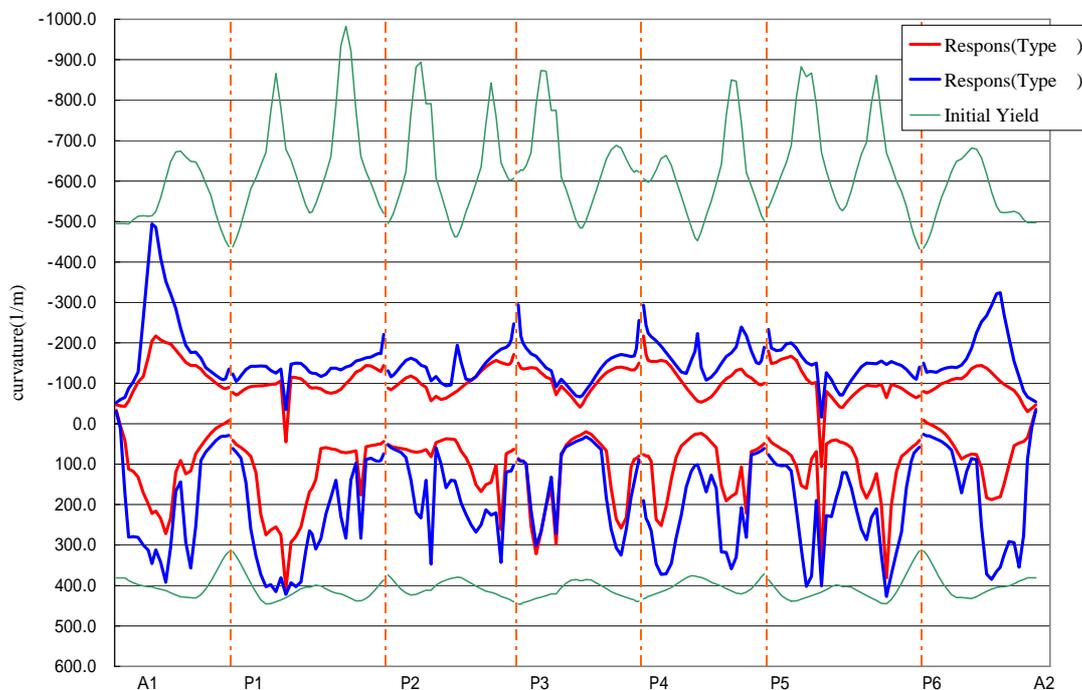
Fig.5 Maximum Response Curvature on the Main Girder of Level 2 Ground Motion

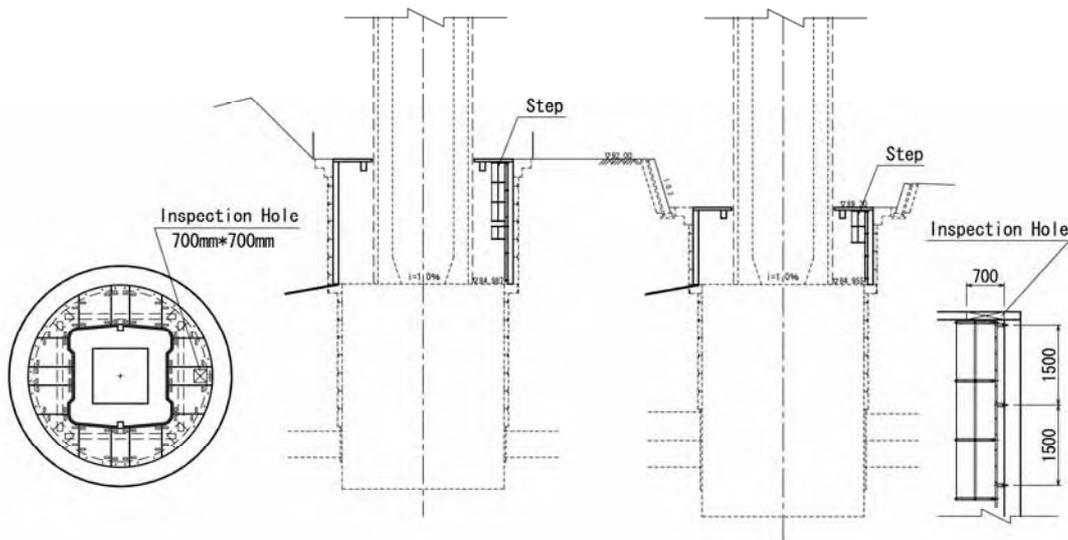
Fig.6 Below-Grade Footings for Short Piers

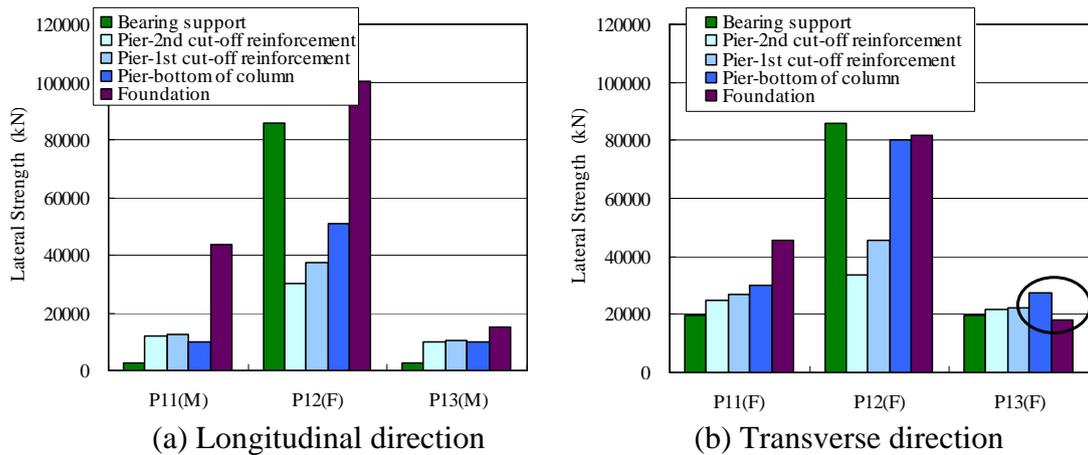
Fig.6 Comparison of lateral strength capacity of each member

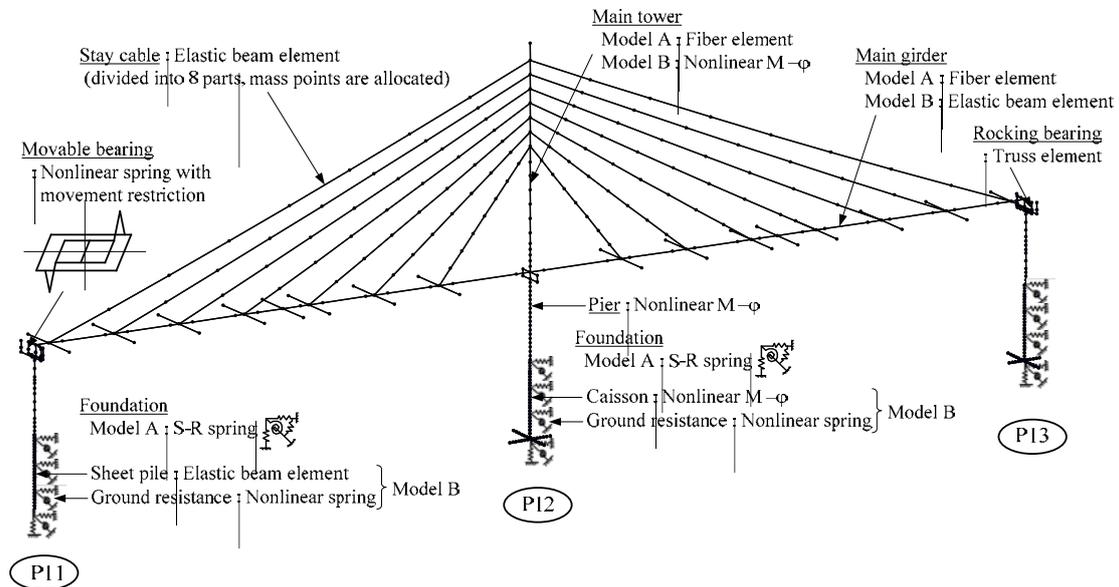
Fig.7 Analytical model

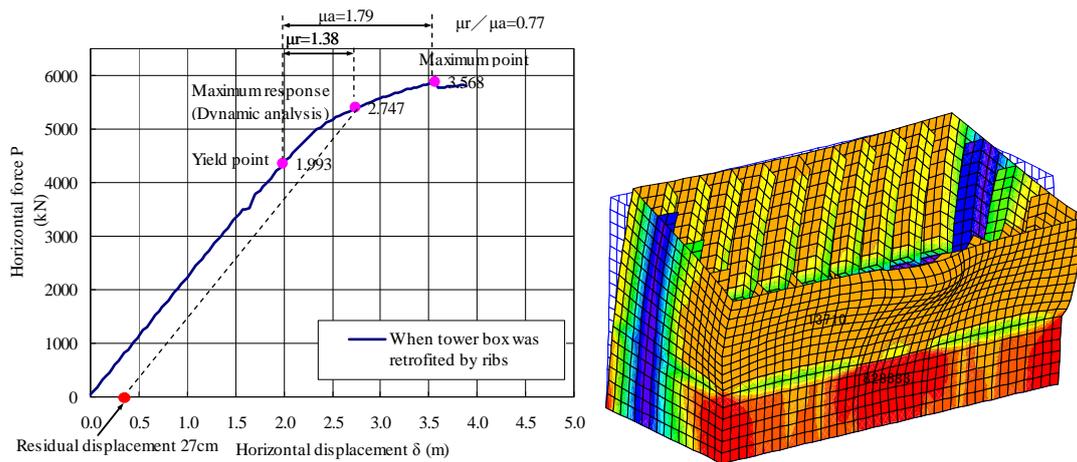
Fig.13 Nonlinear FEM analysis result of tower (Transverse direction, Type1 earthquakes)

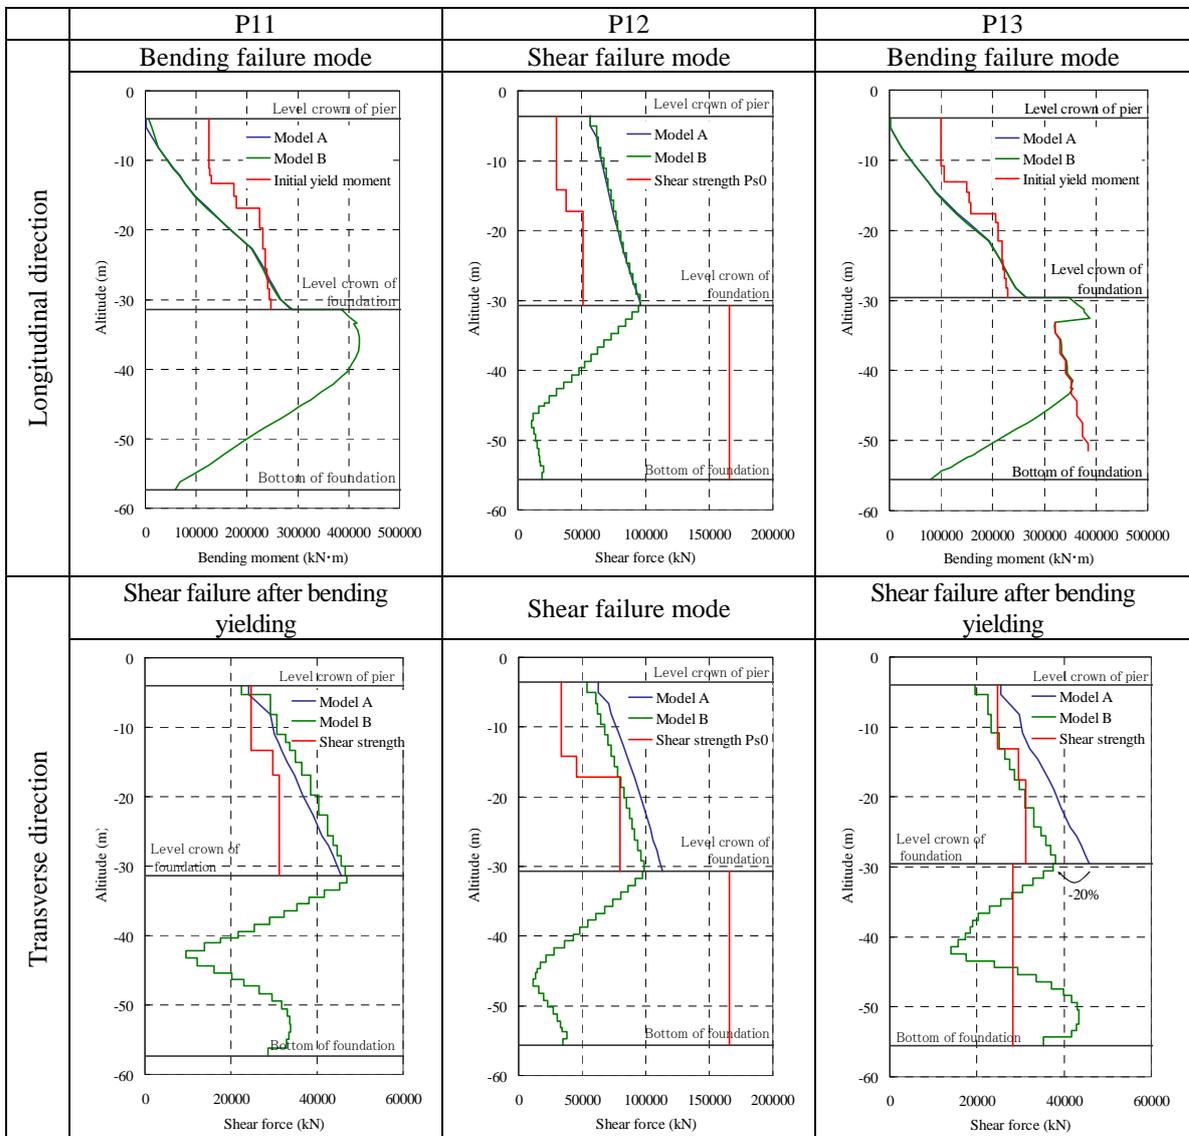
Fig.14 Maximum section force distribution of pier (Type2 earthquakes)

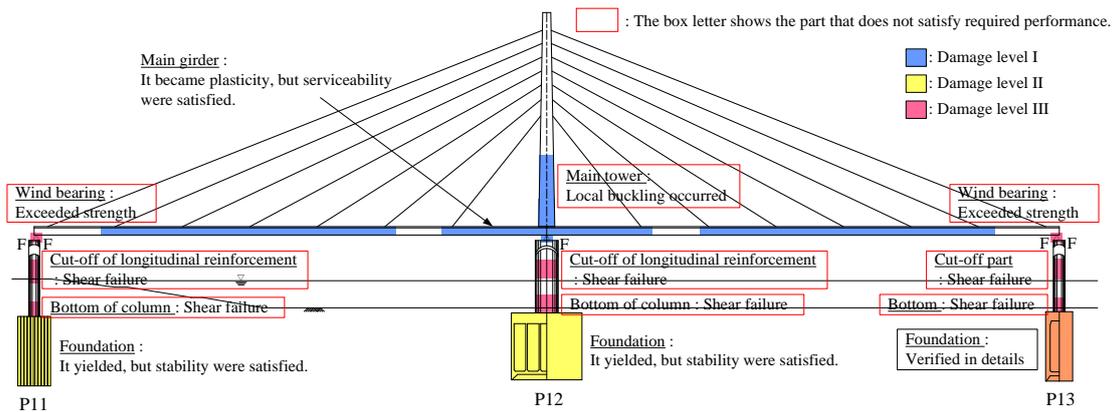
Fig.15 Summary of performance verification result (Transverse direction)

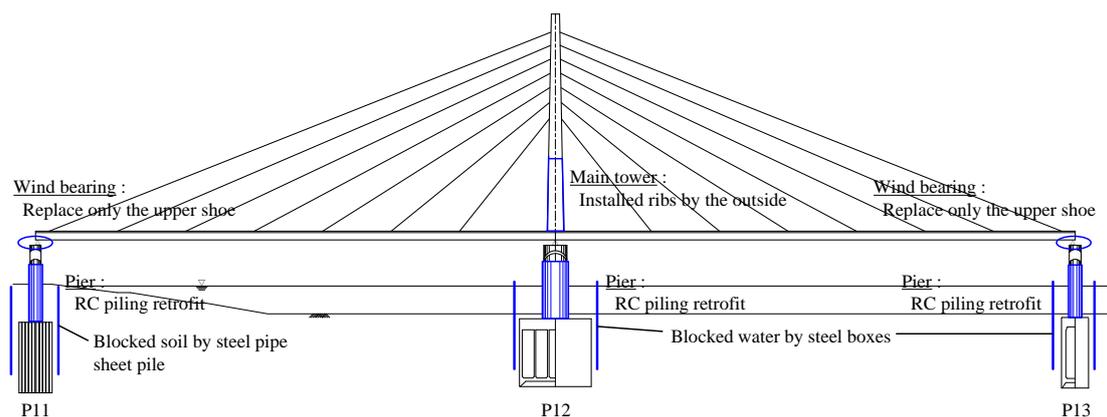
Fig.17 Seismic retrofit measures

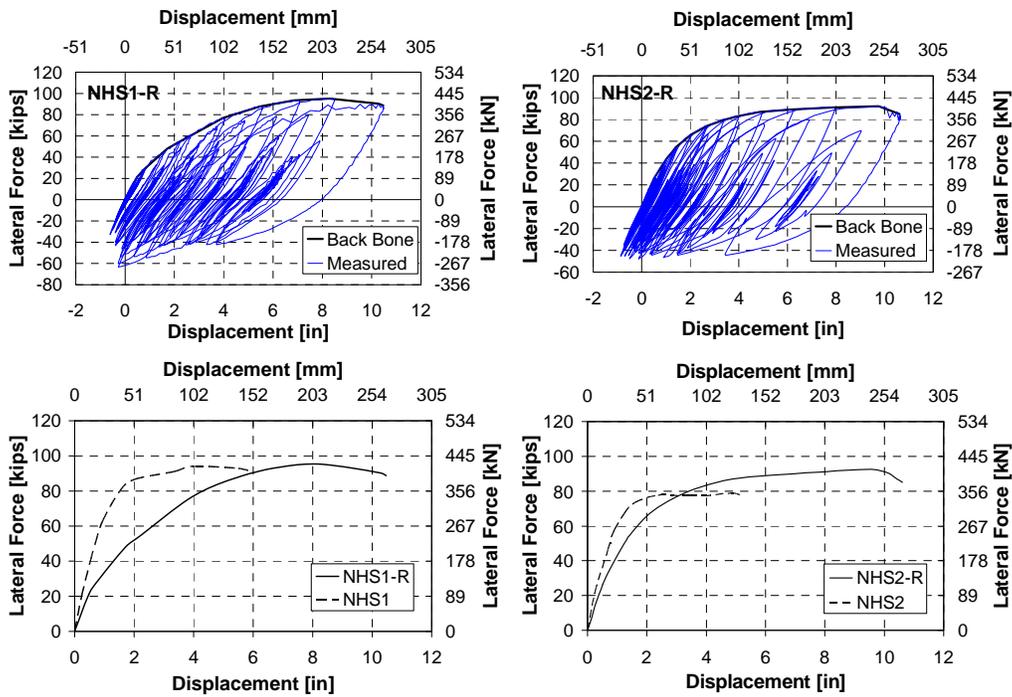
**Fig 5.** Lateral force-displacement relationships for the columns

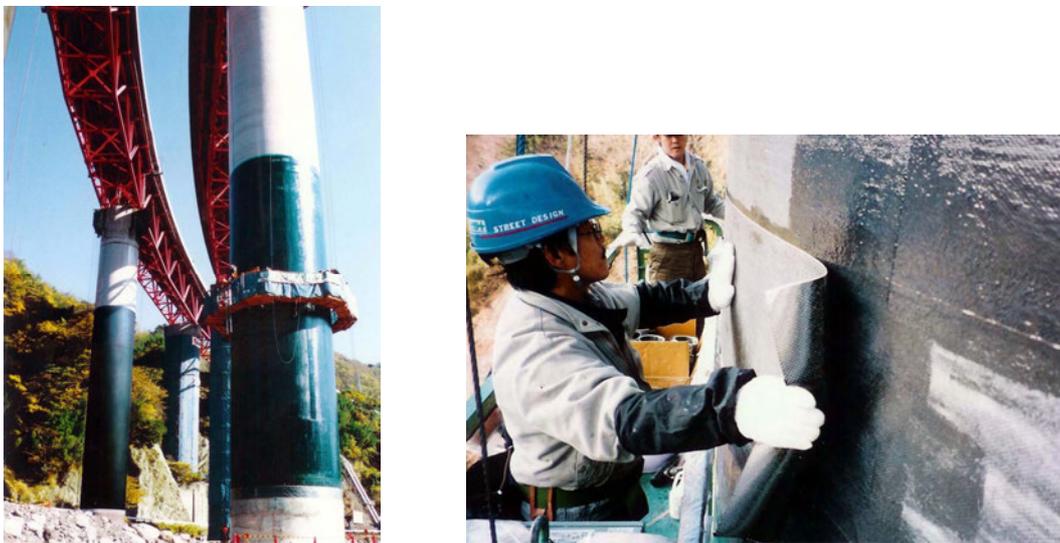
**Fig. 1** Retrofit of RC bridge columns with CFRP sheet

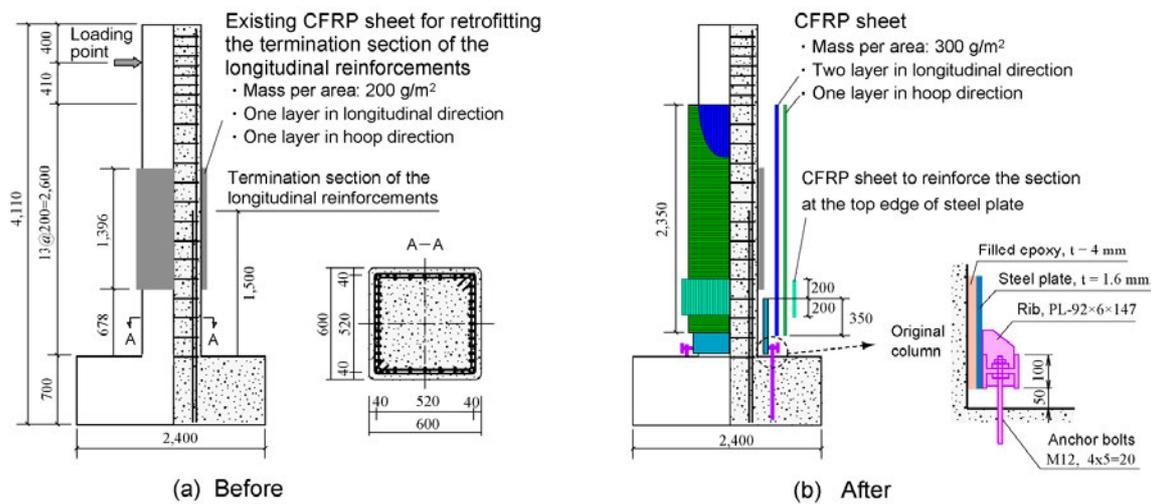
**Fig. 5** Details of RC bridge column specimen before and after retrofit with combination of CFRP and steel jacketing

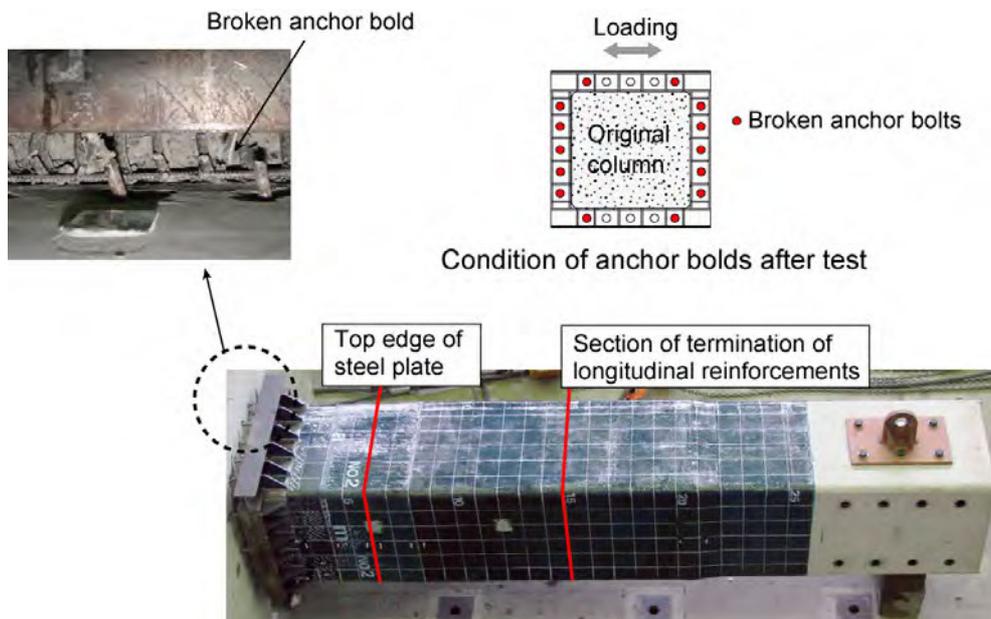
**Fig. 7** Conditions of specimen after test

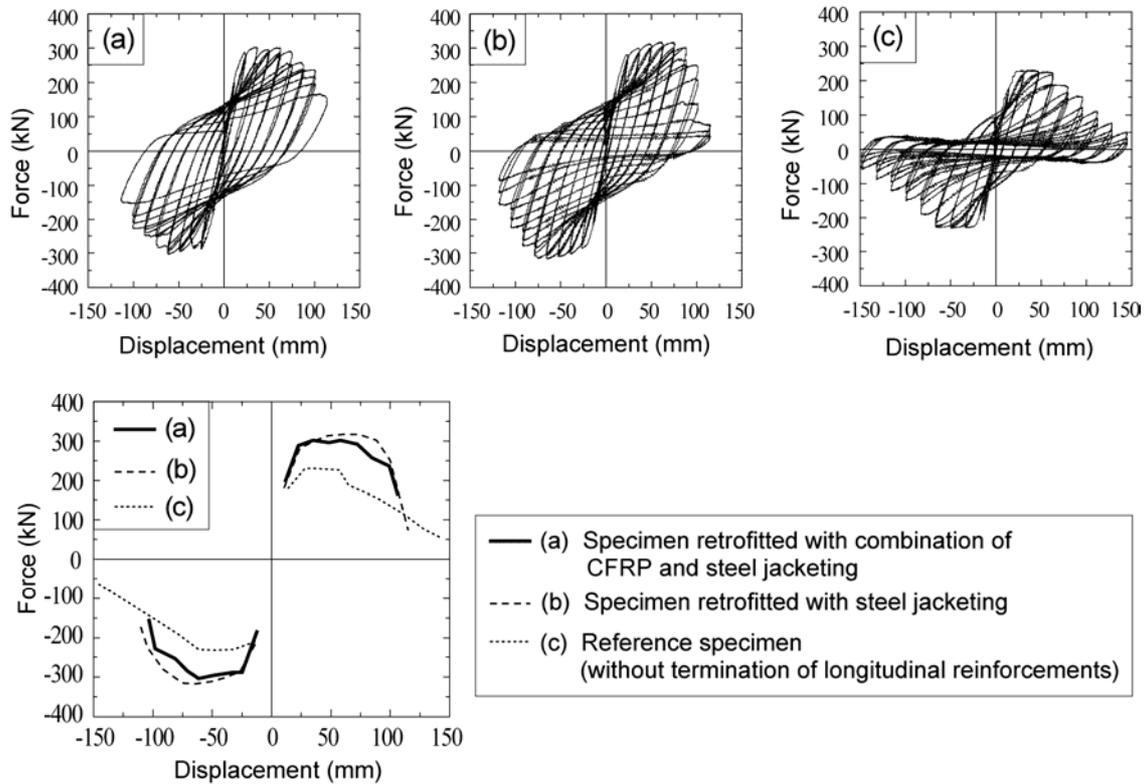
**Fig. 8** Lateral force-displacement

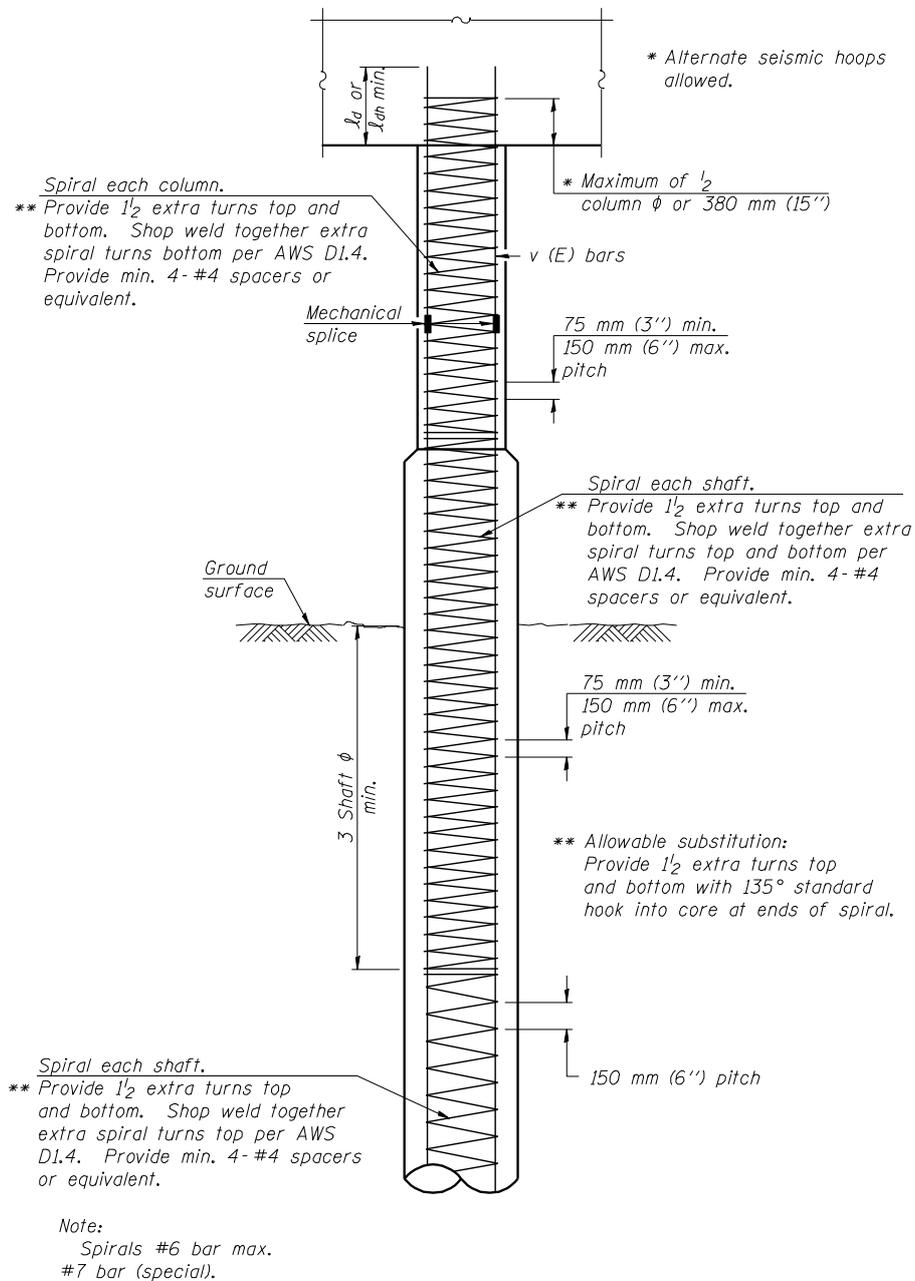
FIG. 5. SEISMIC DETAILS FOR INDIVIDUAL COLUMN DRILLED SHAFT PIERS

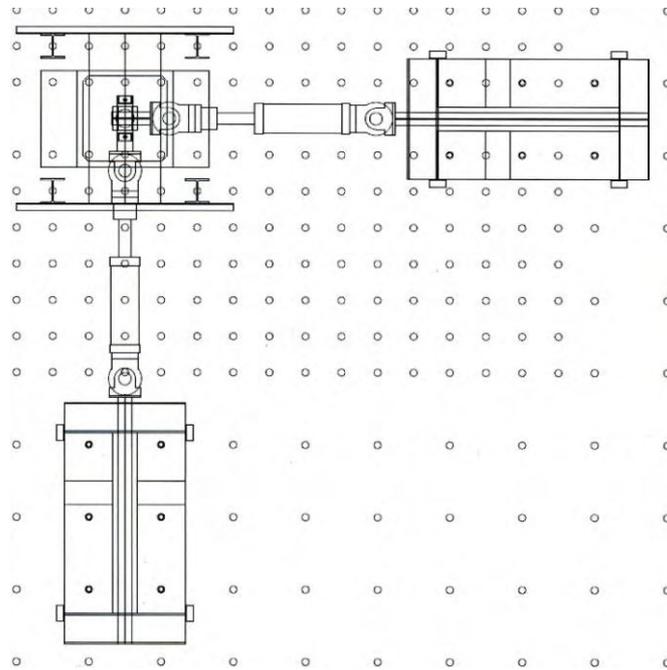
FIG. 6. PRELIMINARY PLAN VIEW OF BEARING TEST SETUP
