**PROCEEDINGS OF
THE 43RD JOINT MEETING
OF U.S.-JAPAN PANEL ON
WIND AND SEISMIC EFFECTS
UJNR**

August 29 - 30, 2011
TSUKUBA, JAPAN

Public Works Research Institute

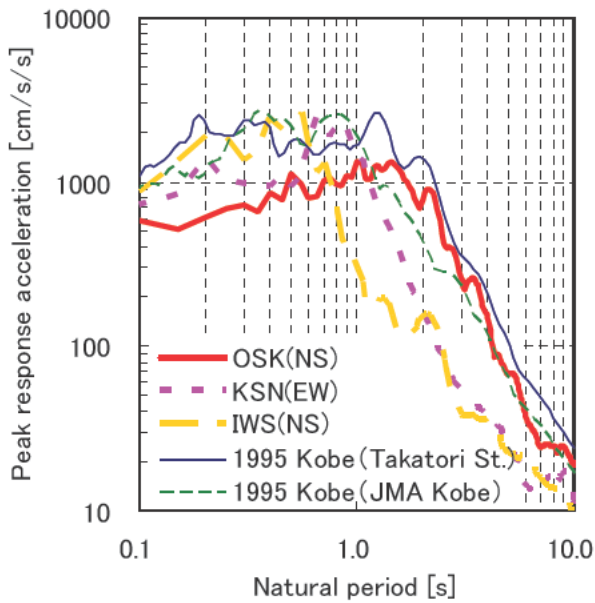
Fig.3 Acceleration response spectra of the strong motion observed at KSN, OSK, and IWS compared with those at Takatori Station and JMA Kobe Observatory of the 1995 Kobe earthquake.

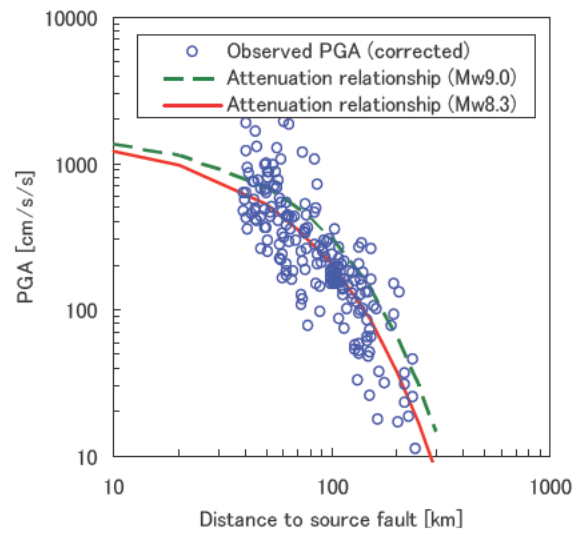
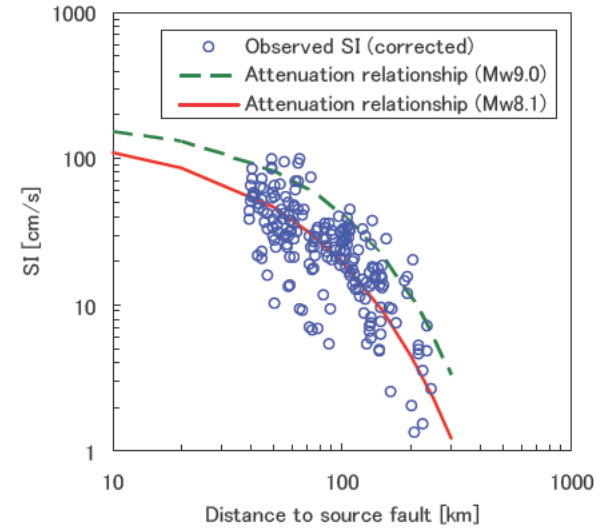
Fig.5 Observed ground motion intensities compared with attenuation relationships [5], which are found to give least errors with the observed PGA and SI when M_w 8.3 and 8.1 are assumed, respectively.

Fig.5 compares observed ground motion intensities with attenuation relationships [5]. It can be seen that the attenuation relationships overestimate both PGA and SI when M_w 9.0 is assumed. The attenuation relationships are found to have least misfit with the observed PGA and SI when M_w 8.3 and 8.1 are assumed, respectively. Though very large PGAs were observed at several stations within 100km from the source fault, the ground motion during the 2011 off the Pacific Coast of Tohoku Earthquake

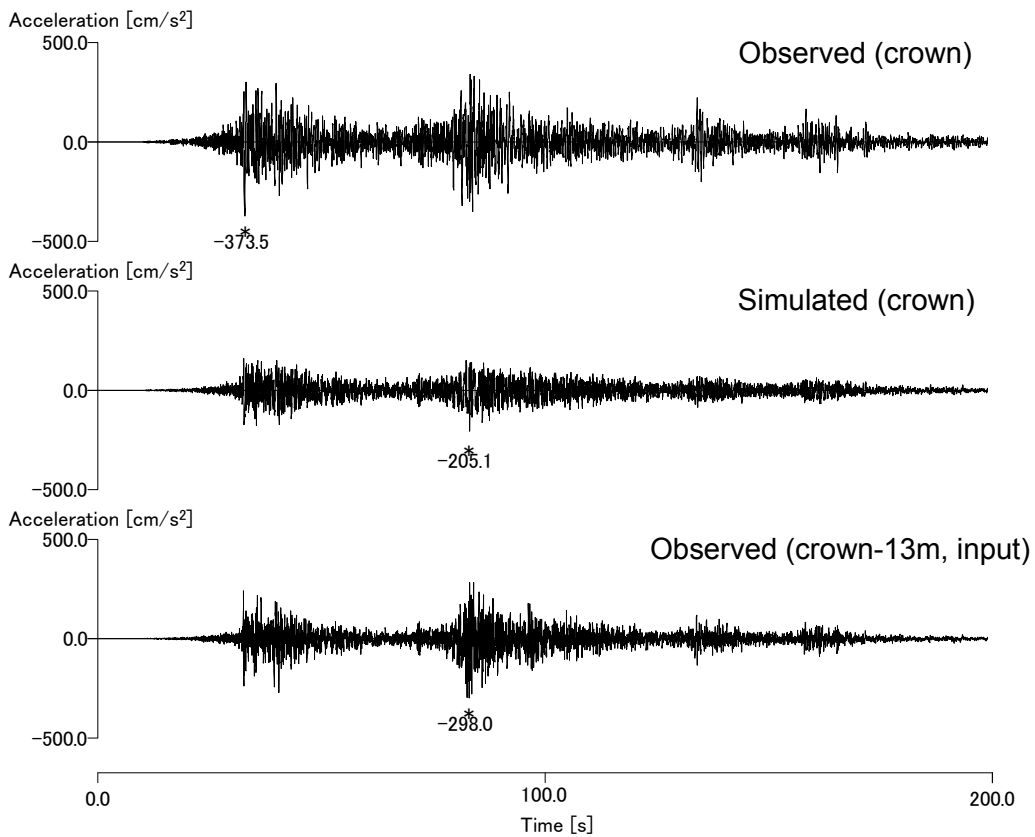
Fig.7 Time history records observed at Nakashimo station during the 2011 off the Pacific of Tohoku Earthquake (NS component, top: crown, bottom: base layer) compared with a simulated motion at the crown by the effective stress analysis (middle).

A computer code for 1-D effective stress analysis [6] was employed for the simulation of the earthquake response of the levee. Fig.7 shows the observed motion at the base layer, which was used as an input motion, and the observed and simulated motions at the crown. Though short period component of the simulated motion is somewhat smaller than the observed one, the entire waveform was reproduced well. Observed and simulated time histories of excess pore water pressure are also compared in Fig. 8. Hydrodynamic pressure and dissipation of pore water pressure were not reproduced at all; freezing soil sampling and 2-D simulation may be required for improving the agreement between observed records and the effective stress analysis.

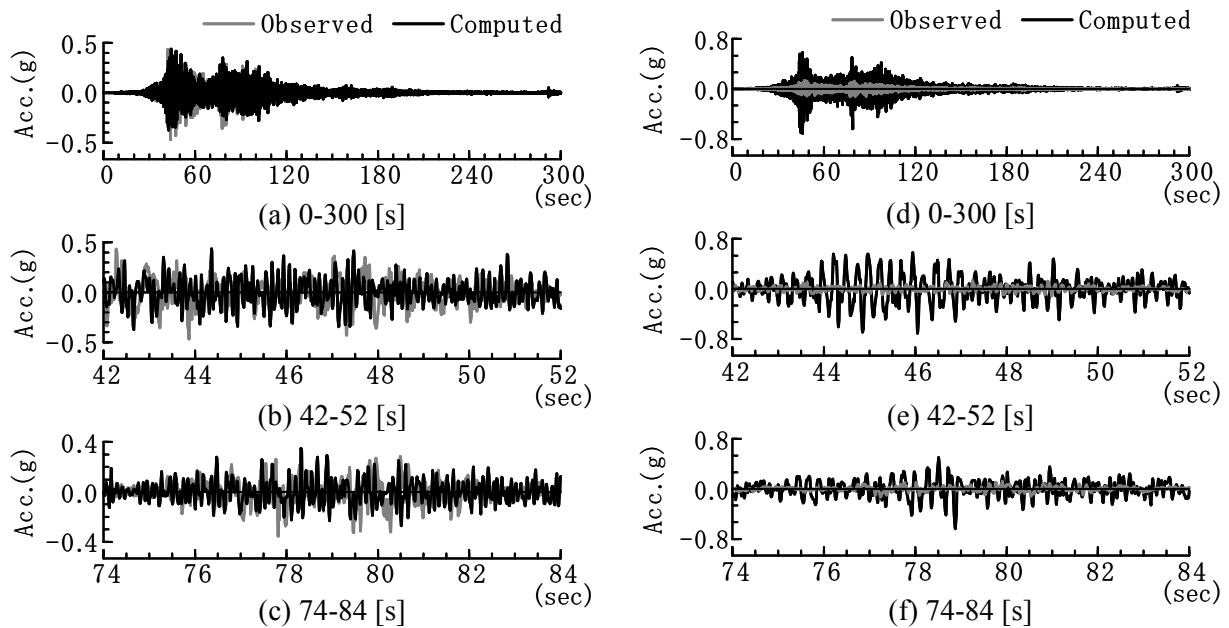
Fig.13 Comparison of the observed and computed earthquake responses of the top of P3.
 (a)(b)(c): Longitudinal direction; (d)(e)(f): Transverse direction.

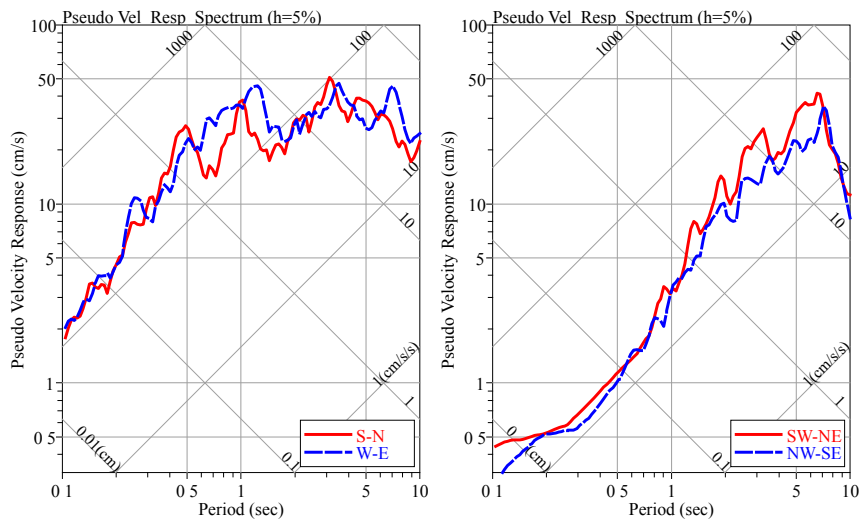
Fig. 2.10 Pseudo Velocity Response Spectra with Damping Ratio of 5% of Records in Tokyo Bay Area (left) and Osaka Bay Area (right)

On the other hand, the response spectrum (right) in the records on the coast of Osaka Bay had a large peak at 7 seconds, and amplitude of the response was not much different from on the coast of Osaka Bay. The coincidence of the fundamental natural period (6.5 to 7 seconds) in the steel office building with a predominant period of the earthquake motion is considered to have caused a resonance phenomenon and then large earthquake responses were observed at the top.

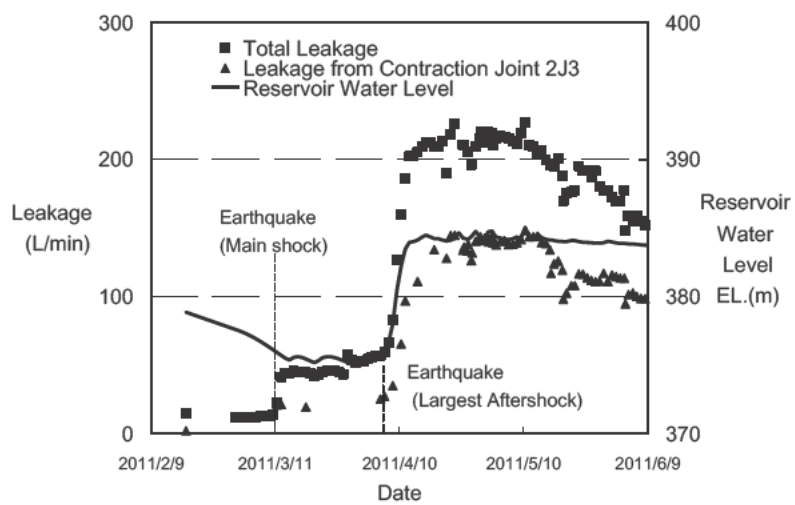
Fig. 6 Time history of leakage at Kamuro Dam

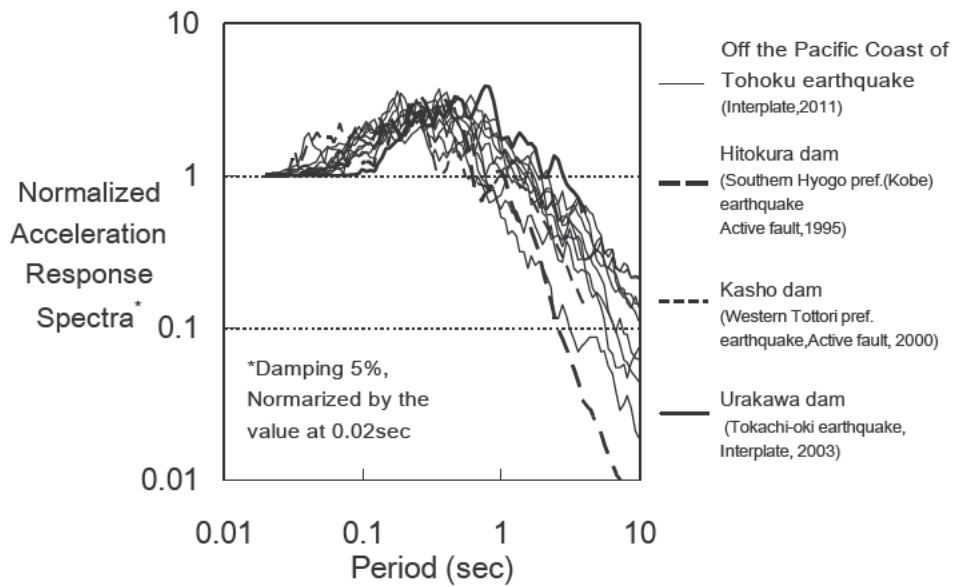
Fig. 11 Acceleration response spectra of earthquake motions observed at dam foundations in stream direction

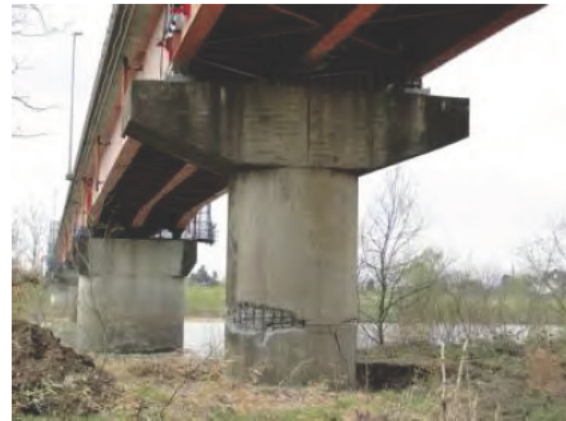
Photo 1 Shear failure of a column due to termination of longitudinal bars with insufficient development (Fuji Bridge) (courtesy of Dr. Hoshikuma, J., PWRI)

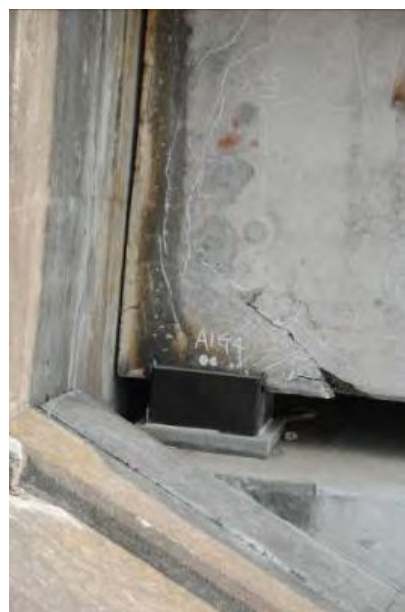
Photo 4 Damage of PC girders near the support

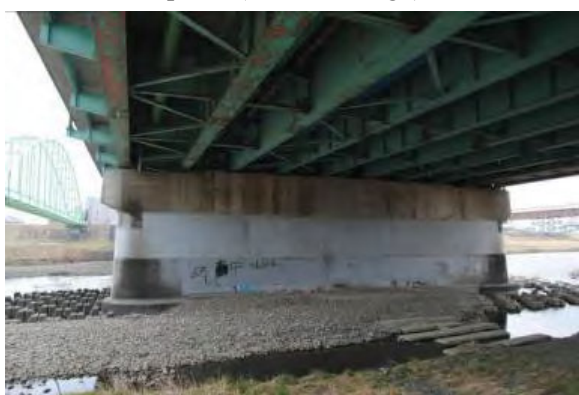
Photo 7 Retrofitted pier of Sendai Bridge which did not suffer damage during 2011 Great East Japan earthquake

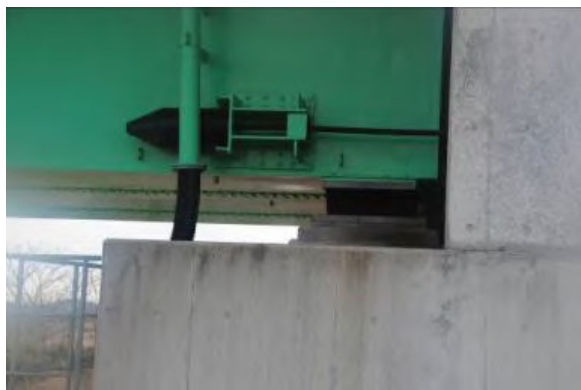
Photo 9 An end of deck supported by elastomeric bearings and unseating prevention devices

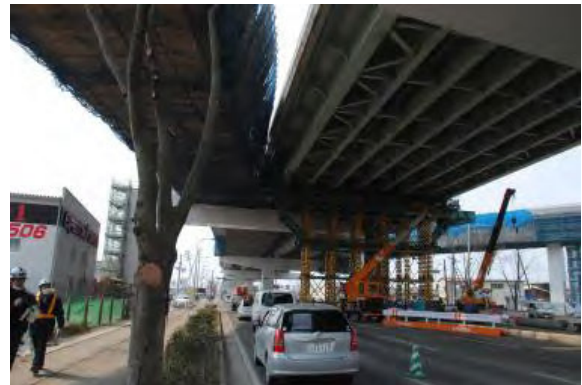
Photo 10 Piers where elastomeric bearings ruptured (Sendai-Tobu viaduct)

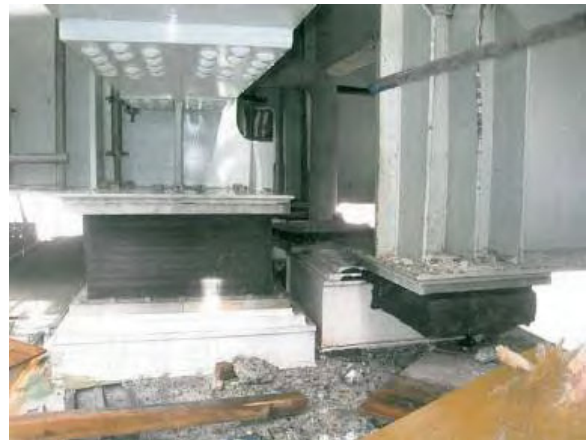
Photo 11 Transverse offset of a girder due to rupture of elastomeric bearings

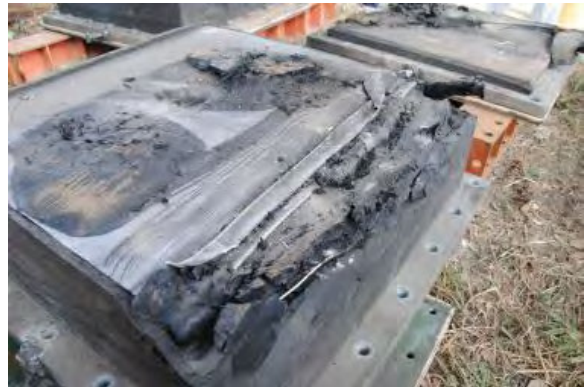
Photo 12 One of elastomeric bearings ruptured

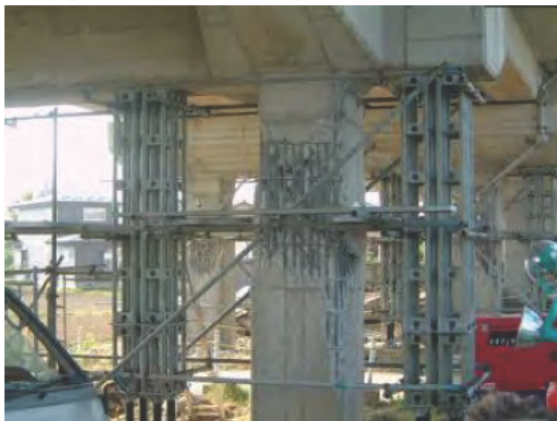
Photo 14 Shear failure of RC columns at Odaki viaducts after 2003 Sanriku-Minami earthquake

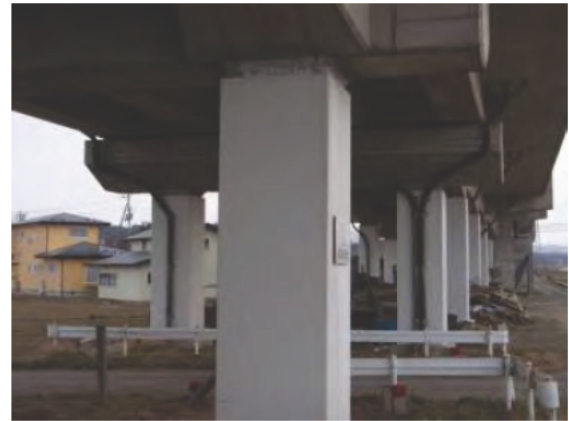
Photo 15 No. 3 Odaki viaducts which were retrofitted after 2003 Sanriku-Minami earthquake performed well during 2011 Great East Japan earthquake

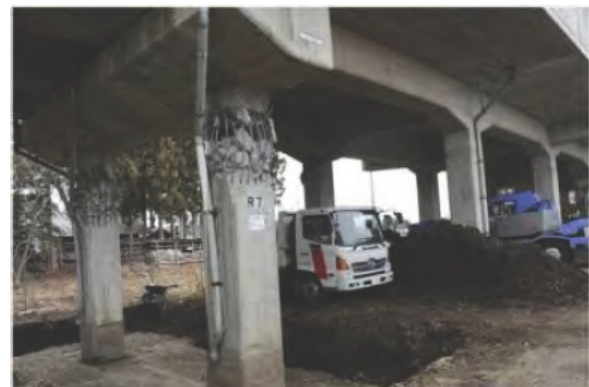
Photo 16 Damage of R7 column, No. 1 Nakasone viaduct during 2011 Great East Japan earthquake

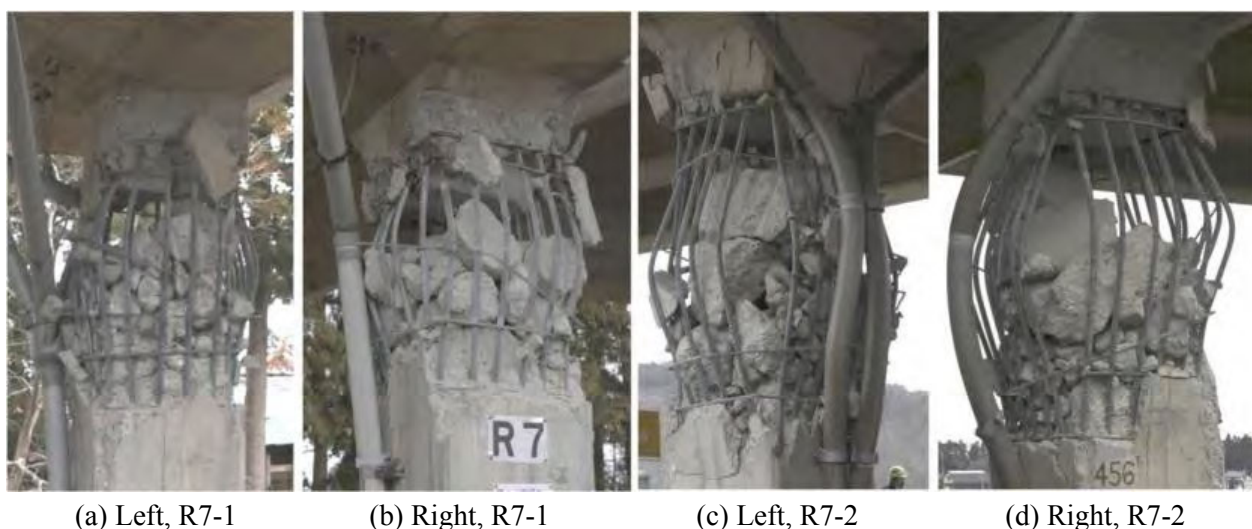
Photo 17 Close view of damage of R7-1 and R7-2 columns

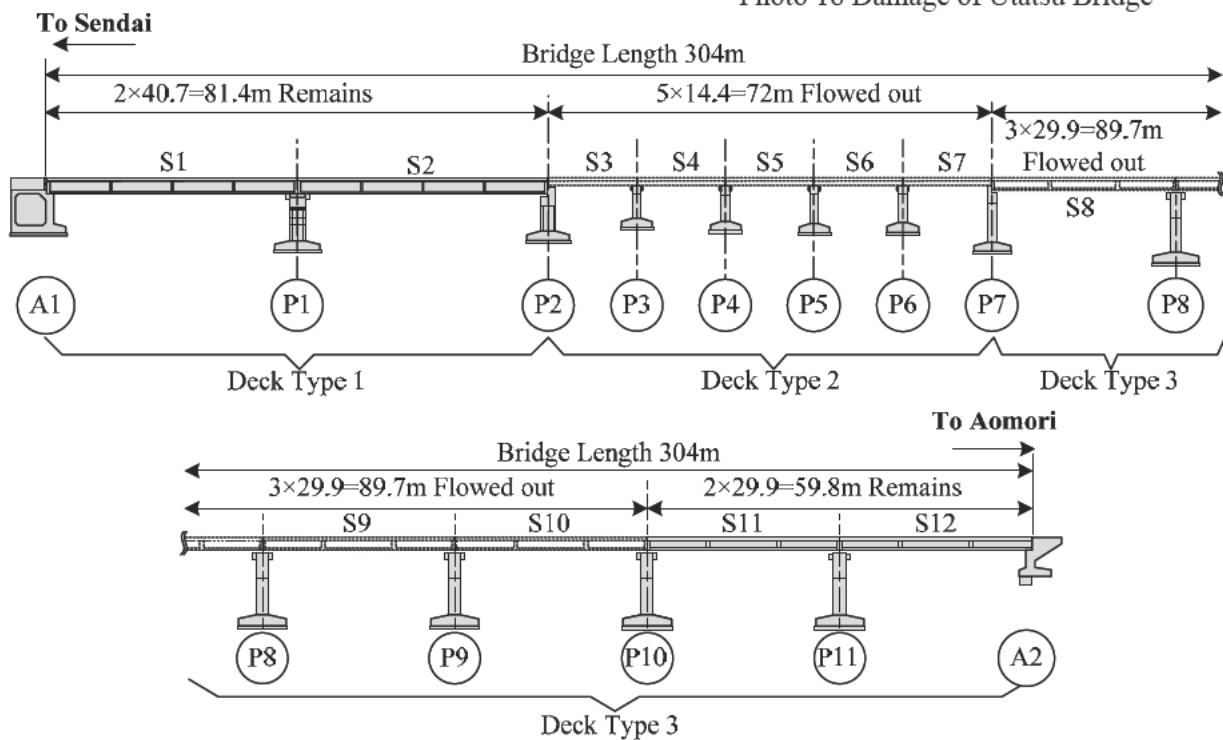
Fig. 6 Utatsu bridge

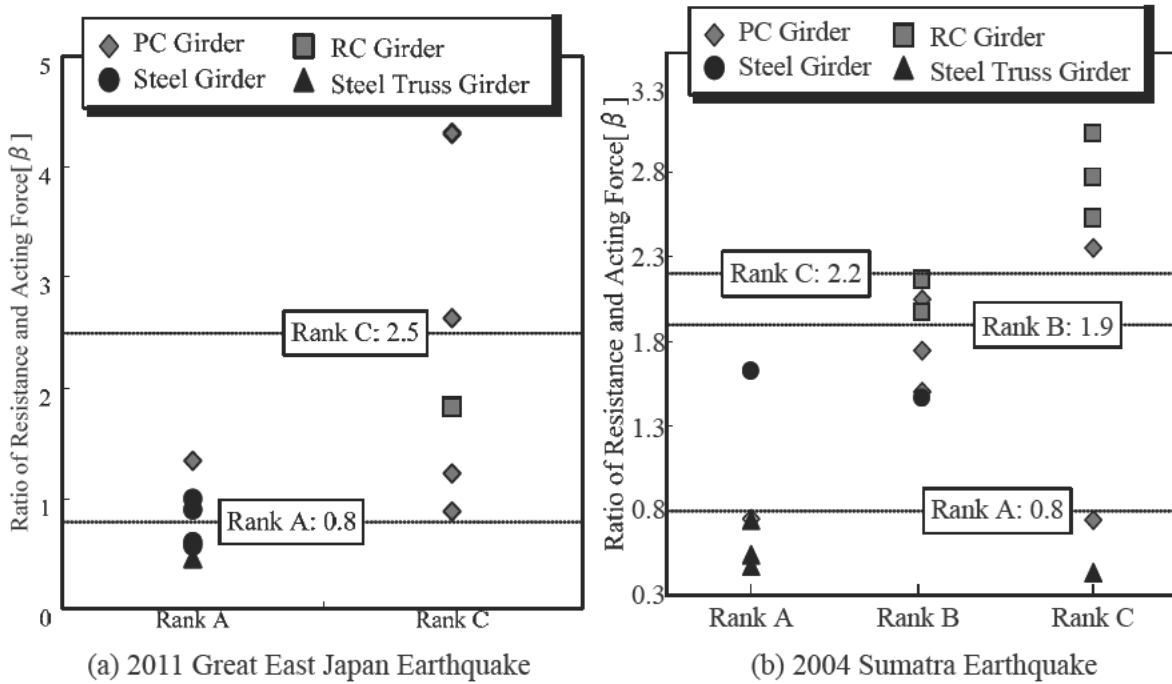
Fig. 9 Correlation of β value with damage ranks

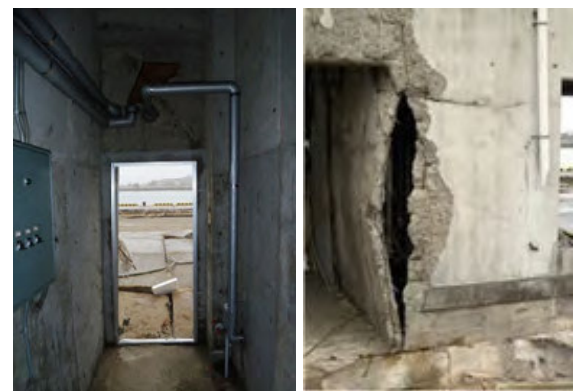
Figure 2: Wall corner joint and flexural failure by internal hydrodynamic pressurization

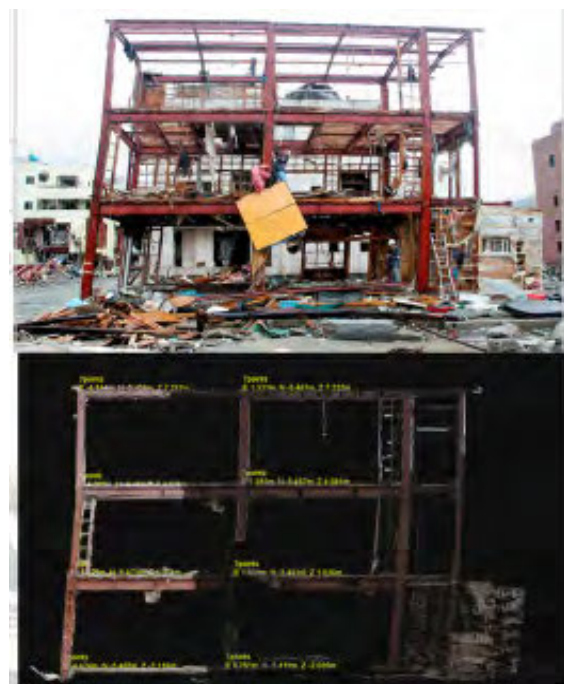
Figure 4 Onagawa 3-Story Steel Frame Pushover
