# Technical Memorandum of Public Works Research Institute

No. 1344

Preliminary Report of Investigations on the Relief and  
Rehabilitation in the Izu-Ohsima Kinkai Earthquake of 1978

Public Works Research Institute  
Ministry of Construction

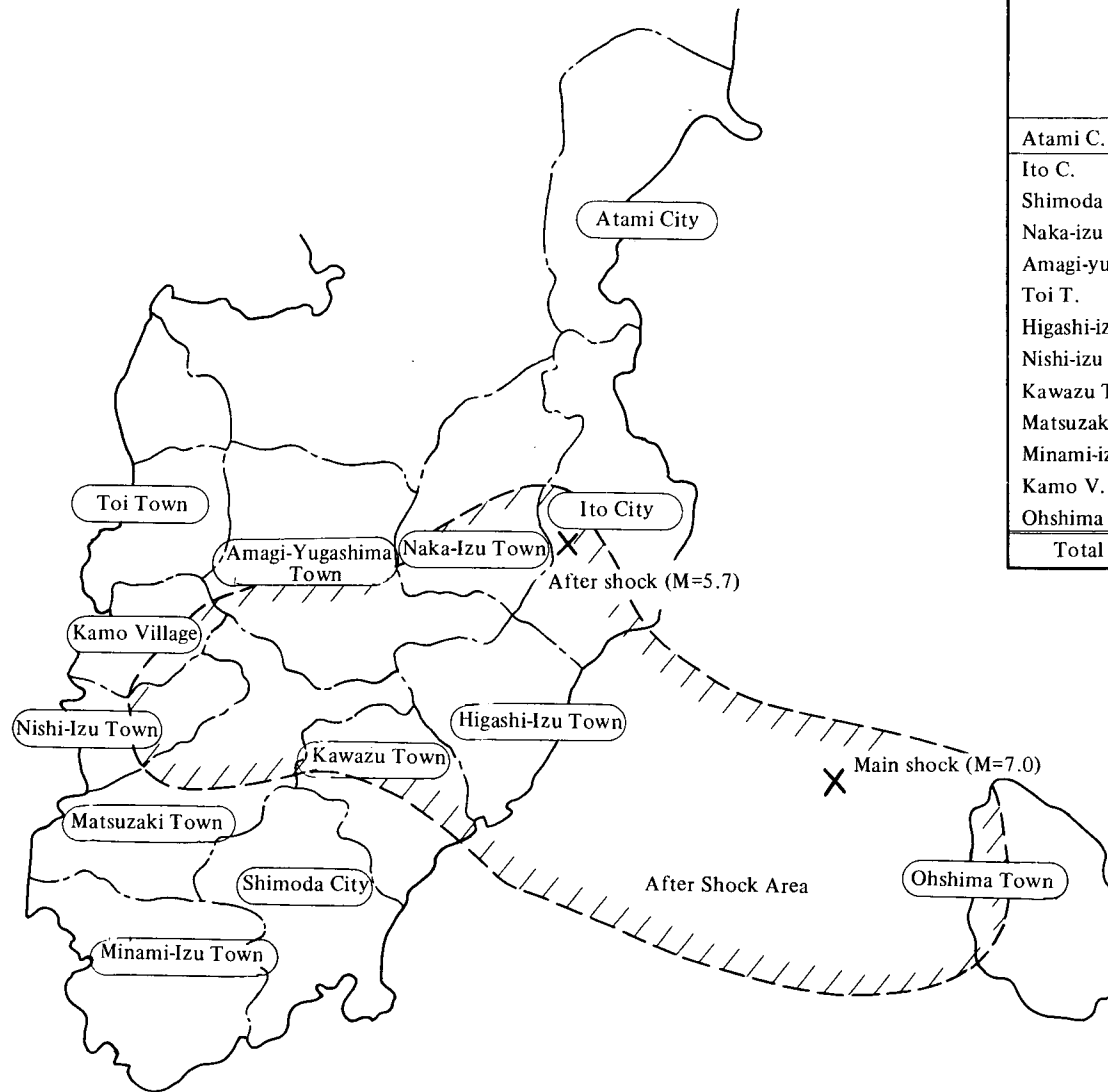
Fig. 1-3 Distribution Map of the Earthquake Damage

Fore and after shock area: Fore and after shocks are distributed in a belt from Ohshima Island to the western coast of the Izu Peninsula across the middle altitude of the peninsula as shown in Fig. 1-3.

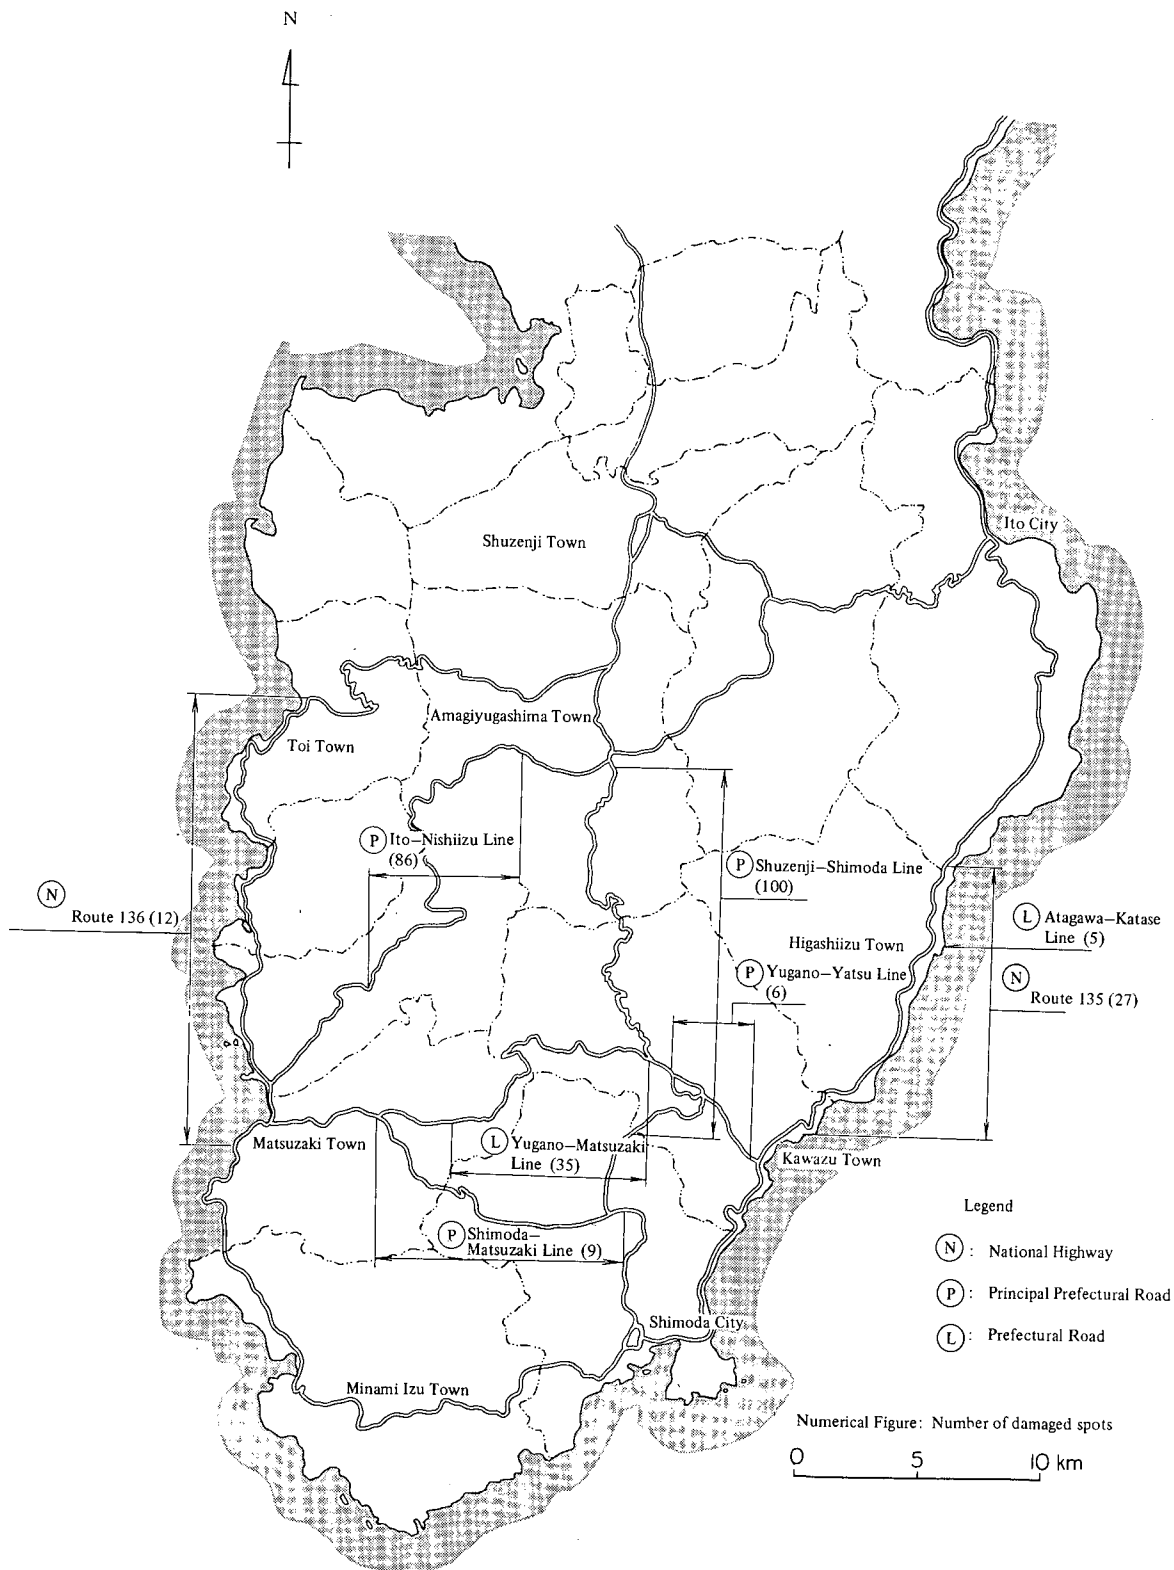
Fig. 2-1 Distribution Map of Damage to Roads

As shown in Fig. 2-1 to 2-4 various damage caused by slidings of embankments, slope failures, surface ruptures and faults occurred on and along the roads listed belows,

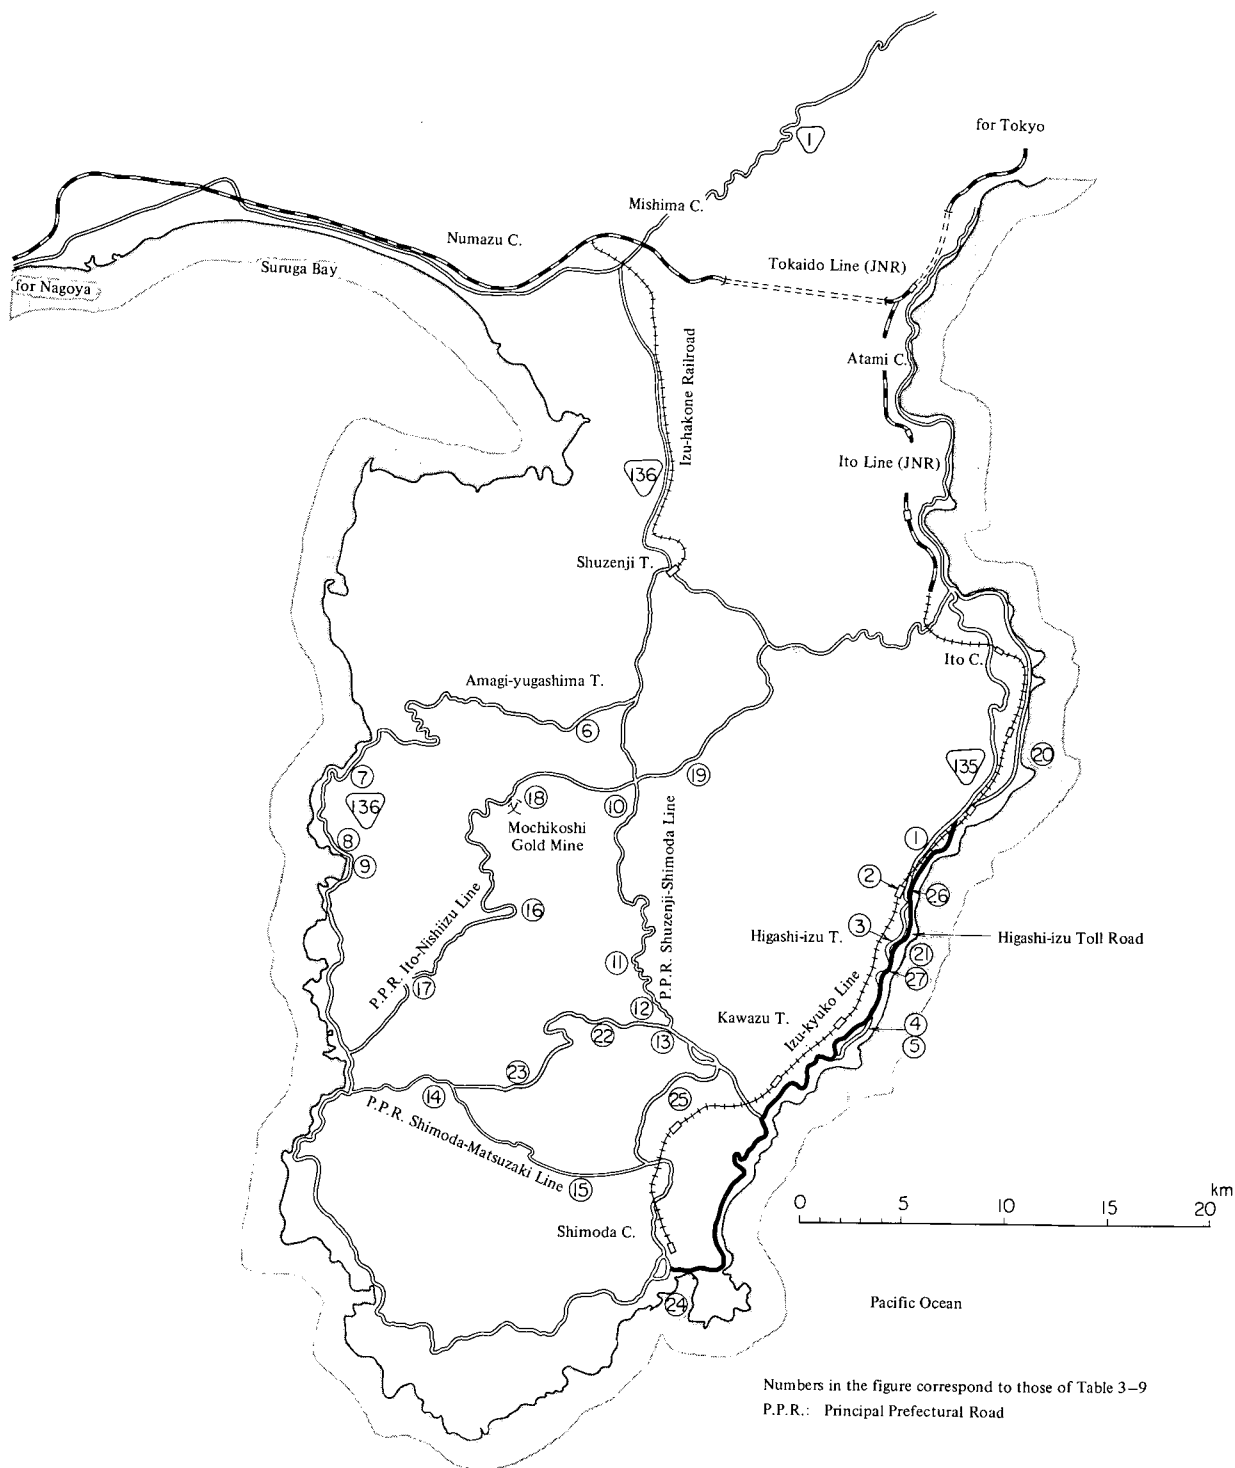
Fig. 3-4 Transportation Network in Izu Territory

The skelton of the highway in the Izu Peninsula is consisted of National Highway route 135 and 136 and a Principal Prefectural Road, Shuzenji-Shimoda Line, part of which are toll roads. The railroad network is of Ito Line (JNR, Atami-Ito), Izu-Kyuko Line (Izu-Kyuko Railroad Co. Ltd, Ito-Shimoda) and Izu-Hakone Railroad Line (Mishima-Shuzenji). (See Fig. 3-4)

Table 3-9 shows the traffic control. The numbers in the table correspond to those in Fig. 3-4. The site indicated by X is still out of service as of Feb. 12. Out of the major highways Route 136 firstly reopened at 12:00, Jan. 16. As for the route on the east coast, both the Higashi-izu Toll Road and ex-national highway route 135 administrated by Japan Highway Public Corporation (JHPC) and Prefectural Construction Office respectively run in parallel. (Fig. 3-5) Both administrators negotiated the priority of the route to be firstly restored and determined either route site by site in accordance
