# **A CASE HISTORY OF BRIDGE PERFORMANCE DURING EARTHQUAKES IN JAPAN**

(To be presented at the International Conference on  
Case Histories in Geotechnical Engineering,  
St. Louis, Missouri, USA, May 6-11, 1984)

**February 1984**

**Earthquake Engineering Division  
Earthquake Disaster Prevention Department  
Public Works Research Institute  
Ministry of Construction**

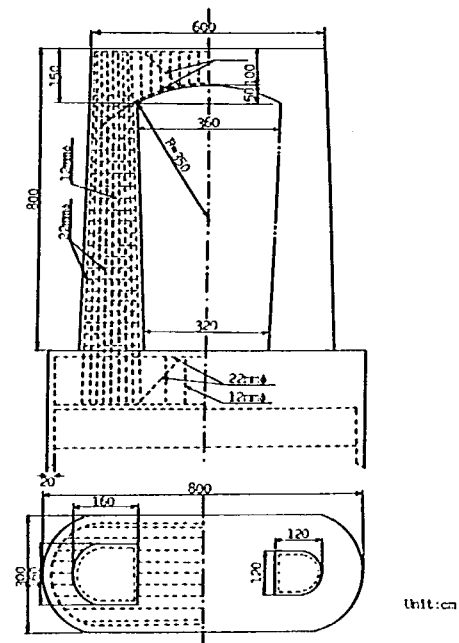
Fig. 10. Detailed Drawings of the Pier of the Nakazuno Bridge

The abutments were of gravity-type reinforced concrete construction with pile foundations. Thirteen piers were reinforced concrete columns resting either on pile or caisson foundations. A general view of a typical pier is shown in Fig. 10. The superstructures having a total length of 257 m and a width of 5.5 m, consisted of 14 simple span steel plate girders (14 x 18.4 m).

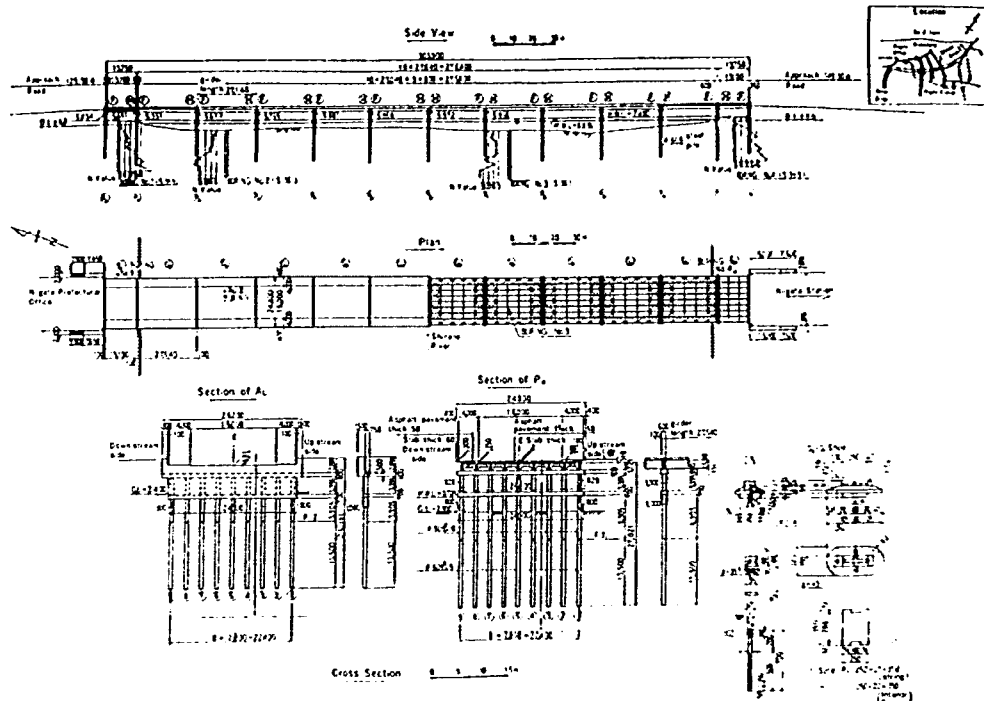
Fig. 21. General View of the Showa Bridge

This bridge crossed Shinano River about 4 km located up to the mouth. The bridge was located some 55 km south of the epicenter. Construction was completed in May 1964 just one month prior to the earthquake.

The ground at this site consisted of sandy soils which were comparatively loose near the left bank and dense near the right bank, as shown in Figs. 18 to 20. Two abutments were pile bents (9 single-row piles of diameter 609 mm and of length 22 m) and so were piers (9 single-row piles of diameter 609 mm and of length 25 m). These bents had collar braces and cap beams, as shown in Fig. 21. The design seismic coefficient for the bridge structure was 0.2 horizontally. The superstructures having a total length of 303.9 m and a width of 24 m consisted of 12 composite steel simple span girders ( $13.75 + 10 \times 27.64 + 13.75$  m).

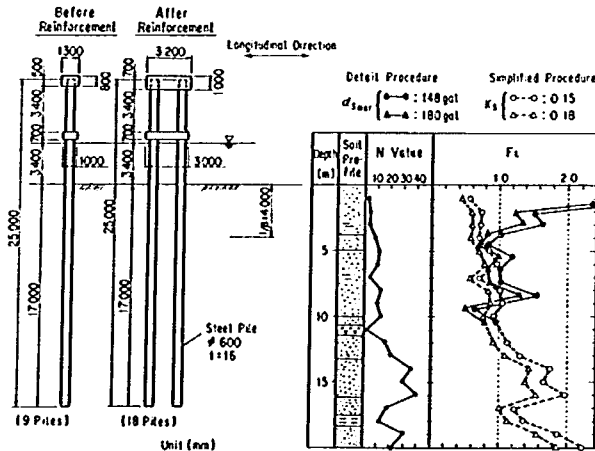
Fig. 28 shows the outline of pier 5 for both before and after the earthquake. As shown in the figure, the pier was reinforced by adding nine piles (totally 18 piles in two rows) after the earthquake. The figure also illustrates some results of insitu tests and assessment of soil liquefaction potential. N-values denote the number of blows obtained by the standard penetration test procedure. For the shallow depth N-values for mostly sandy soils are around 10 or less, which suggests the soils are very vulnerable to liquefaction.  $F_L$ -values, so called the liquefaction resistance factor, indicate an ability to resist liquefaction occurrence, and is defined by

Fig. 28. The Substructure (P5) of the Showa Bridge and the Results of Assessment of Soil Liquefaction Using  $F_L$ -Values

Normally  $r_d = 1.0 - 0.015 z(z$ : depth in m) is proposed. When the factor  $F_L$  at a certain depth is less than 1.0, the soil is judged to be likely to liquefy during a given earthquake. The right side of Fig. 28 illustrates the results of the calculation of  $F_L$ -values by two procedures, namely the detailed one and the simplified one. From this it is seen that liquefaction is likely to have taken place for the shallow layer up to the depth of about 10m.

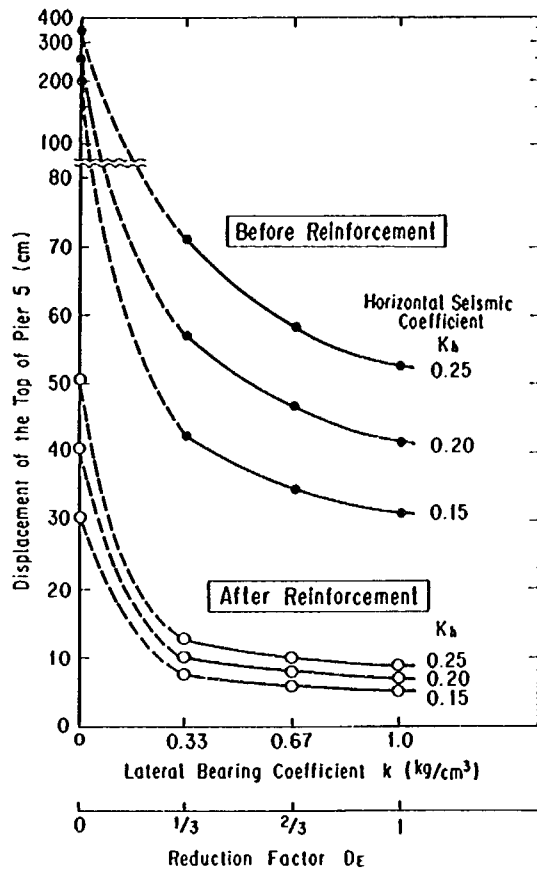
Fig. 29 summarizes the relationship between the calculated maximum displacement at the crest of Pier 5 (in cm), and the coefficient of lateral subgrade reaction, and the reduction factor  $D_e$ . From this figure, it is found that the displacement of the pier increases according to the decrease to  $k$ -values. It is also seen that the displacement after the reinforcement work (after the earthquake) is considerably smaller comparing with the one for the original structure before the earthquake.

Fig. 29. Relationships between the Maximum Displacement of the Top of Pier 5 and the Reduction Factor  $D_e$  or the Lateral Bearing Coefficient of Grounds  $k$

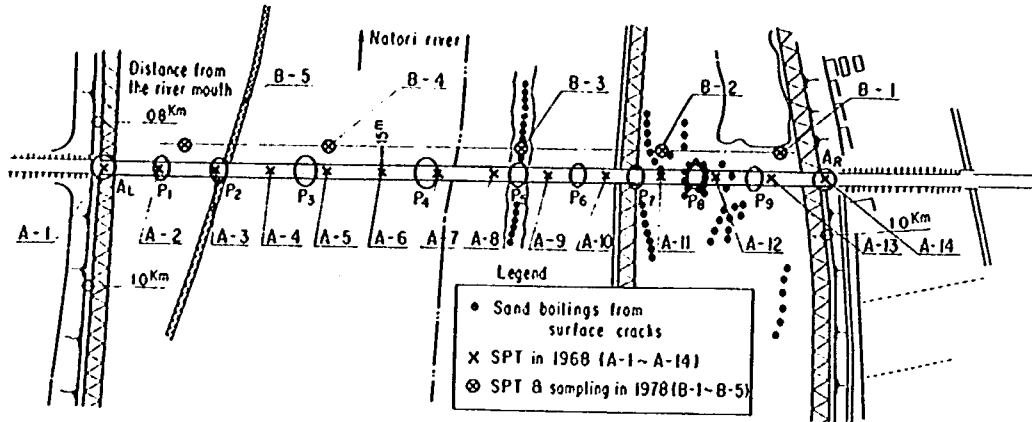
As shown in Figs. 39 and 40, sands spouted from ground surface cracks at numerous points near Pier-5 and between Pier-7 and 9. At these points the ground settles about 10 cm relatively to the piers. In situ soils investigations (see Fig. 40), laboratory tests for undisturbed specimens, and liquefaction assessment analyses were conducted after the earthquake. It was revealed that the subsoils of sands are loose near the surface and median to dense underneath. A hard layer exists 70 m below the surface. The results of liquefaction assessment are illustrated in Fig. 41.

Fig. 40. Points of Sand Boils and Insitu Soil Tests at Yuriage Bridge

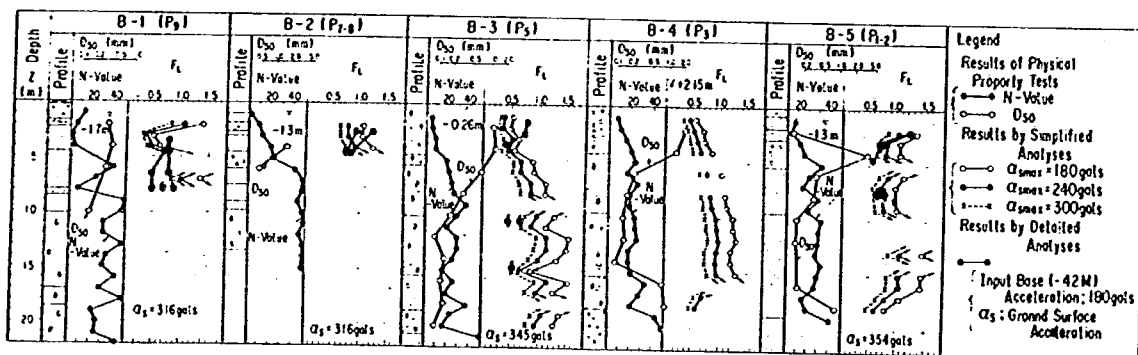
Fig. 41.  $F_L$  Values at Yuriage Bridge (B-1, B-2, B-3; Liquefied, B-4, Liquefaction Unconfirmed, B-5; Non-Liquefied)

In the figure  $F_L$  values, factor of liquefaction resistance as explained in the previous section, are estimated at five points, namely B-1, B-2, and B-3 (sand boils observed), B-4 (sand boils unconfirmed because of water stream), and B-5 (no sand boils). Two procedures, the detailed method and the simplified method, were employed in the liquefaction assessment analyses. In the detailed method, the acceleration record obtained at a dam site close to the bridge was selected. The peak acceleration value of 180 gals was taken at the level of 42m depth. On the other hand, in the simplified method, three values of the peak ground acceleration were assumed to be 180, 240, and 300 gals.

It is seen from Fig. 41 that  $F_L$  values less than 1.0 distribute nearly at the depth of 2 to 6m (at B-1 point), 2 to 5m (at B-2 point), 1 to 8m (at B-3 point), 1 to 7m (at B-4 point), and 3 to 9m (at B-5 point).  $F_L$  values are greater than 1.0 near the ground surface at B-5 point. It is supposed that at B-1, B-2, B-3, and B-4 points, liquefaction took place at the layers from the surface to the above-mentioned depths, and that at B-5 point liquefaction did not occur near the surface (up to about 3m), but liquefaction might have occurred at a deeper layer (between 3 to 9m). Sand layers with lower values of  $F_L$  well correspond to the layers of sand boiling.

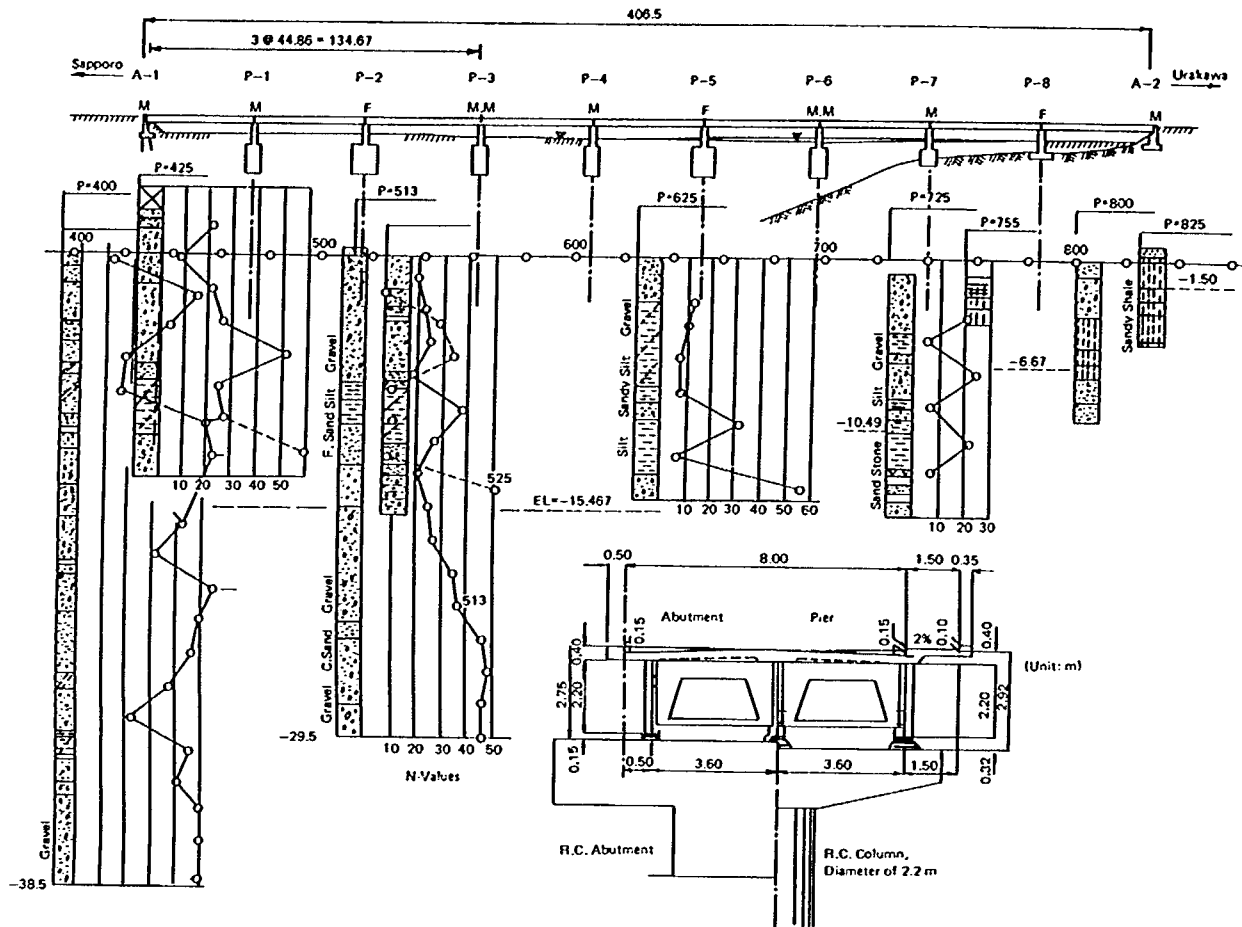
Fig. 46. General View, Cross Section, and Soil Profiles of Shizunai Bridge

Soil conditions at the bridge site are shown in Fig. 46. Soft soils are deeper at the right-bank side (or Abutment-1 side), and the mid-span part. Soft soils are very shallow at the left-bank side (or Abutment-2 side). A bedrock layer (mudstone of Tertiary Era) is seen on the surface near the site of Abutment-2. Pier-8 and Abutment-2 have spread foundations resting directly on the mudstone layer.

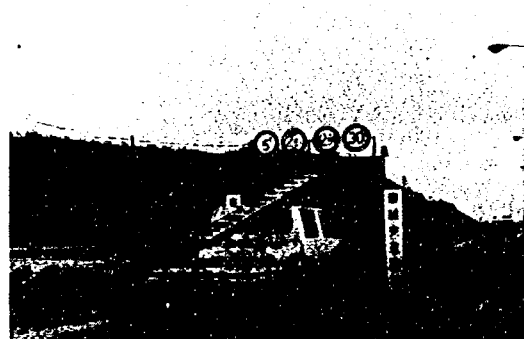
Fig. 56. Several Restrictions Such As a Speed Limit

Quick repairing works for Piers-2, 3, and 6 completed by the middle of April, and one-lane of the bridge reopened on April 15 for light traffic (lighter than 5 tons) with several restrictions such as a speed limit (see Fig. 56). It took six months to completely repair all the damages, and the bridge eventually reopened on October 1, 1982 for all vehicles without any restrictions.

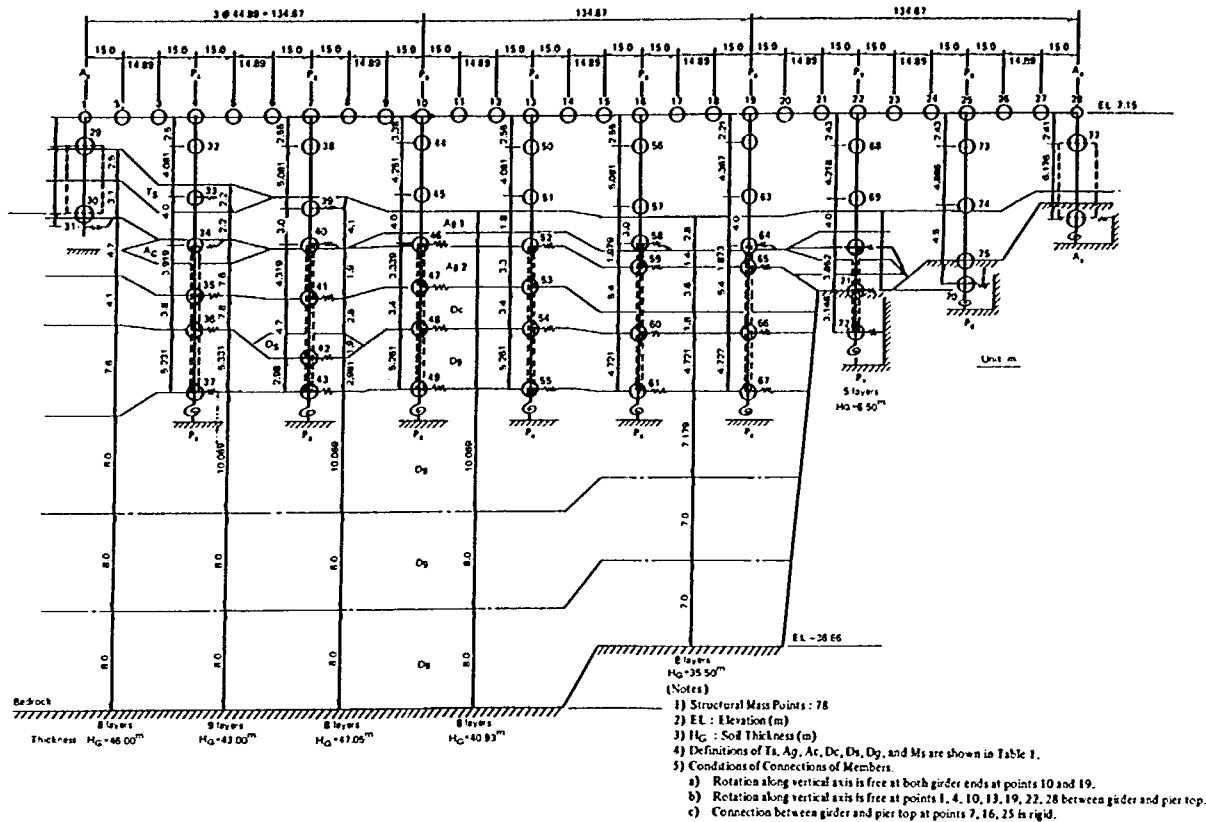
In view of the above features of the bedrock line, a seismic analysis for soil layers was conducted for grounds between Abutment-1 and Pier-7. Fig. 58 illustrates a classification of soil layers considered in the analysis. In this figure, an analytical model for structural members is also shown. Table V tabulates shear wave velocities from insitu measurements for these soil layers. In the analysis, shear moduli and hysteretic damping constants were determined as functions of strain levels (non-linear properties), which were obtained from the results of dynamic torsional shear tests for soil specimens sampled from the field.

Fig. 58. Analytical Model of Overall System of Shizunai Bridge

From a characteristic value analysis (or an eigenvalue analysis) for the overall system shown in Fig. 58, the fundamental mode shape (or the first mode) is shown in Fig. 60. The fundamental natural period is about 0.6s, and thus the entire parts of the system move to the same direction. Bending deformations of pier columns prevail for the fundamental mode. The participation factor for the fundamental mode is most essential comparing with the other modes.

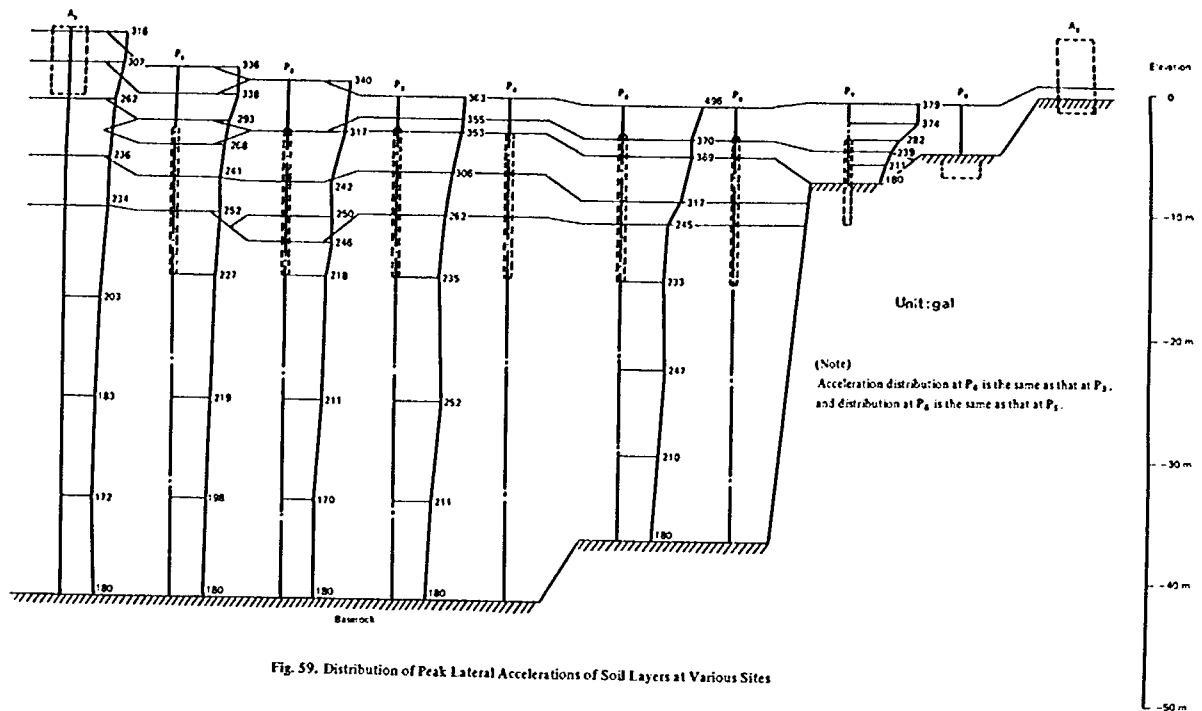
Fig. 59 indicates a distribution of response accelerations of grounds, when a motion of Shirunai Bridge record was input. The peak accelerations on the ground surface become 300 to 400 gals. The displacements on the ground surface (relative displacements to the bedrock) are 4.8 cm at Abutment-1 site, 3.1 cm at Pier-1 site, 3.3 cm

Fig. 59. Distribution of Peak Lateral Accelerations of Soil Layers at Various Sites

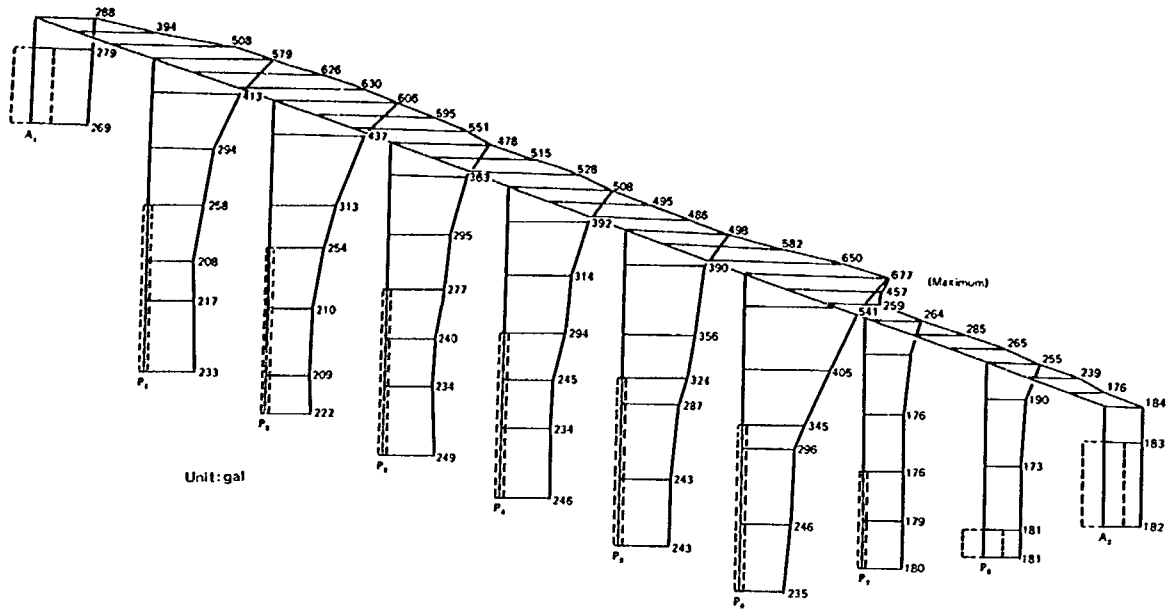
Fig. 61. Distribution of Peak Response Accelerations at Various Structural Points

Figs. 61 and 62 illustrate the distribution of peak response accelerations and peak response displacements, respectively, when Shizunal Bridge is subjected to the input motion of Shizunal Bridge record shown in Fig. 57 (the peak acceleration at the bed-rock is adjusted to be 180 gals), in the transverse direction to the bridge axis. Maxi-

mum response accelerations can be observed at pier tops and girders between Piers-1 and 6, and the peak acceleration value is very large (480 to 660 gals). Maximum response displacements at the sites between Abutment-1 and Pier-6 are also large (4.2 to 6.6 cm).

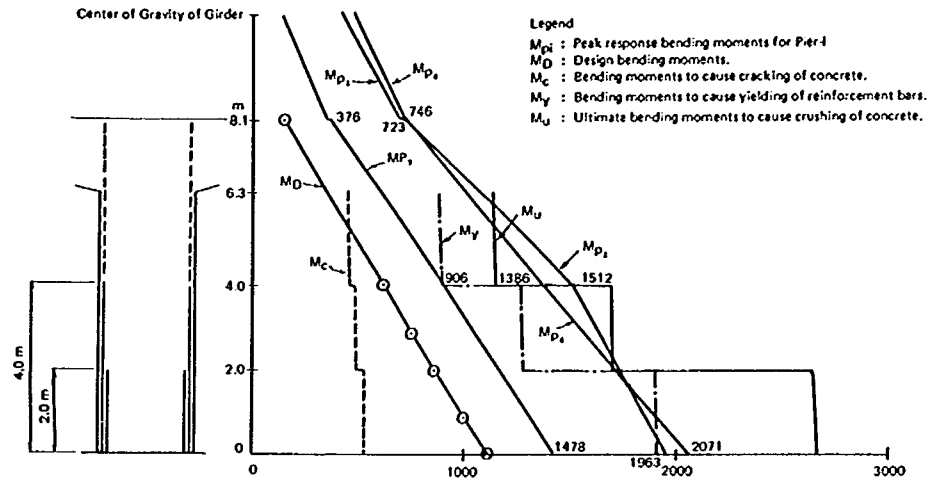
Fig. 63. Distributions of Peak Bending Moments for Pier-1, Pier-4, and Pier-7

Next, Figs. 63 to 66 show the distributions of peak bending moments for all pier columns. In the figures, design bending moments ( $M_D$ ), bending moments to cause initial cracks ( $M_C$ ), bending moments to cause yielding ( $M_Y$ ), and ultimate bending moments ( $M_U$ ) are illustrated, as well as the peak response bending moments ( $M_{PI}$ ) given for each pier from the dynamic analysis performed. It is seen from these figures that response bending moments ( $M_{PI}$ ) are quite large ( $M_{PI} > M_U$ ) at Piers-3 and 6 which sustained very heavy cracks during the Urakawa-oki Earthquake of

1982. Response bending moments at Piers-1, 2, 4, 5, 7 are nextly large ( $M_{PI} > M_D$ , and  $M_{PI}$  are nearly equal to  $M_U$  at the section of cut-off of reinforcing bars). Response bending moments at Pier-8, which did not receive any cracks, are small ( $M_{PI} < M_D$ ). Peak response shearing forces are higher than shearing strengths at Piers-1, 2, 3, 5 and 6, although response shearing forces are less than shearing strengths at Piers-4, 7 and 8.

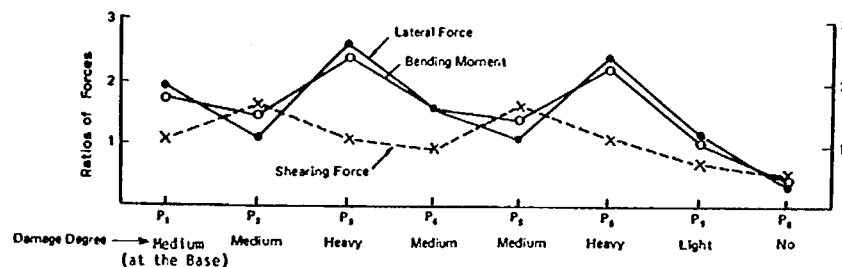
Table VII shows (A) comparison of design lateral forces and response lateral forces analyzed, (B) comparison of yielding bending moment and response bending moments analyzed, and (C) comparison of shearing strength at most dangerous sections and response shearing forces analyzed. A figure below the table shows the ratios of

response lateral forces to design lateral forces, the ratios of response bending moments to yielding bending moments, and the ratios of response shearing forces to shearing strengths for all the nine pier columns, indicating degree of damages during the Urakawa-oki Earthquake of 1982.

From the figure below Table VII the following can be pointed out. Ratios of response lateral forces to design lateral forces for Piers-3 and 6 which sustain heavy cracks, are very large (2.6 and 2.4). The ratios for Piers-1, 2, 4, 5, and 7 which received moderate to minor cracks, are between 1.1 and 1.5. The ratio for Pier-8 with no damage is very small (0.3). Ratios of response bending moments to yielding bending moments are also large for Piers-3 and 6, and small for Pier-8. The tendency is identical to the case of lateral forces. Furthermore, ratios of response shearing forces to shearing strengths are greater than 1.0 for Piers-1, 2, 3, 5 and 6, and less than 1.0 for Piers-4, 6, and 8.
