# **THE WESTERN NAGANO PREFECTURE EARTHQUAKE, 1984 AND DAMS**

May, 1985

Fill Type Dam Division  
Dam Department  
Public Works Research Institute  
Ministry of Construction

by  
Dr. Norihisa Matsumoto  
Nario Yasuda  
Minori Shiga

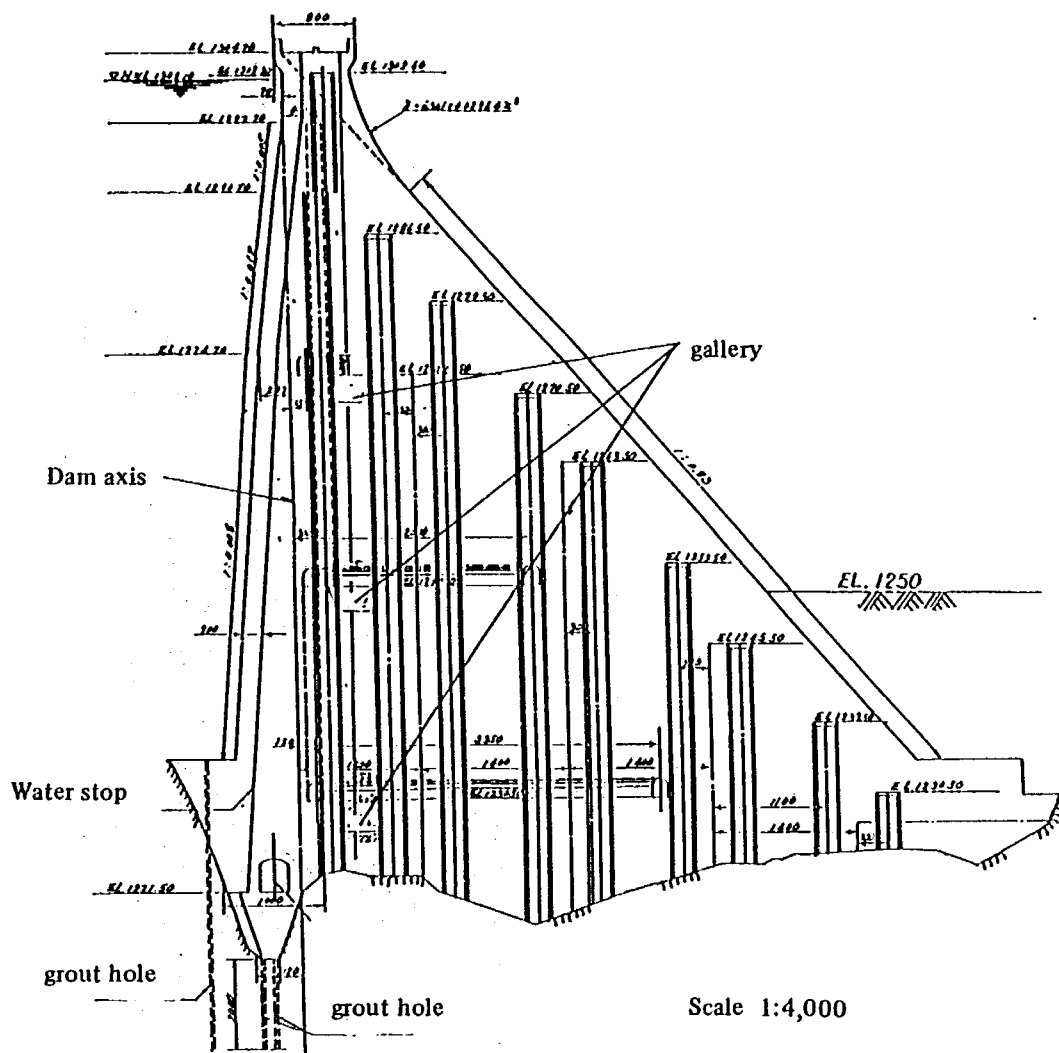
Fig. 4.4 Cross section of Miure Dam

Miure Dam is located just upstream of Makio Dam and Ohtakigawa Dam and is concrete gravity type as shown in Figure 4.4. The general discription is given in Table 4.2. A shock of intensity 4 on the scale of Meteorological Agency (Japan) was felt at Miure Dam during the Western Nagano Earthquake. The reservoir level was 1,301.6 m (2.5 m below the normal water level). Emergency inspections of dam body, abutments and hydraulic structure were made immediately after, but nothing unusual was reported. For example, the leakage of 17.75 liters from dam body remained unchanged.

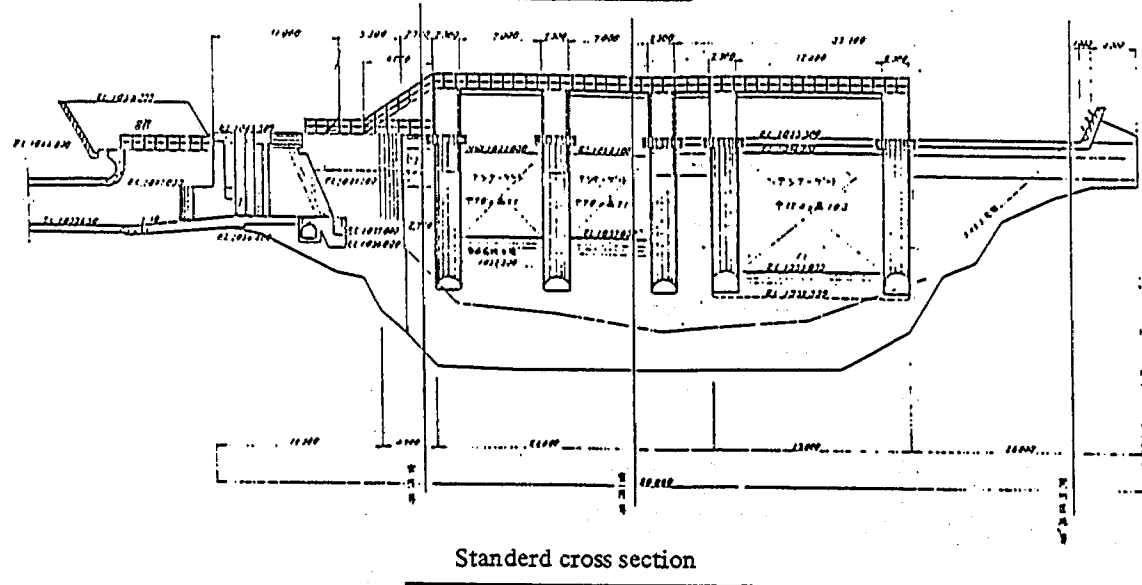
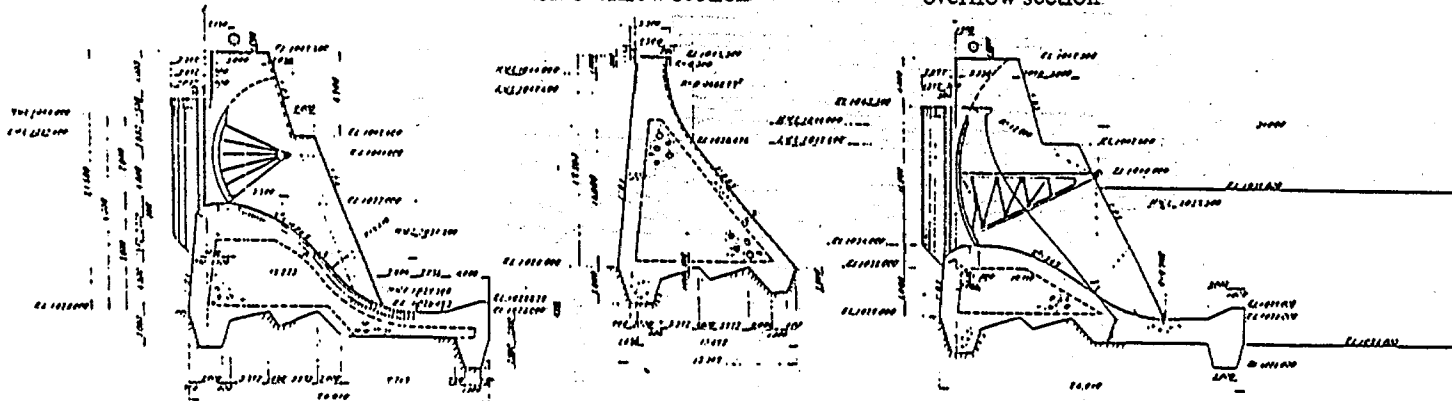
Fig. 4.5 Upstream view and cross sections of Ohtakigawa Dam

Ohtakigawa Dam is a concrete gravity dam and is located between Miure Dam and Makio Dam. The general discription and the maximum cross section are given in Table 4.3 and Figure 4.5 respectively. Nothing unusual was found from the emergency inspection except for a hand-rail at crest, which sustained slight damage from waves during the earthquake.

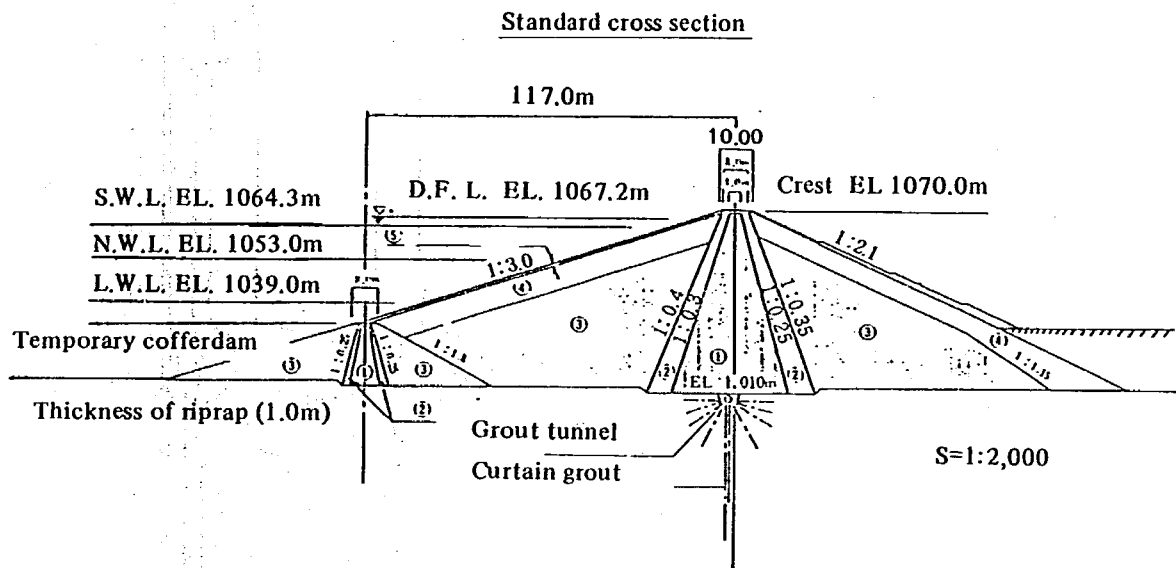
**Fig. 4.6** Cross section of Narai Dam

Narai Dam is a rockfill dam with a central core and was completed in 1982. Its height is 60 m as shown in Figure 4.6. The general description is shown in Table 4.4. The reservoir water level was 1,056.6 m.

Leakage before the earthquake increased by 18 liters to about 130 liters, but increment has been gradually decreasing.
