PROCEEDINGS OF THE 27th U.S. – JAPAN BRIDGE ENGINEERING WORKSHOP

Tsukuba, Japan
November 7, 8 and 9, 2011

Technical Report
of PWRI No.4218

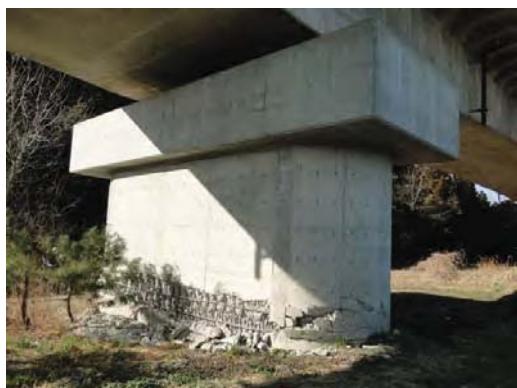
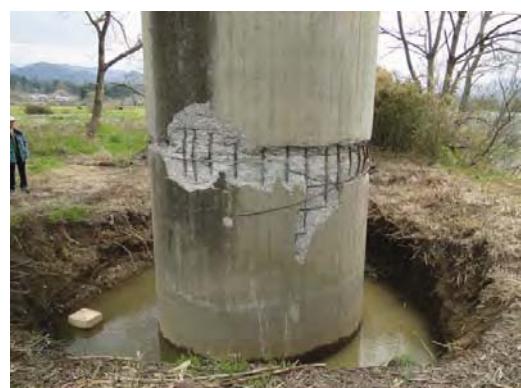
Intensive damage due to the ground motion was developed in many unretrofitted bridges designed in accordance with pre-1980 design specifications. Almost of damage modes of those bridges have ever been observed in the past earthquakes. Photos 1 to 3 show the damage to reinforced concrete piers, steel bearing supports and the attachment of the bearing support to pier top or the superstructure, respectively. Although some bridge columns collapsed during the 1995 Kobe earthquake, the only one bridge collapsed during the 2011 Great East Japan earthquake. As shown in Photo 4, an old steel girder bridge supported by steel pile-bent columns (Rokko Ohashi Bridge) in the local roadway was collapsed due to the ground motion of the earthquake. Rokko Ohashi is to be replaced a new bridge and the new one was being constructed at the time of the earthquake.

Photo 1 Damage of Reinforced Concrete Columns at Cut-off Section of Longitudinal Reinforcement

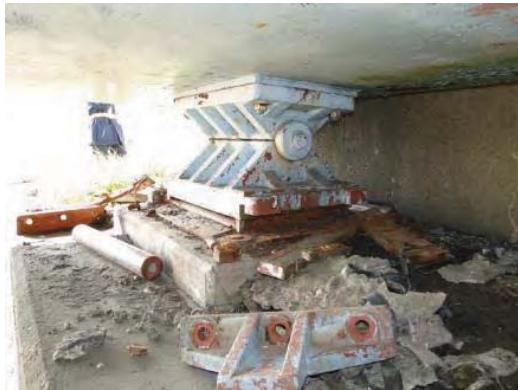
Photo 2 Damage of Steel Bearing Support

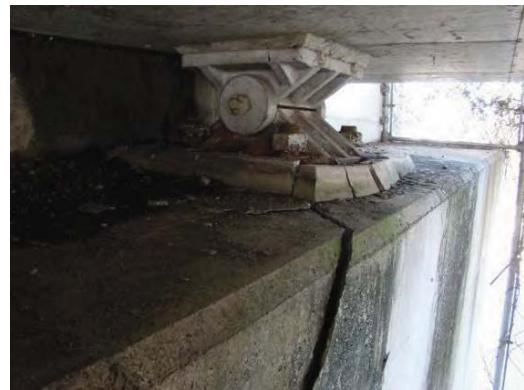
Photo 3a Damage of Pier Top

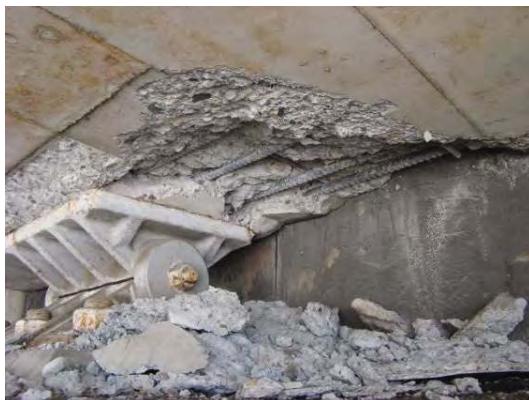
Photo 3b Damage of Attachment of Bearings to Superstructure

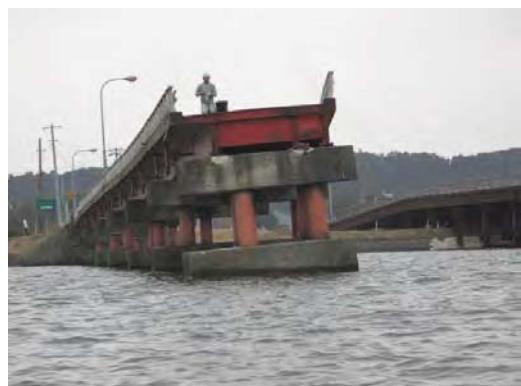
The ground motion effect to damage of bridges was less significant than the tsunami effect. One bridge (Rokko Ohashi Bridge, an old steel girder bridge supported by steel pile-bent columns located in Ibaraki prefecture) was collapsed due to the ground motion of the earthquake. Although the collapsed bridge was observed at the only Rokko Ohashi in the highway bridges, it was found in the bridge designed in accordance with pre-1980 design specifications that damage to RC columns at section of cut-off of longitudinal rebars, damage to RC pier-wall with small amount of reinforcement, damage to steel bearings and attachment of bearings, damage to bracing and steel members, and subsidence of backfill soil of abutment. These damage modes have already observed in the past earthquakes. However, rupture of elastometric rubber bearings were observed at the Sendai-Tohbu viaduct designed based on Post-1995 design specifications.

Photo 4 Collapse of Steel Pile-bent Columns

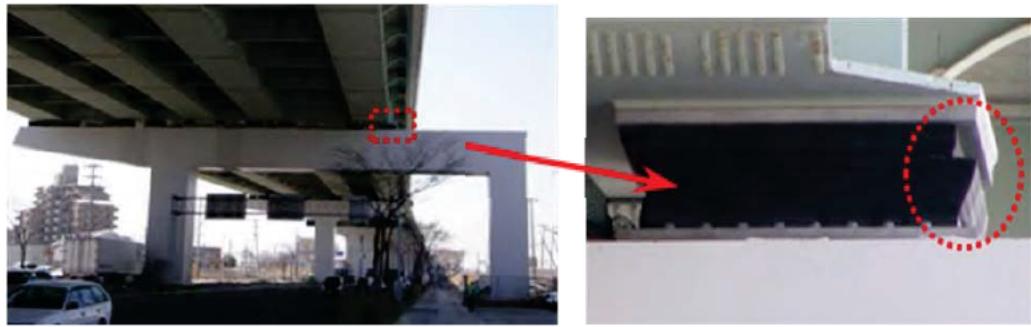
However, as shown in Photo 5, it should be noted that elastometric rubber bearings ruptured at the Sendai-Tohbu viaduct designed based on Post-1995 design specifications. Fig. 2 illustrates the structure of the Sendai-Tohbu viaduct and the positions of the elastometric rubber bearing with the rupture. As seen in Fig. 2, bridge structure in this junction is very complicate. Bridge width changes significantly in the 4-span continuous box girder with the change of the section. Span length of the section from P52 to 56 is around 70m, while that from P56 to P58 is 39m. P52 and P53 are single-column hammerhead steel piers, while P54, P55 and P56 are two-column steel frames. Rupture of the elastometric rubber bearings in the transverse direction was observed at the deck-end of P52 side in 4-span continuous box girder, though there are few damaged elastometric rubber bearings at the other deck-end side of the box girder on Pier 56. Photo 6 shows failure mode of the elastometric rubber bearing with the rupture. Comparison of the failure mode with the result of the shear loading test should be made, to estimate the capacity of the elastometric rubber bearing and the applied seismic force combination.

Photo 5 Rupture of Elastometric Rubber Bearings in Sendai Tobu Viaduct
(P54, Two-column Steel Frame)

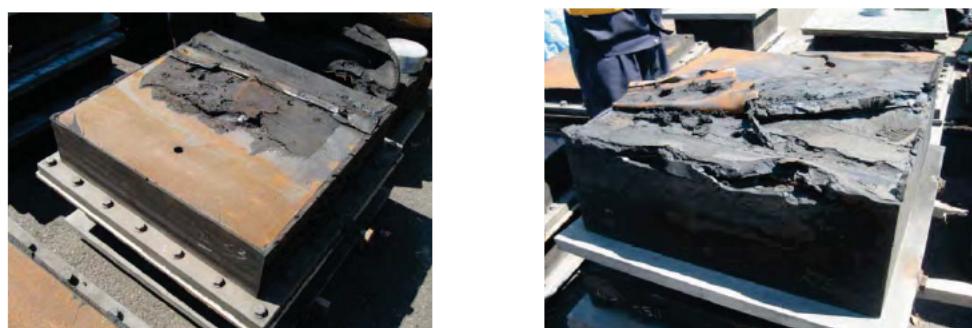
Photo 6 Details of Rupture of Elastometric Rubber Bearings

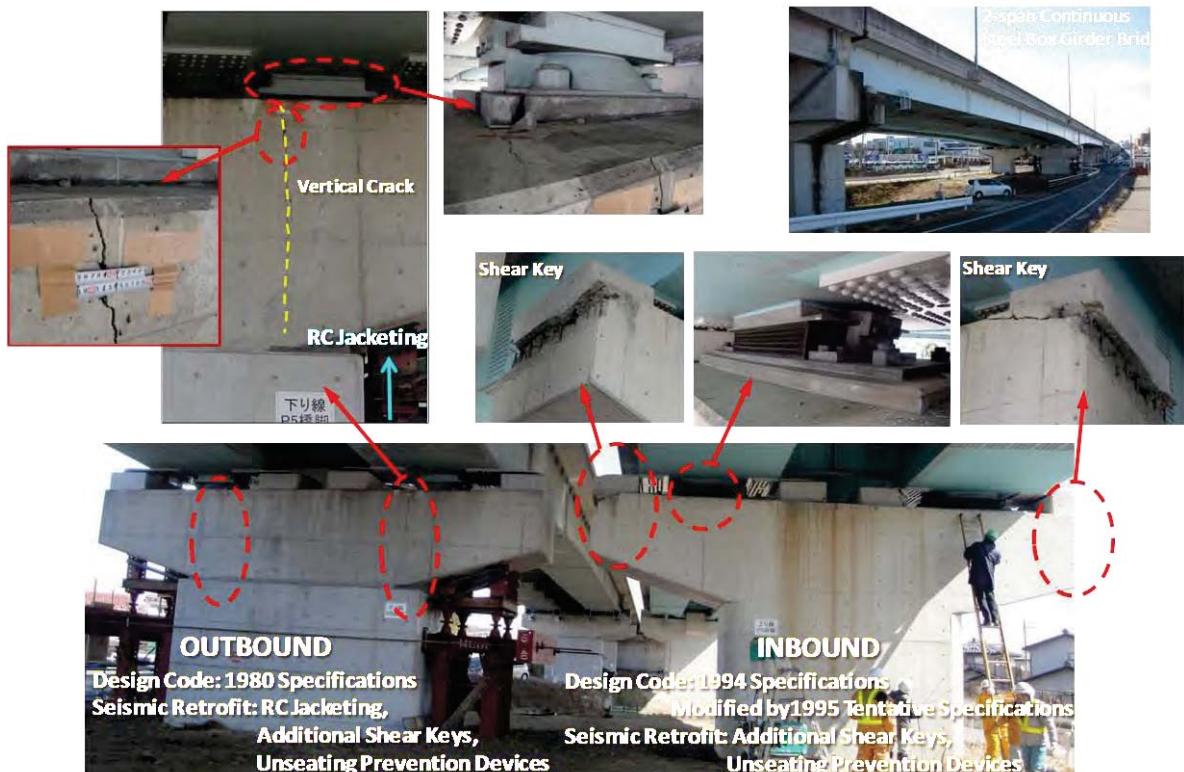
(Kameda Ohashi Bridge)

On the other hand, there are a few remarkable damage examples in the retrofitted bridges. Photo 8 shows adjacent two reinforced concrete columns in Kameda Ohashi Bridge. Each column supports 2-span continuous steel box girder at the middle. The outbound column was designed with 1980 specifications and retrofitted by reinforced concrete jacketing for strengthening the cut-off section without increasing the flexural strength of the column base. Furthermore, additional shear keys were anchored to column top to supplement the strength of the existing bearings. Although no damage was found to the steel bearings and shear keys, vertical cracks of nearly

10mm width were observed at the beam section as shown in Photo 8. The inbound column was designed with 1994 specifications basically and some modifications were made based on the 1995 tentative specifications (published soon after 1995 Kobe Earthquake). In the inbound column, elastometric rubber bearings were deformed in the transverse direction and the side stoppers were failed. Concrete of the beam edge portion attaching the supplemental shear keys also spalled off (see Photo 8) due to the transverse seismic force induced by the inertia of the superstructure, while vertical crack observed in the beam of the outbound column was not developed in the inbound beam.

Photo 8 Comparison of Damage Mode between Adjacent Two Bridge Columns

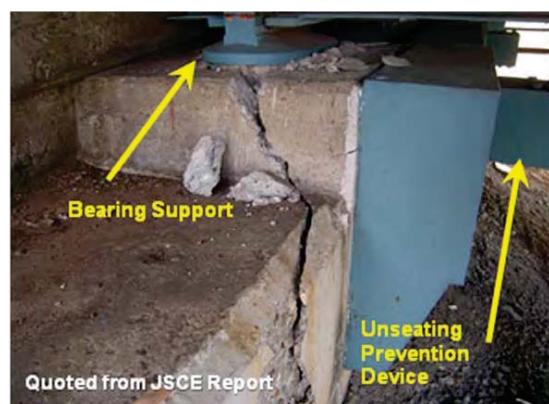
Photo 9 shows the failure of pier top. This type of damage has ever observed in the old bridge columns since the past earthquakes. Bearing capacity of the pier top was insufficient to transmit the seismic force to column. It should be noted in this bridge that the crack reaches the portion of the anchor bars of the steel bracket for attaching the unseating prevention devices. Since the unseating prevention devices should work at the unexpected situation of failure of bearing supports.

Photo 9 Crack to Pier Top Affects Attachment

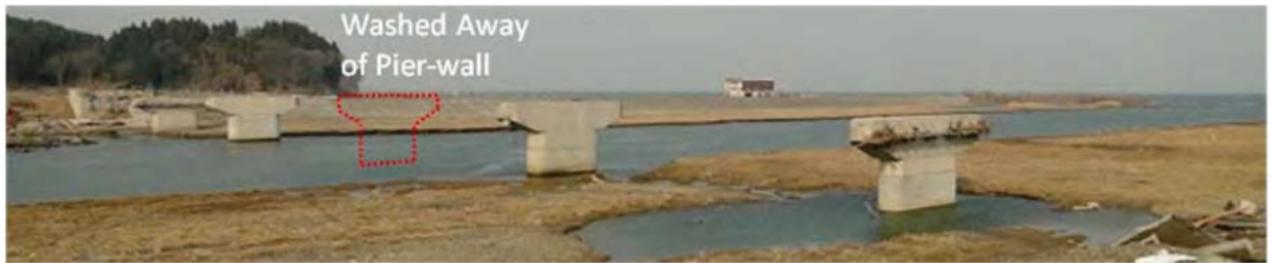
Photo 10a Washed Away of Steel Superstructure and Pier-wall (Koizumi Bridge)

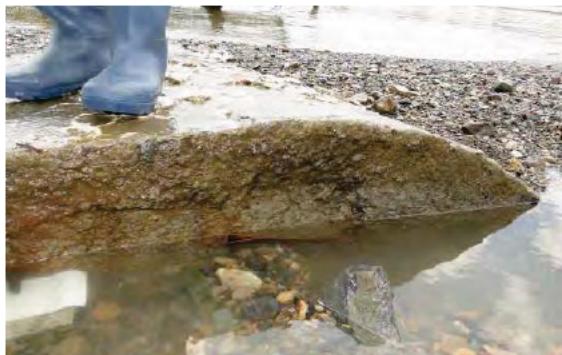
Photo 10b Failure Section of Pier-wall (P3)

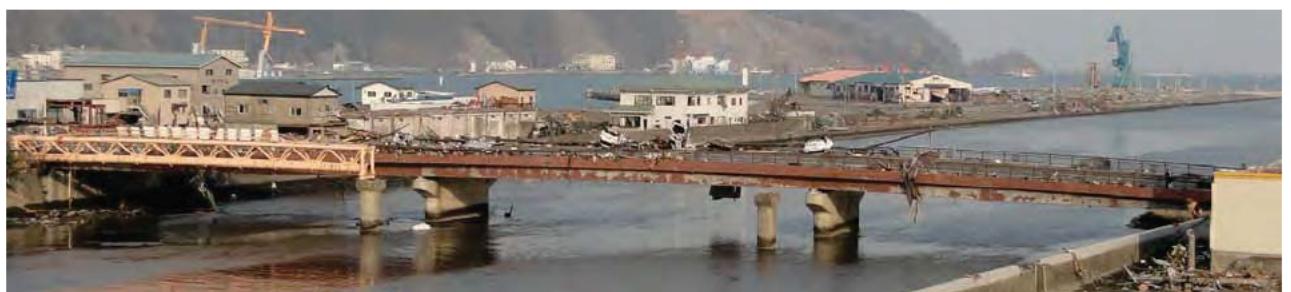
Photo 12 Bridge Survived Washed Away Due to Tsunami (Yanoura Bridge)

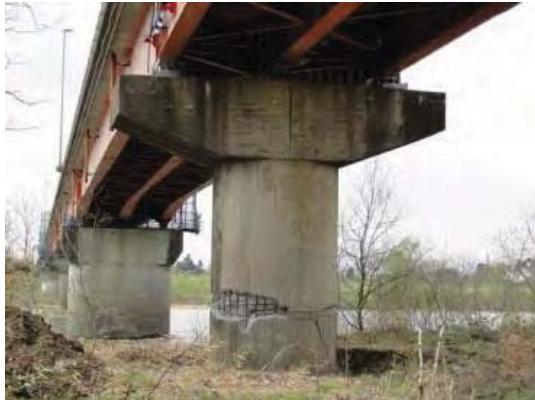
Photo 1 Shear failure of a column due to termination of longitudinal bars with insufficient development (Fuji Bridge) (courtesy of Dr. Hoshikuma, J., PWRI)

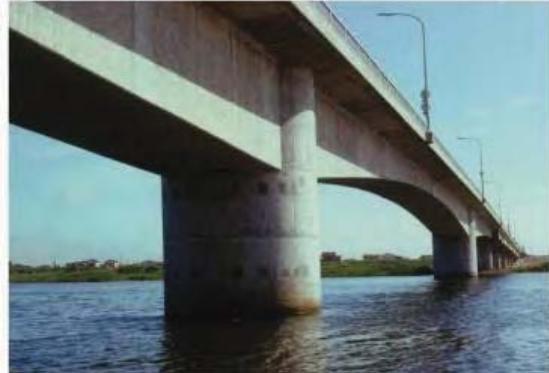
Photo 2 Yuriage Bridge

Yuriage Bridge as shown in Photo 2 suffered extensive damage at reinforced concrete hollow and solid columns, supports of prestressed concrete girders, and steel pin and roller bearings during 1978 Miyagi-ken-oki earthquake. Since the damaged

columns were repaired and strengthened by reinforced concrete jacketing, they did not

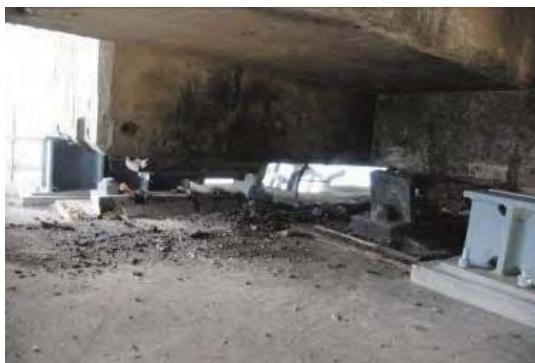
Photo 3 Damage of pin and roller bearings

suffer damage this time. However pin and roller bearings suffered damage again in the similar way as shown in Photo 3. It is obvious that pin and roller bearings are vulnerable to seismic action, because the stress builds up until failure by allowing virtually no relative displacement at pin bearings and relative displacement accommodated in roller bearings is insufficient to realistic relative displacement developed under a strong excitation.

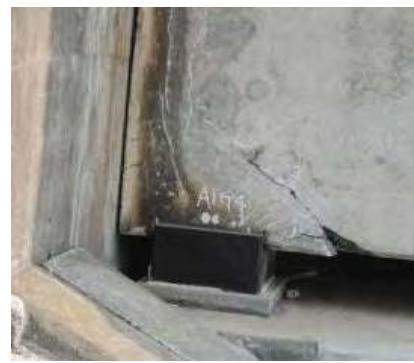
Photo 4 Damage of PC girders near the support

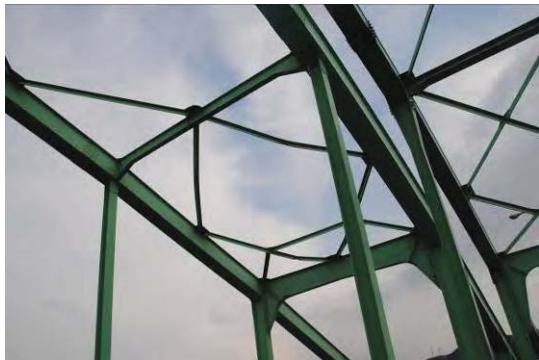
Photo 5 Buckled truss braces

Tennoh Bridge built in 1959 suffered extensive damage during 1978 Miyagi-ken-oki earthquake. This bridge suffered extensive damage again during this earthquake at the same members; truss braces and pin and roller bearings as shown in Photo 5.

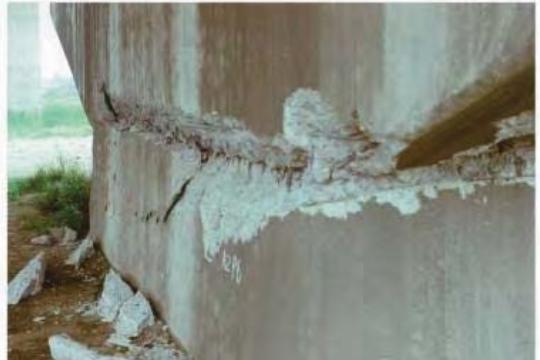
Photo 6 Damage of a pier during 1978 Miyagi-ken-oki earthquake (Sendai Bridge)

On the other hand, damage of bridges which were already retrofitted suffered virtually no damage. For example, Sendai Bridge which is a symbolic bridge in Sendai suffered extensive damage at columns and bearings as shown in Photo 6 during 1978 Miyagi-ken-oki earthquake. However this bridge suffered no damage during this earthquake, because columns were retrofitted as shown in Photo 7 and steel bearings were replaced with elastomeric bearings.

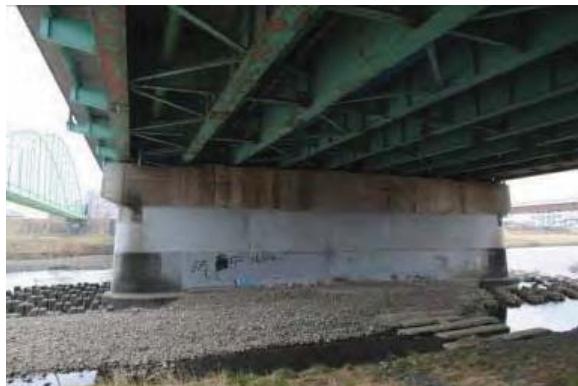
Photo 7 Retrofitted pier of Sendai Bridge which did not suffer damage during 2011 Great East Japan earthquake

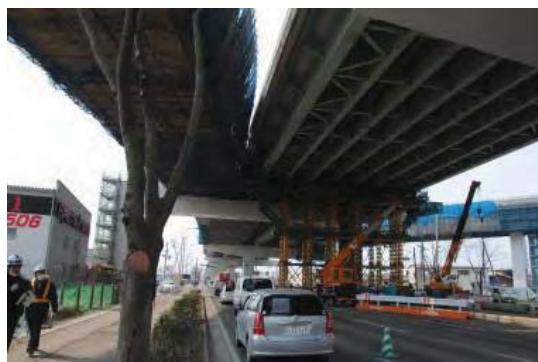
Photo 10 Piers where elastomeric bearings ruptured (Sendai-Tobu viaduct)

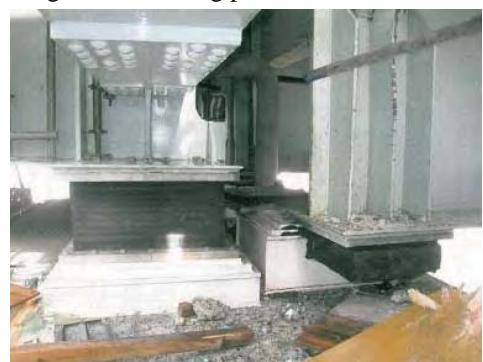
Photo 11 Transverse offset of a girder due to rupture of elastomeric bearings

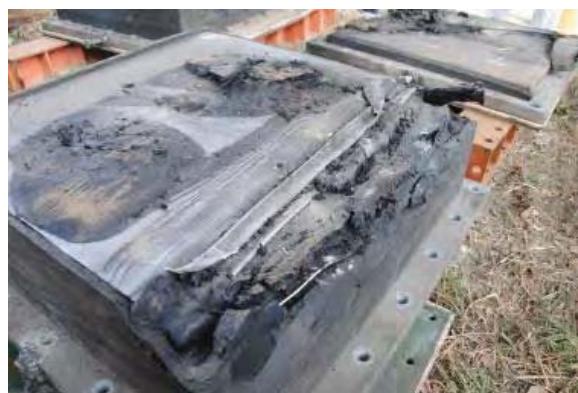
Photo 12 One of elastomeric bearings ruptured

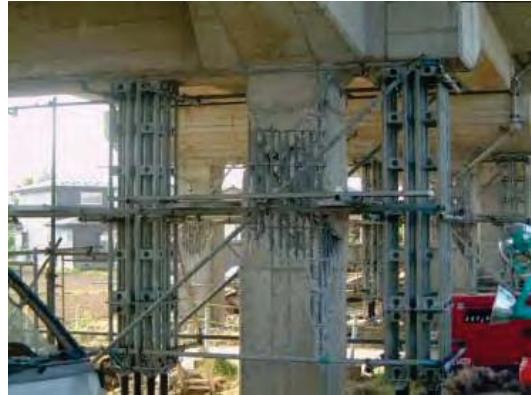
It should be noted that all viaducts which suffered damage during 2011 Great East Japan earthquake had not yet been retrofitted. Most viaducts in Iwate-ken were single story RC moment resisting frame with a Gerber girder at both sides. Damage concentrated at the side columns during 2003 Sanriku-Minami earthquake as shown in Photo 13. Since the side columns were shorter than the center column, a parameter defined as a ratio of the shear capacity to the flexural capacity was smaller in the side columns than the center columns, which led shear failure in the side columns.

Photo 14 Shear failure of RC columns at Odaki viaducts after 2003 Sanriku-Minami earthquake

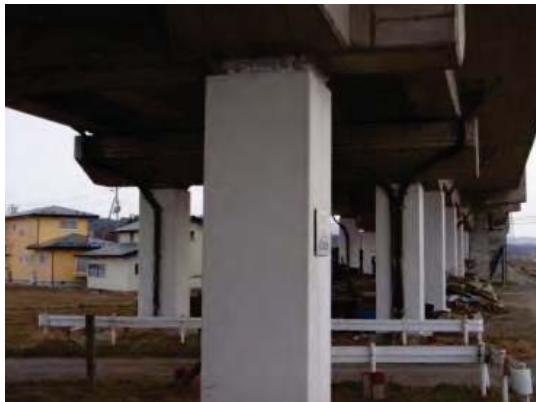
Photo 15 No. 3 Odaki viaducts which were retrofitted after 2003 Sanriku-Minami earthquake performed well during 2011 Great East Japan earthquake

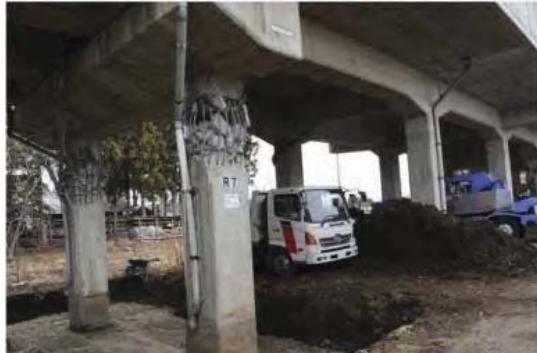
Photo 16 Damage of R7 column, No. 1 Nakasone viaduct during 2011 Great East Japan earthquake

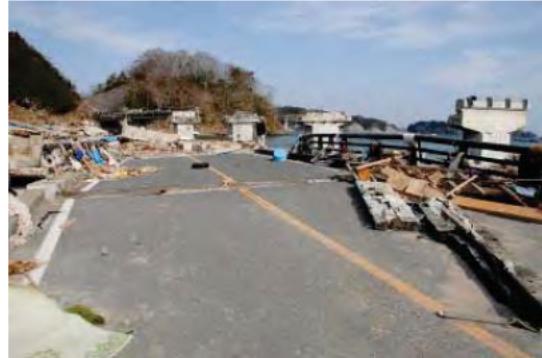
Photo 18 Damage of Utatsu Bridge

Utatsu Bridge at Minami-sanriku Town over Irimae Bay suffered extensive damage by tsunami as shown in Photo 18. It consisted of 3 types of superstructures with spans ranging from 14.4m to 40.7m, as shown in Fig. 6. The superstructures from S3 to S10 were completely washed away from their supports in the transverse direction due to tsunami while the superstructures S1, S2, S11 and S12 were not washed away. The

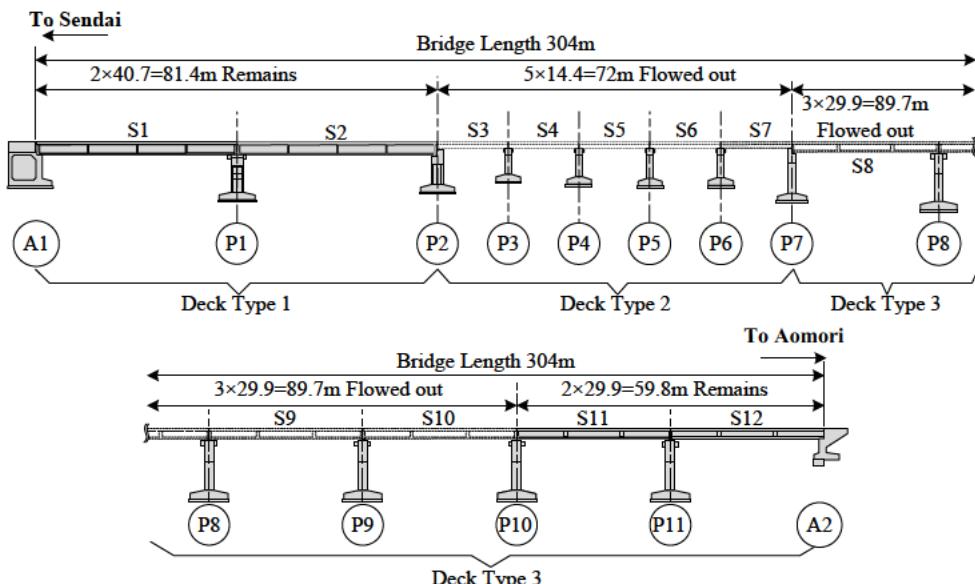
Fig. 6 Utatsu bridge

outflow displacements of S3~S10 are shown in Fig. 7. It should be noted that the spans located at the center such as S5-S7 and S8 were flowed 28 m and 41 m away from the original position, while the spans located at the sides such as S1, S2, S11 and S12 were

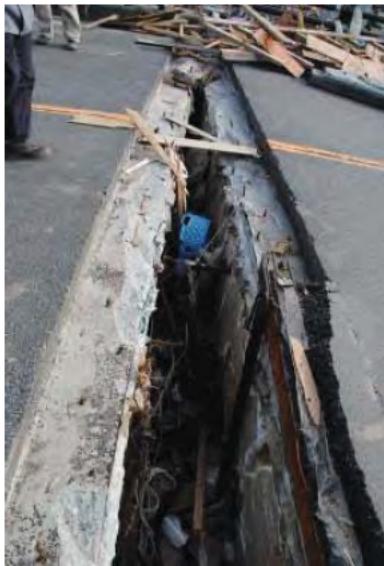
Photo 19 Effective restrainers to tie together adjacent decks

not washed away. It is noted that S3, S4 and S4', and S5, S6 and S7 which flowed out together because they were tied by cable restrainers for preventing excessive superstructure response under a large seismic excitation as shown in Photo 19. S8, S9 and S10 overturned during being floated as shown in Photo 20.

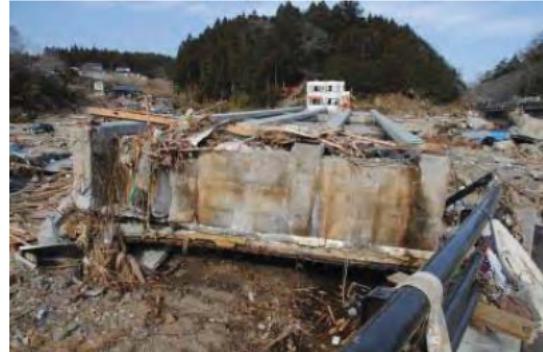
Photo 20 An overturned superstructure

Fig. 8 shows possible mechanism of damage of bridges due to tsunami. As mentioned earlier, overturning of foundation due to scouring did not occur in road bridges. It is likely that damage of decks in Photos 20 and 21 occurred due to mechanism shown in Fig. 8 (b) and (c), respectively.

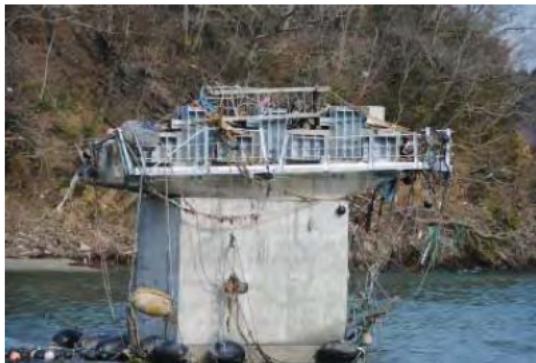
Photo 21 shows the top of a pier after superstructures were washed away. Two types of steel devices were set as an unseating prevention device in this column; one is the devices aiming of increasing seat length required by the recent code, and the other is the devices which were set for preventing excessive deck displacement in the longitudinal direction. It is important to know that none of those devices tilted or were

detached from the pier which must have happened if the decks were simply washed away laterally. It is likely that the decks were uplifted by tsunami buoyancy force and then they were washed away. Steel plate bearings used in this bridge was very simple as shown in Photo 22 such that both uplift and lateral force capacities were limited.

Photo 21 Steel devices for extending seat length (short device) and steel stoppers for preventing excessive longitudinal deck response due to ground motions (tall device)

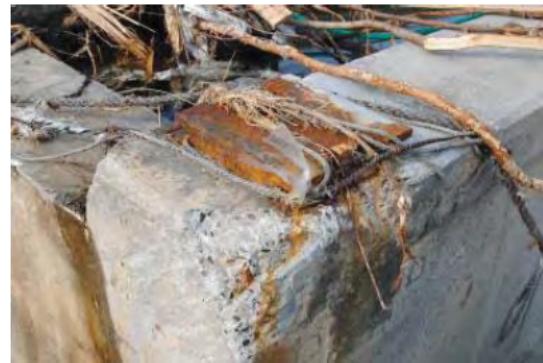
Photo 22 Failure of a RC side stopper, and four steel stoppers for preventing excessive longitudinal deck response which were not damaged

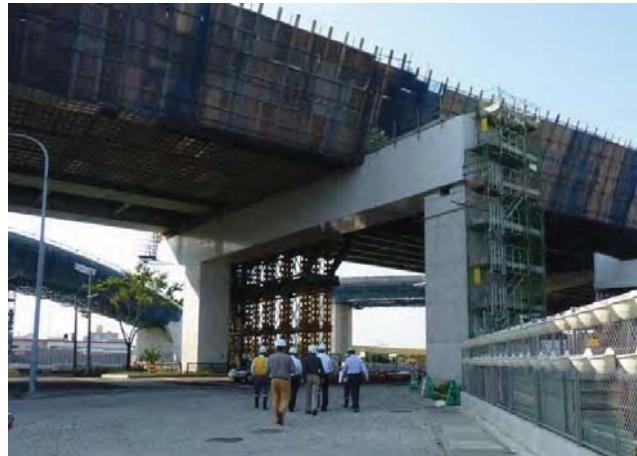
The pattern of the bearing damage in Table 1 is particularly interesting. It is concentrated in regions of the viaduct where there is a significant change in lateral stiffness – from single-column hammerhead piers at Pier 57 to two-column frames at Piers 54, 55 and 56, for example. There is also a significant change in the in-plane stiffness of the superstructure in this section, from eight I-girders in Spans 52 and 57 to multiple single-cell box girders in Spans 53 to 56. This section of the viaduct is therefore very stiff (and particularly Spans 55 and 56) while sections to the north and south are comparatively flexible. When earthquake loads are applied, the difference in displacements at the two interfaces (Piers 52 and 56) generate high lateral forces in the stoppers at these two piers leading to their failure and the transfer of load to the bearings.

FIGURE 2 – TWO-COLUMN FRAME, PIER 56
SENDAI-TOBU VIADUCT (Photo: E. Monzon)

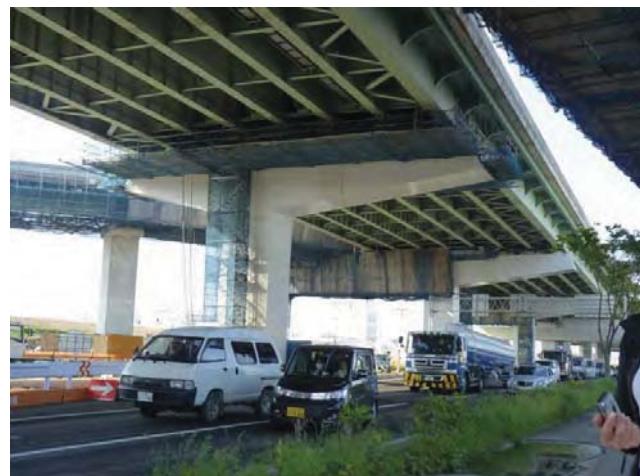
FIGURE 3 – SINGLE COLUMN, PIER 57
SENDAI-TOBU VIADUCT (Photo: E. Monzon)

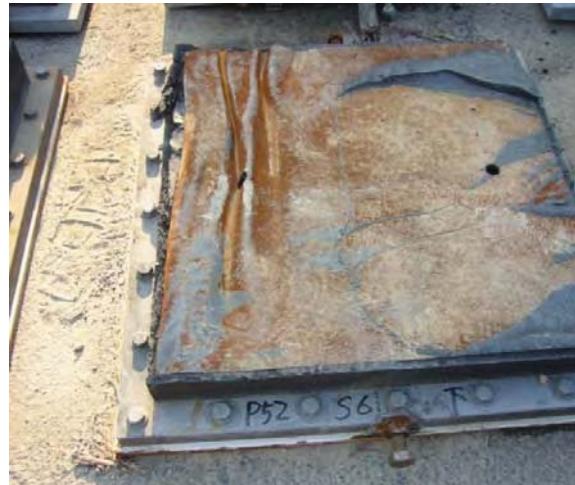
Inspection of the damage to the bearings showed that many had ruptured completely through the elastomer, as if in direct tension. Others showed damage to the internal shims which had been severely distorted (Figure 4). Typical dimensions of the bearings at Pier 56

are 820 x 870 x 508 mm, with 8 x 33 mm layers of elastomer, 7 x 4.5 mm shims and 2 x 45 mm end plates. The masonry and sole plate connections were detailed to transfer both shear and axial forces (tension and compression) into the bearings.

FIGURE 4 – DAMAGED ELASTOMERIC BEARING FROM PIER 52, SENDAI-TOBU VIADUCT (Photo: E. Monzon)

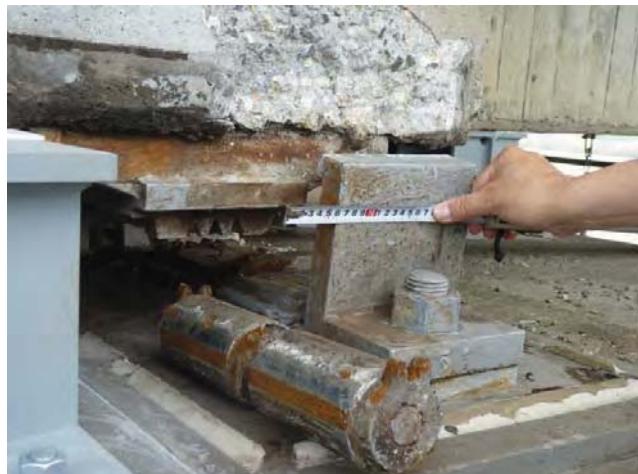
FIGURE 6 - EJECTED ROLLER BEARING AND PERMANENT LONGITUDINAL MOVEMENT AT PIER 2, YURAGE BRIDGE (Photo: E. Monzon)

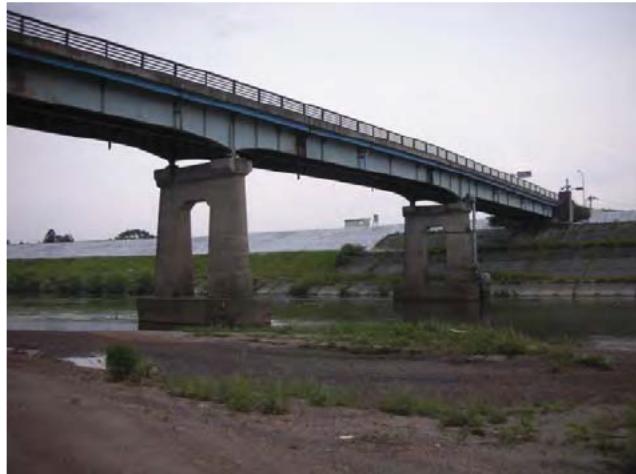
deck joint have discolored the two in-span hinge areas. Also visible are seat extensions installed on the piers throughout the bridge. No other seismic retrofitting was seen.

FIGURE 7 – PIERS 7 AND 8 OF PLATE-GIRDER SHIDA BRIDGE (Photo: L. Marsh)

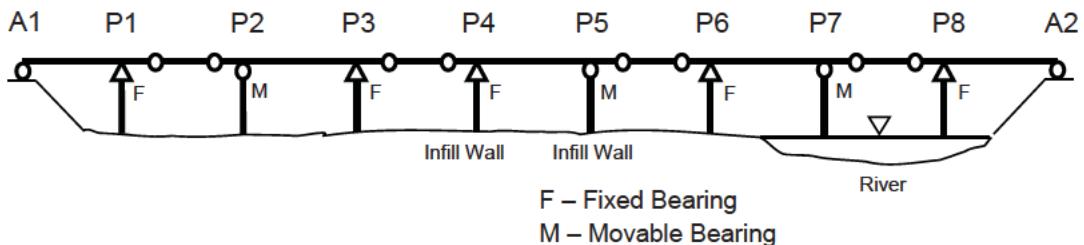
FIGURE 8 – LOCATIONS OF IN-SPAN HINGES AND F-M BEARINGS IN THE SHIDA BRIDGE (Graphic: L. Marsh)

The superstructure rests on steel bearings at each pier and each continuous span (i.e. alternate spans to the drop-in spans) has one fixed and one movable (sliding) bearing in the longitudinal direction arranged as shown in Figure 8.

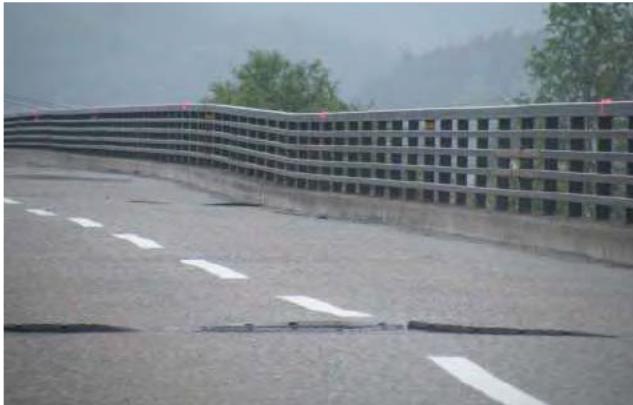
FIGURE 10 – SETTLEMENT IN BARRIER AND DECK AT PIER 3, SHIDA BRIDGE (Photo: D. Frost)

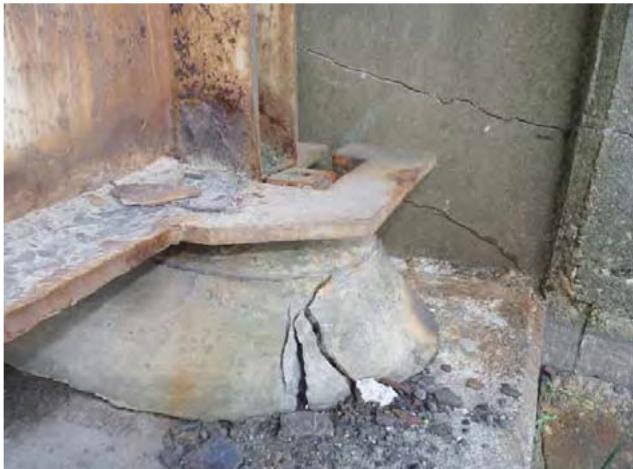
Approximately 15 cm of settlement occurred in the backfill behind the abutment and pressure behind the abutment backwall was sufficiently large to crack and yield this wall. This likely occurred as the abutment fill settled and moved towards the river channel during the earthquake. The abutment is founded on a levee that parallels the river channel and movements in this levee, just upstream from the bridge, are described later in this section.

FIGURE 11 – DAMAGE TO PEDESTAL AND ABUTMENT BACKWALL, SHIDA BRIDGE (Photo: E. Monzon)

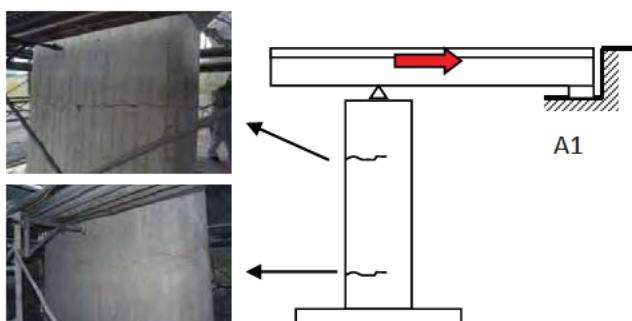
FIGURE 12 – FLEXURAL DAMAGE IN PIER 1 DUE TO LONGITUDINAL MOVEMENT, SHIDA BRIDGE (Photos and Graphic: E. Monzon)

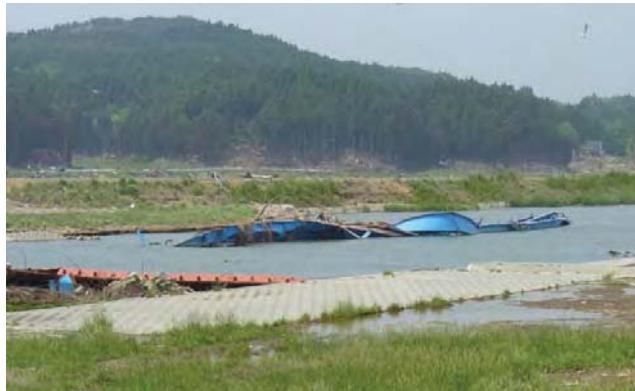
It is clear that the longitudinal dampers installed at the abutments and the transverse keys (stoppers) over the piers, offered little restraint to the lateral loads imposed by tsunami. Once these devices failed, the relatively light weight of the steel I-girders, together with the buoyancy effects of air trapped between the girders, enabled the superstructure to be easily lifted and carried significant distances upstream. The loss of Pier 3 was probably due to scour but this could not be confirmed. Despite the low tide at the time of the visit, the foundation was still underwater.

FIGURE 14 – GIRDERS FROM KOIZUMI BRIDGE 400m UPSTREAM IN TSUYA RIVER CHANNEL (Photo: E. Monzon)

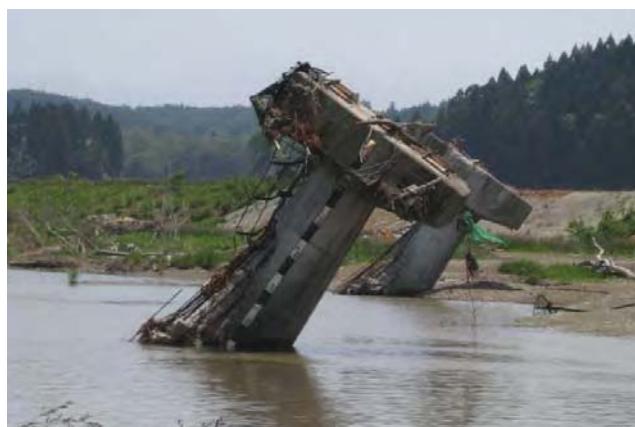
About 900 m upstream of the Koizumi Bridge, the JR East rail line to Kesenuma crosses the Tsuya River on a multispan, prestressed concrete girder viaduct. Five of these spans were washed out, but the piers survived (Figure 15). The in-coming tsunami apparently breached the levee behind the piers allowing flow oblique to the channel. The piers are tilted toward the breach, and the simple span, three-girder superstructures came to rest on the opposite side of the levee.

FIGURE 15 – DAMAGED PIERS OF THE JR RAIL VIADUCT AT THE TSUYA RIVER (Photo: S. Dashti)

Of interest is the damage to the lower portions of the piers. The exposed reinforcement seen on the left side of the each pier appears to have been pulled outward from the center of the column and rupturing the relatively light transverse steel. This type of behavior is seen in the failure of beams that are unreinforced for shear, where a shear crack precipitates failure and tearing of the tensile reinforcement from the beam. In the case of the JR East piers, potential buoyancy of the superstructure due to trapped air and the hydrodynamic forces produced lateral loads on the piers along with eccentric vertical loading. The piers may have failed in shear above the foundation after plastically deforming under the combined lateral and vertical effects. Following the loss of shear capacity at the base, the tension reinforcement was torn from the piers.

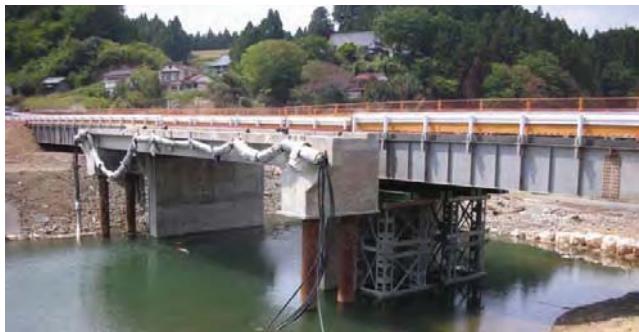
Apart from the loss of the seaward extension, this bridge has performed remarkably well from a structural point of view. It is essentially intact and the principal reason for closure was the loss of back fill due to erosion. Despite the buoyancy of trapped air, the superstructure was well anchored both vertically and laterally to the abutment seats and was not dislodged by the tsunami despite being overtapped. It is of course possible that the erosion of the abutment backfills and the opening up of two alternative hydraulic channels took load off the bridge, but nevertheless the performance of this bridge under these circumstances is noteworthy.

FIGURE 16 – LOSS OF BACKFILL ON BOTH APPROACHES TO SINGLE-SPAN NIJYU-ICHIHAMA BRIDGE (Photo: L. Marsh)

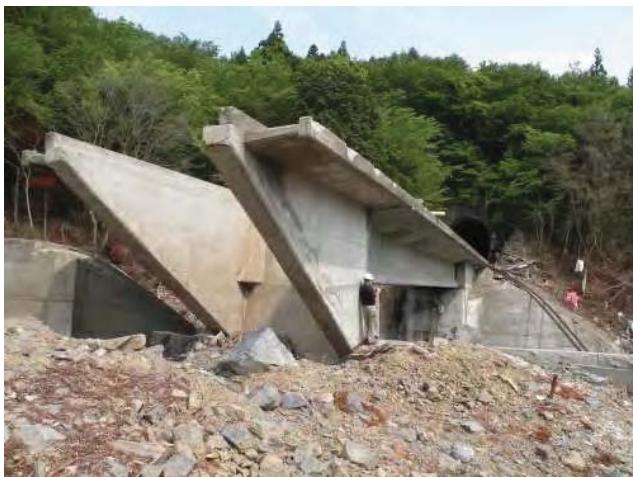
FIGURE 17 – EXPOSED WINGWALLS OF JR RAIL BRIDGE 100m UPSTREAM OF NIJYU-ICHIHAMA BRIDGE DUE TO LOSS OF APPROACH EMBANKMENT (Photo: D. Frost)

bridge over the river (Figure 17). The unprotected embankment fill appeared to be a granular material. As the wave overtopped the embankment, it displaced the tracks and significantly scoured and removed the upper 4 to 5 m of the fill. Apart from the loss of the approach fills, all the bridges in the valley appeared to be intact.

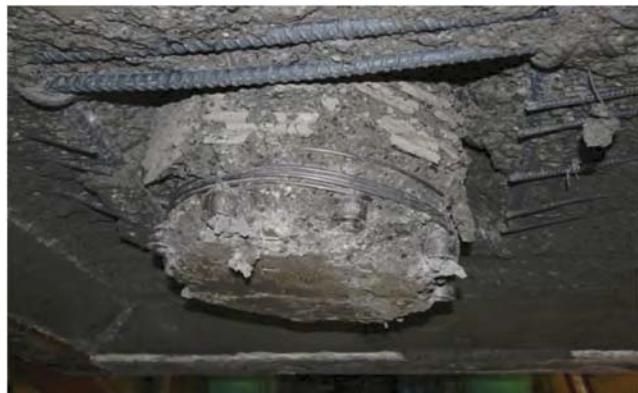
Figure 8 shows Specimen SF-3, seen from below, after failure. The column can be seen to be relatively intact, with all the damage concentrated in the surrounding footing concrete. The failure surface suggests a punching shear failure under combined vertical load and bending.

FIGURE 8. SPECCEIMEN SF-3 AFTER FAILURE (FROM BELOW).

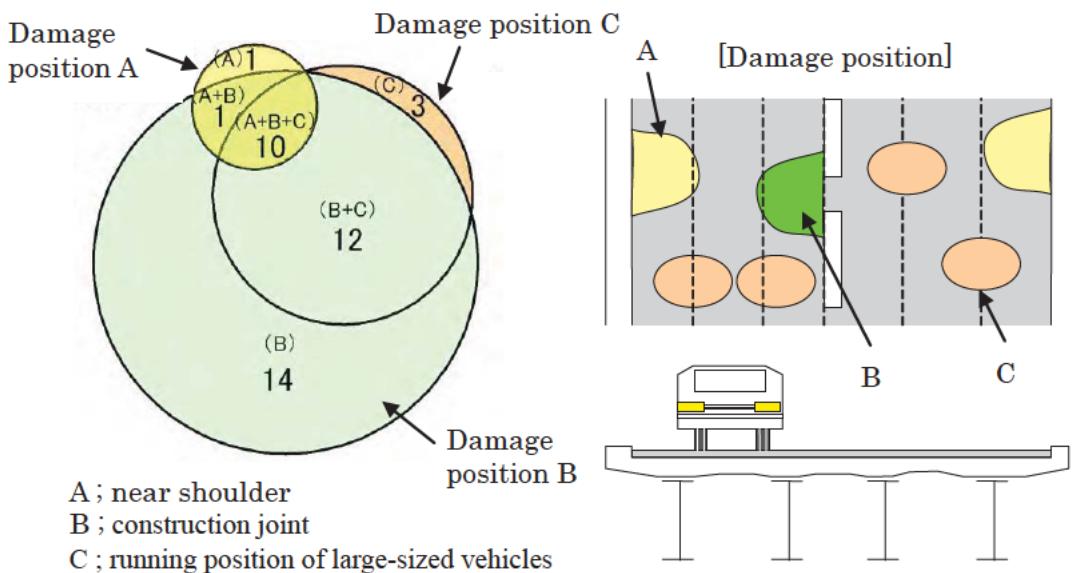
We did a questionnaire survey, in 2006, for about 400 bridges repaired by overlaying. The survey showed that re-deterioration occurred in 12% of bridges. When we studied the record of damage and analyzed damage positions, we found that potholes occurred most at the construction joint between lanes (Fig.2) and tended to be near the shoulder next to running position of large-sized vehicles. Fig.3 shows the cross section of floor slab where many potholes were found. The damage state indicates infiltration of water from the construction joint and staying of slag at the boundary between existing floor slab and overlaying.

Fig.2 Damage position of overlaying floor slab

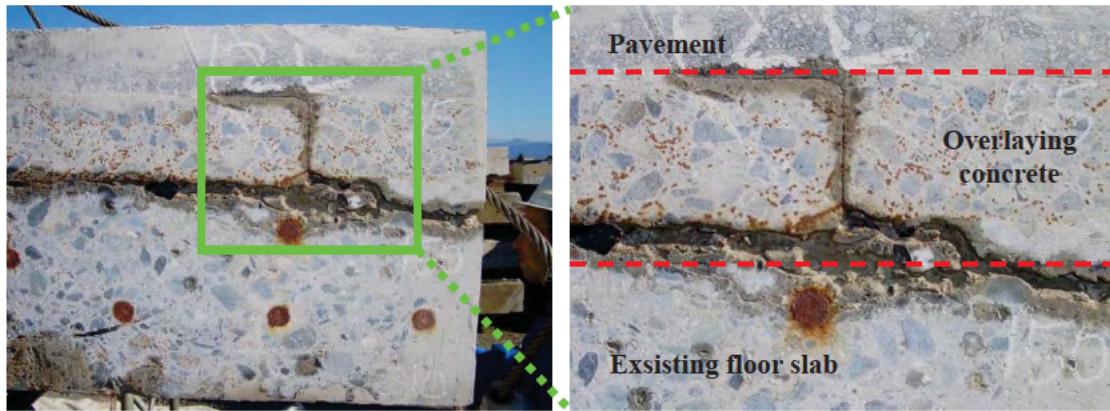
Fig.3 Section of floor slab with many potholes at construction joint

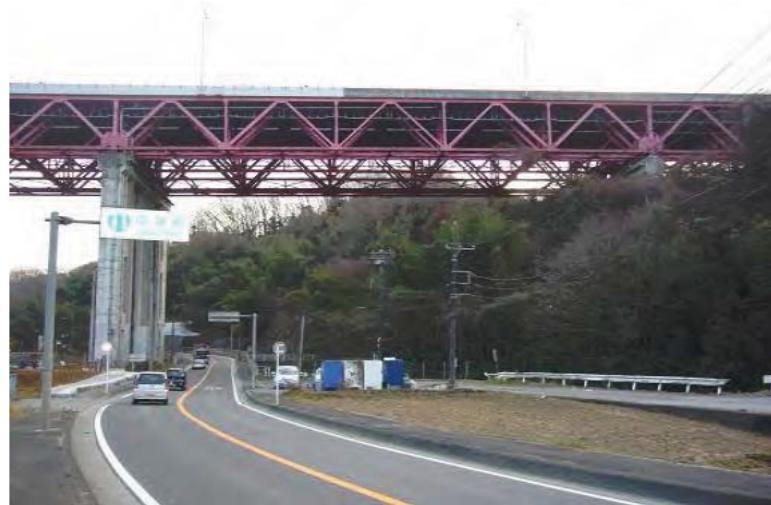
In 2002, we repaired a re-deteriorated floor slab of a steel truss bridge which was reinforced by overlaying in 1990 (Fig.8). As some ten years had passed since the repair, potholes were often found in the pavement. Inspections showed that there was separation between the existing floor slab and overlaying concrete. It was assumed that this separation caused the damage to the pavement. Thereupon, we tried injecting resin in the interface of the re-deteriorated floor slab. This method was selected considering safety of road users and so that roadwork restrictions to control traffic are held down as much as possible as traffic on the bridge was more than 80,000 vehicles per day.

Fig.8 The bridge repaired by overlaying floor slab

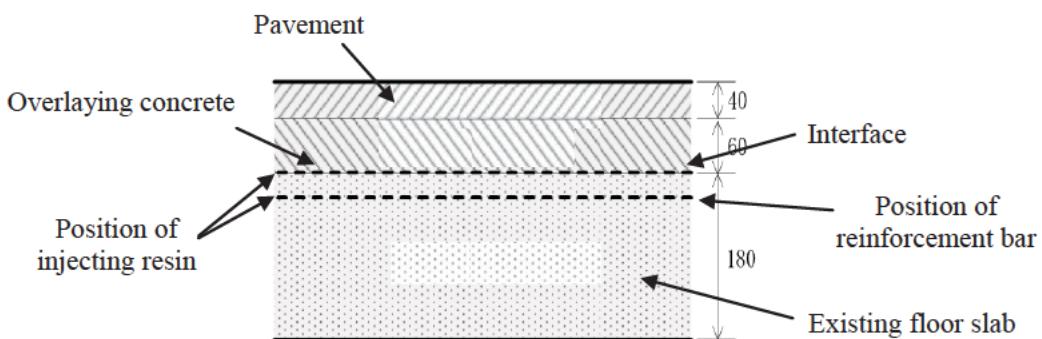
Fig.9 Section where resin was injected

Fig.9 shows a section of the bridge actually repaired by injecting resin. After cutting the pavement, injection holes 100mm deep and with a diameter of 10mm were drilled, and the resin was injected. The resin was partly injected from the pavement surface as traffic control requirements restricted the work that can be carried out (Fig.10). In either case, the holes were cleaned by air (compressed air infusion) after drilling. But places where the concrete have turned to gravel were washed with water. Resin was injected every 1m in both longitudinal and perpendicular directions. Core sampling was performed after injection, and it was confirmed that filling was satisfactory in most of the repaired locations.

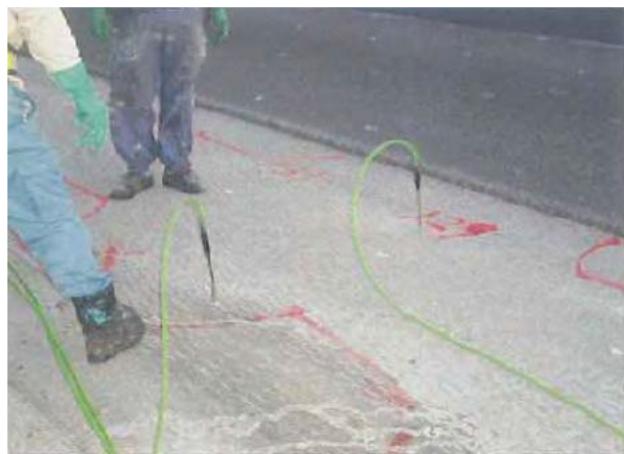
Fig.10 Shows resin being injected

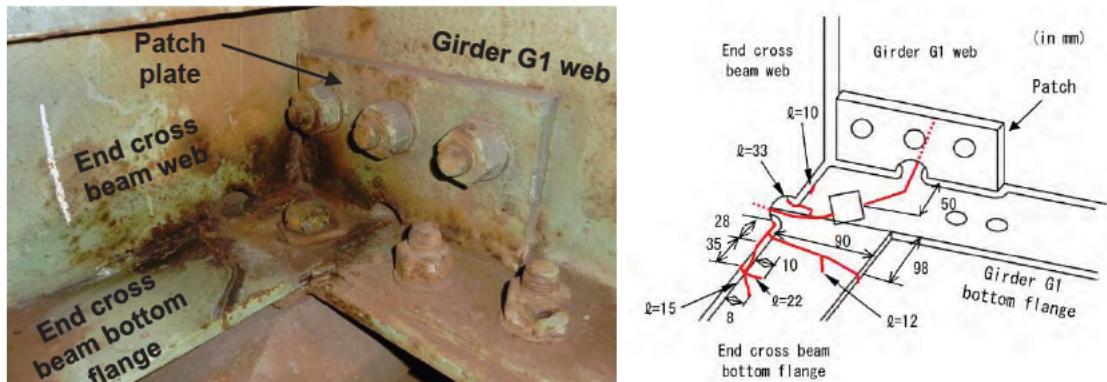
Cracks in girder G1 initiated in weld beads between the sole plate and the end cross beam bottom flange and grew penetrating through the flange and partly propagating further into the weld between the flange and the web of the end cross beam. Cracks were also found in the main girder bottom flange, originating at around the bearing set bolt. None of them was propagating into the main girder web which had a patch plate on it.

PHOTO 1 CRACKS IN GIRDER G1

Gap was found between the sole plate and the top shoe in both girders G1 and G7. The girders were found to move in the vertical direction with every passage of vehicle, generating metal sound.

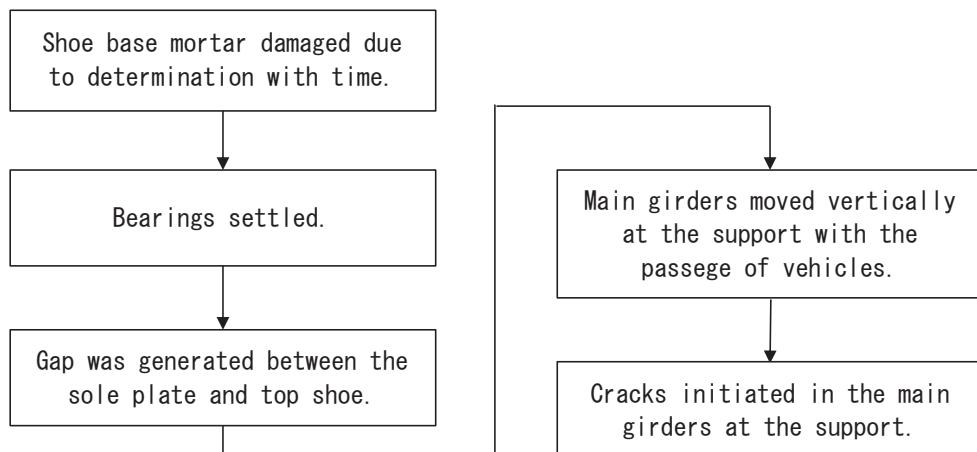
The focus was then moved to the damage to the shoe base mortar on girders G1 and G4. The assumption was that deterioration of the shoe base mortar with time caused settlement of the bearings, which resulted in vertical movements of the main girders, giving impacts to the damaged parts (Figure 6).

FIGURE 6: COURSE OF DAMAGE EVOLUTION
