# Lessons Learned from the Flood Disaster in Industrial Estates/Parks/Zones in Thailand

— Based on the experience of the 2011 flood —

Technical Note of PWRI No. 4322

## **Technical Note of PWRI**

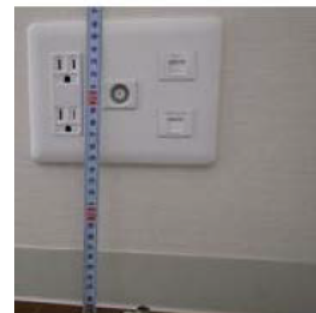
Electric outlet and modular jack with slots 20cm from floor

#### **Relationship between inundation depth and impact on evacuation or power supply**

- 30 cm: Water level beyond which automobiles (including ambulances) cannot travel easily and people requiring assistance during a disaster cannot be evacuated easily.
- 50 cm: It is difficult to move on foot.
- 60 cm: JAF's tests have shown that sedans and SUV cannot travel easily.
- 70 cm: Power fails as power outlets are submerged. (70cm = floor height of 50cm + outlet height of 20cm above floor). If fixed modular jacks of communication devices are at the same height as electric power outlets, communication function also fails.

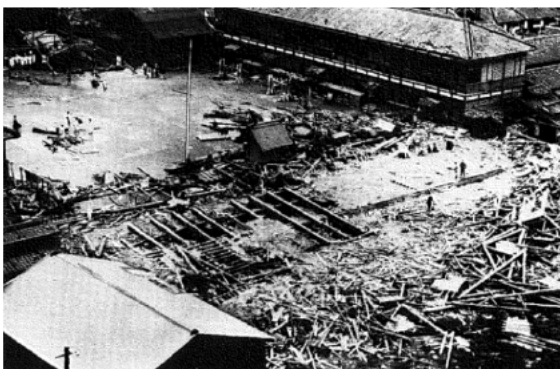
Elementary school in Osaka damaged by the Muroto Typhoon (1934)<sup>[18]</sup>
